Our ref: PS134976-ASB-REP-001-RevA

29 November 2022

Wickham Woolshed Ongoing Airborne Fibre Monitoring

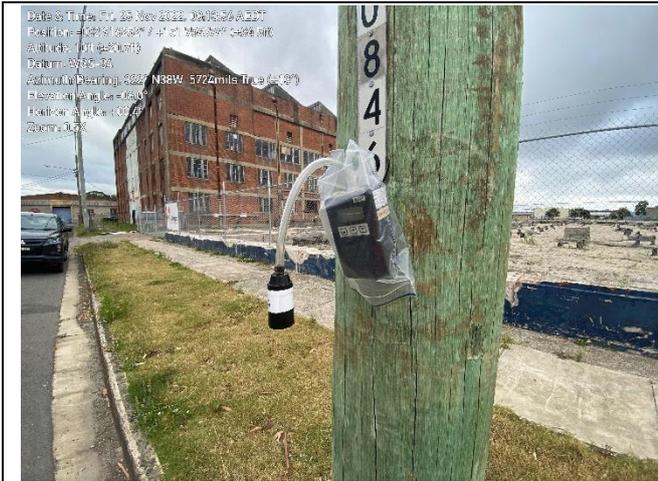
- The monitoring location was directly adjacent (south) to the previous location of the wool store fire site.
- The impact site has been cleared down to timber footings.
- No obvious signs of asbestos containing material (ACM) contamination to public areas were observed.
- The third (western) wool store building remains standing, with an assumed ACM roof in-situ and is fenced-off due to dilapidation.
- Some level of residual ACM contamination is assumed to inaccessible areas nearby.

Photo 1: Annie Street monitoring location

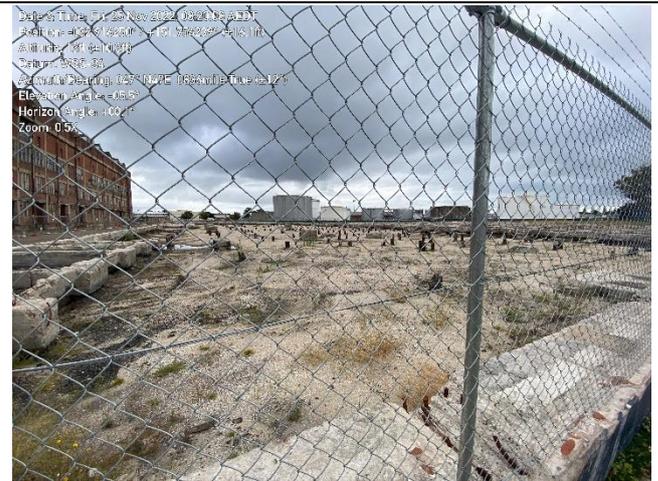
Photo 2: The previous location of the wool store fire

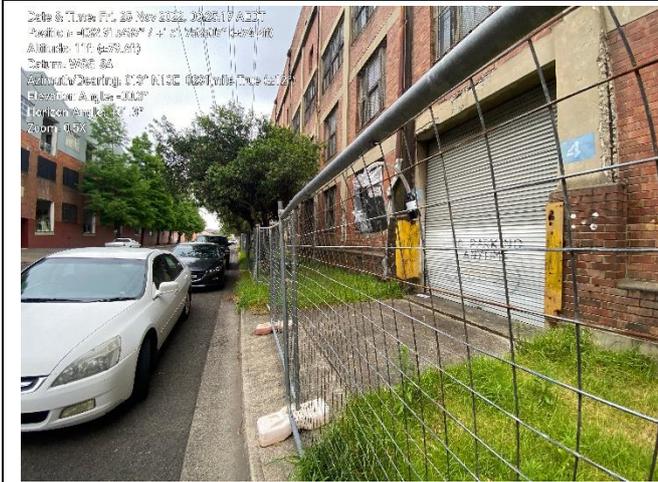
- The monitoring location was directly adjacent to the third (western) remaining wool store building on Milford Street, which remains standing, with an assumed ACM roof in-situ and is fenced-off due to dilapidation.
- No obvious signs of ACM contamination to public areas were observed.
- Some level of residual ACM contamination is assumed to inaccessible areas nearby.

Photo 3: Milford Street monitoring location

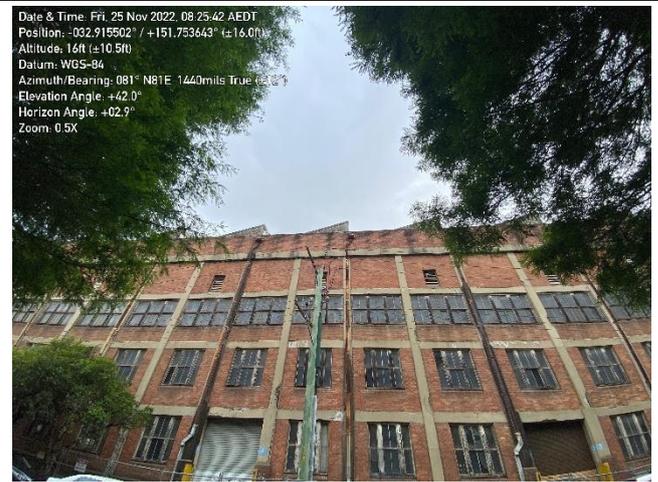
Photo 4: The remaining wool store building with asbestos roof structure assumed

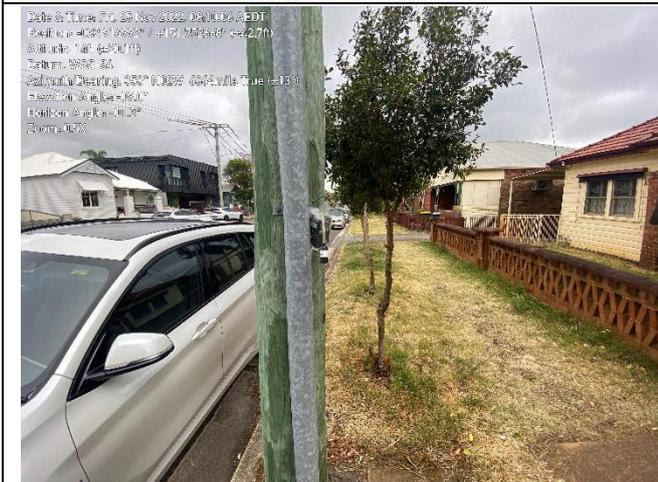
- The monitoring location was directly adjacent to 27 Roslyn Avenue on the eastern side of the street.
- Nearby suspected ACM debris was observed to the base of trees outside the Soqué Warehouse Apartments and to road guttering throughout the street.

Photo 5: Roslyn Avenue monitoring location

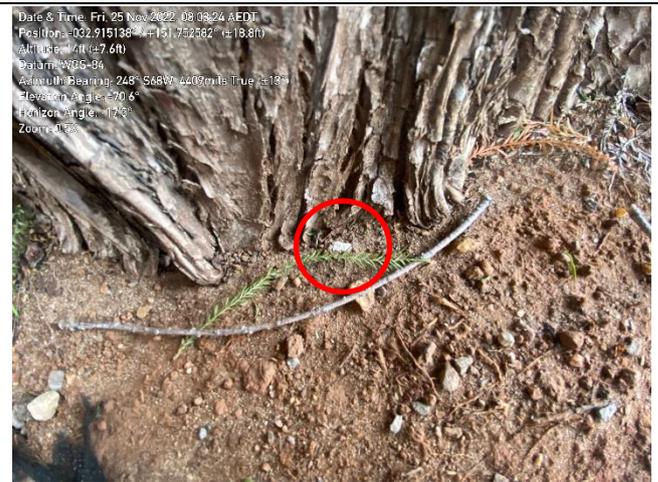
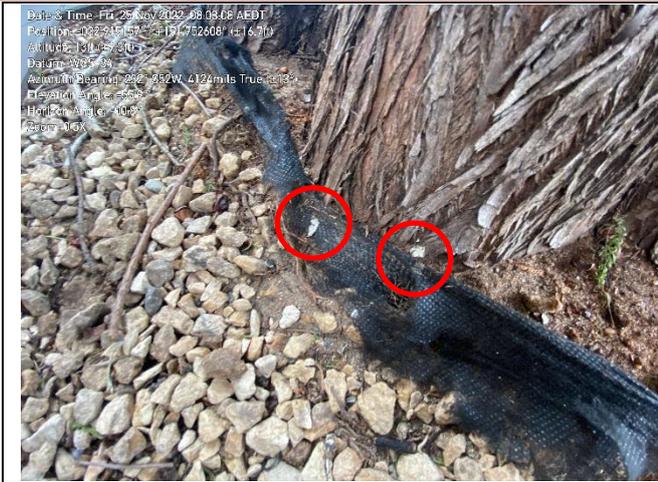
- Apartment roof areas to the east may be a source of ongoing contamination following extreme wind events.
- Horizontal rainwater pipes may be a source of ongoing gutter contamination due to inaccessibility during remediation works.
- Some level of ACM contamination is assumed to inaccessible areas nearby.

Photo 6: Suspected asbestos debris observed to base of tree adjacent Soqué Warehouse Apartments

Photo 7: Suspected asbestos debris observed to base of tree adjacent Soqué Warehouse Apartments

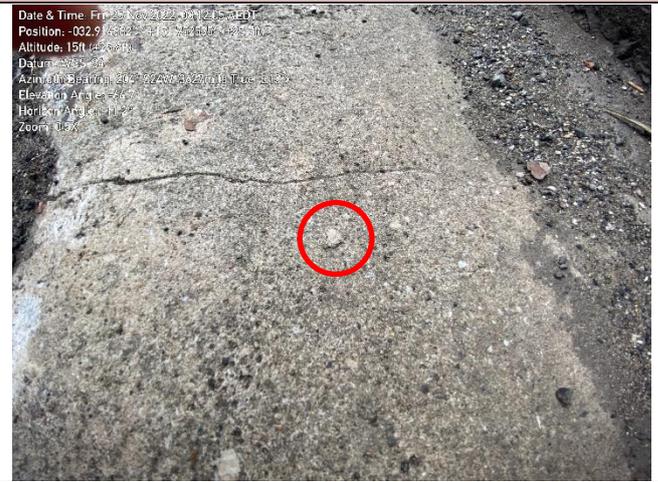
Photo 8: Suspected asbestos debris observed to road gutter adjacent monitoring location

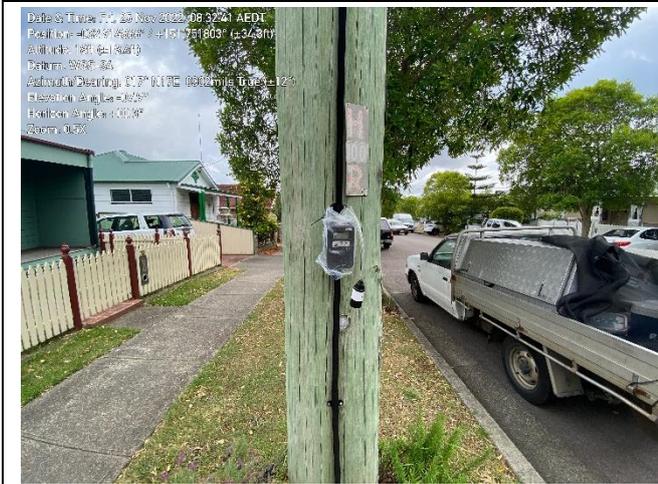
- The monitoring location was directly adjacent to 32 Norfolk Avenue on the western side of the street.
- No obvious signs of ACM contamination to public areas were observed.
- Some level of residual ACM contamination is assumed to inaccessible areas nearby.

Photo 9: Norfolk Avenue monitoring location

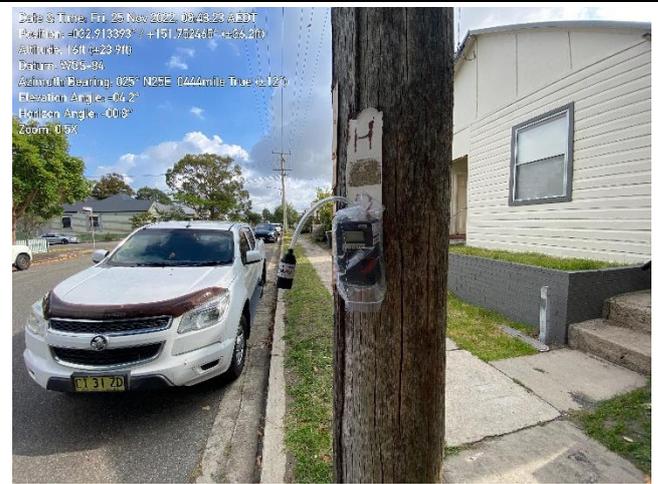
- The monitoring location was directly adjacent to 1 Estell Street on the eastern side of the street.
- No obvious signs of ACM contamination to public areas were observed.
- Some level of residual ACM contamination is assumed to inaccessible areas nearby.

Photo 10: Estell Street monitoring location

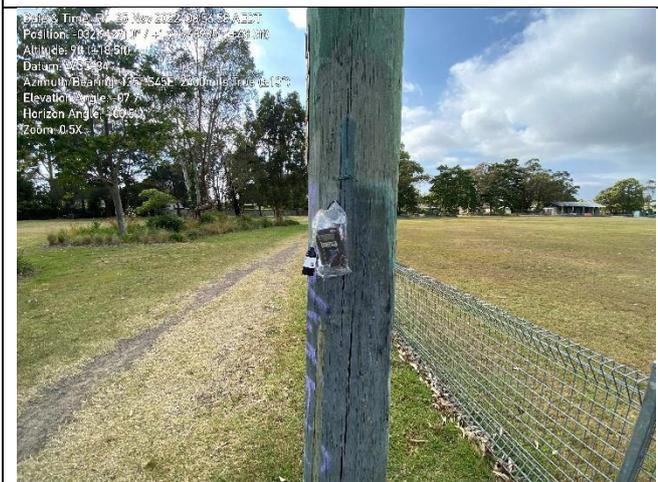
- The monitoring location was to the northern side of the sports field, adjacent to the cycle track.
- No obvious signs of ACM contamination to public areas were observed.
- Some level of residual ACM contamination is assumed to inaccessible areas nearby.

Photo 11: Islington Park monitoring location

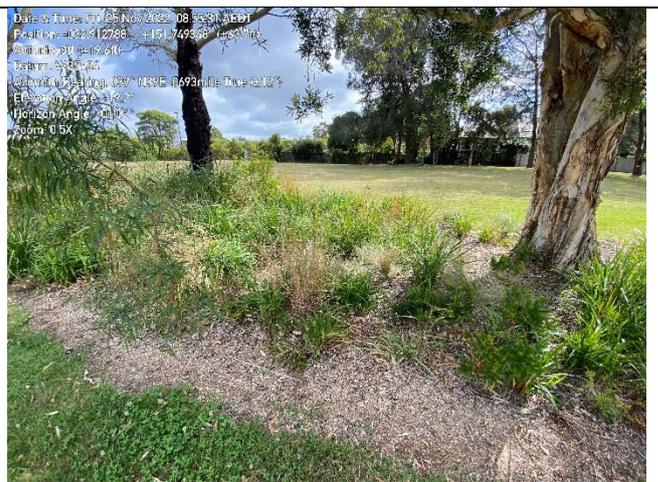
Photo 12: Asbestos debris assumed to densely vegetated areas

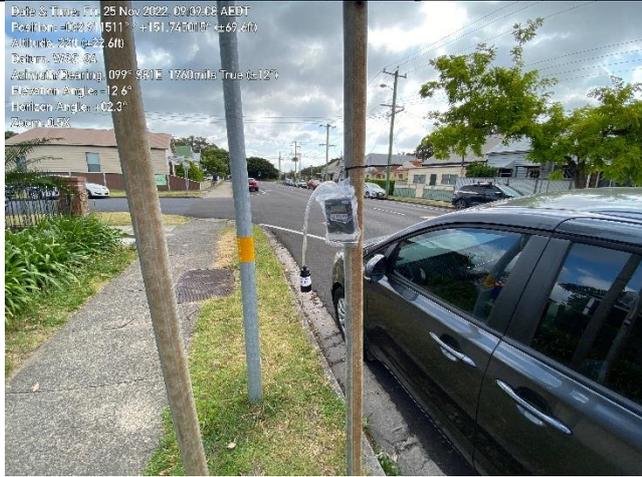
- The monitoring location was directly adjacent to 13 Hubbard Street on the northwest side of the street.
- No obvious signs of ACM contamination to public areas were observed.
- Some level of residual ACM contamination is assumed to inaccessible areas nearby.

Photo 13: Hubbard Street monitoring location

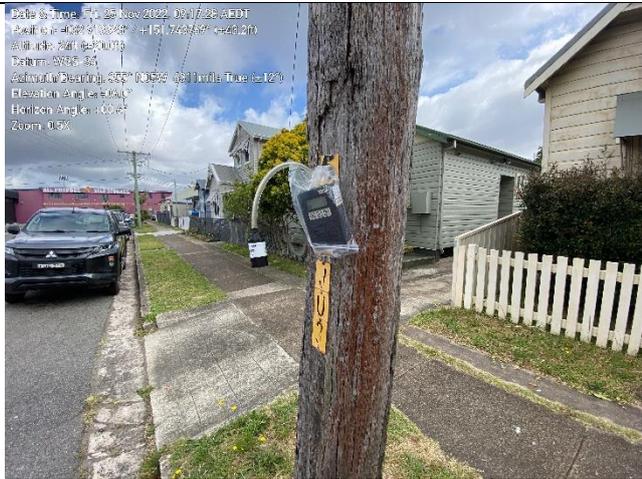
- The monitoring location was directly adjacent to 121 Fern Street on the north-east side of the street.
- No obvious signs of ACM contamination to public areas were observed.
- Some level of residual ACM contamination is assumed to inaccessible areas nearby.

Photo 15: Fern Street monitoring location

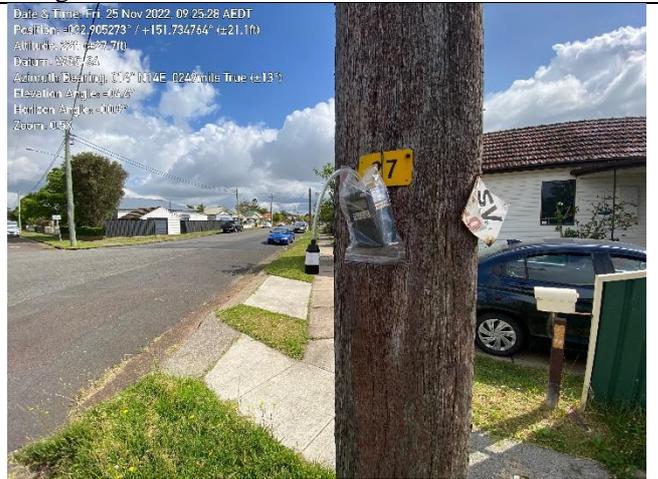
- The monitoring location was directly adjacent to 48 Rawson Street on the eastern side of the street.
- No obvious signs of ACM contamination to public areas were observed.
- Some level of ACM contamination is assumed to inaccessible areas nearby.

Photo 16: Rawson Street monitoring location

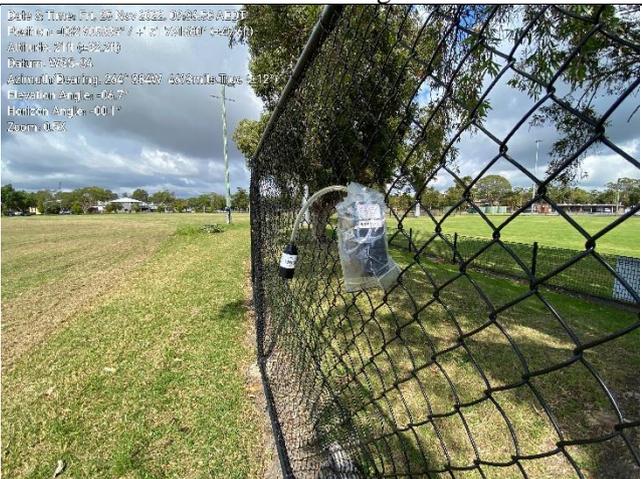
- The monitoring location was directly south-east of the Waratah Oval cricket field in the centre of Waratah Park.
- No obvious signs of ACM contamination to public areas were observed.

Photo 17: Waratah Park monitoring location
