## Internal Memo

**TO:** All Councillors  
**CC:** Acting General Manager  
**FROM:** Director Liveable City  
**DATE:** Monday 18 July 2011  
**SUBJECT:** Laman Street Risk Identification and Management

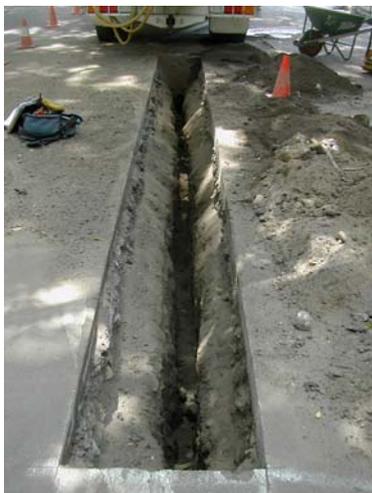
- 2006 trenching adjacent to the Fig trees found no primary woody roots.
- 2009 Ground Penetrating Radar (GPR) investigations suggested root distribution within the road and footway area.
- 2010 additional trenching to confirm the GPR findings found one woody primary root.

Trenching Laman Street Precinct 2010.

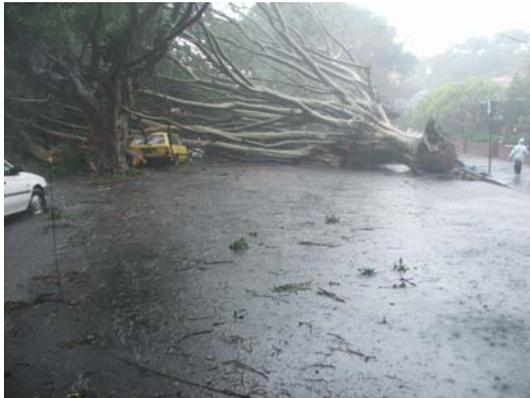
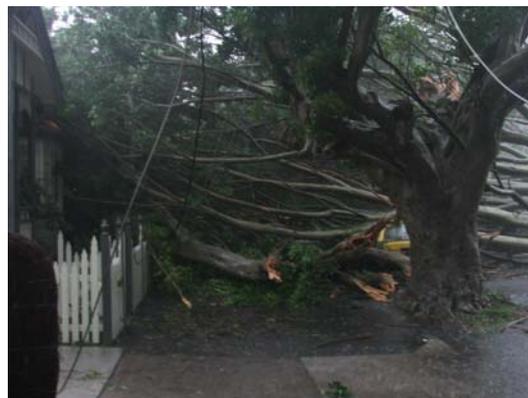
Council has also used the Matheny and Clarke hazard assessment method, having regard for the case history and accumulated technical reports. The assessment identified a high priority for the design and implementation of a risk mitigation strategy for Laman Street. The potential impact of a tree failure in Laman Street is considered severe because the case history shows large trees that failed in 2007 did not get hung up in adjacent trees or buildings. These failures due to defective linear root plates demolished adjacent large fig tree, crushed vehicles and damaged buildings.

Bruce St 2007 Hills Failure due to a defective lineal root plate.
