REVISED CONSERVATION MANAGEMENT PLAN

FORMER AUSTRALIAN AGRICULTURAL COMPANY MINE MANAGER'S HOUSE HAMILTON NSW

195 Denison Street
Hamilton NSW 2303

Prepared by EJE Heritage
December 2015
10929-CMP-001 Rev D

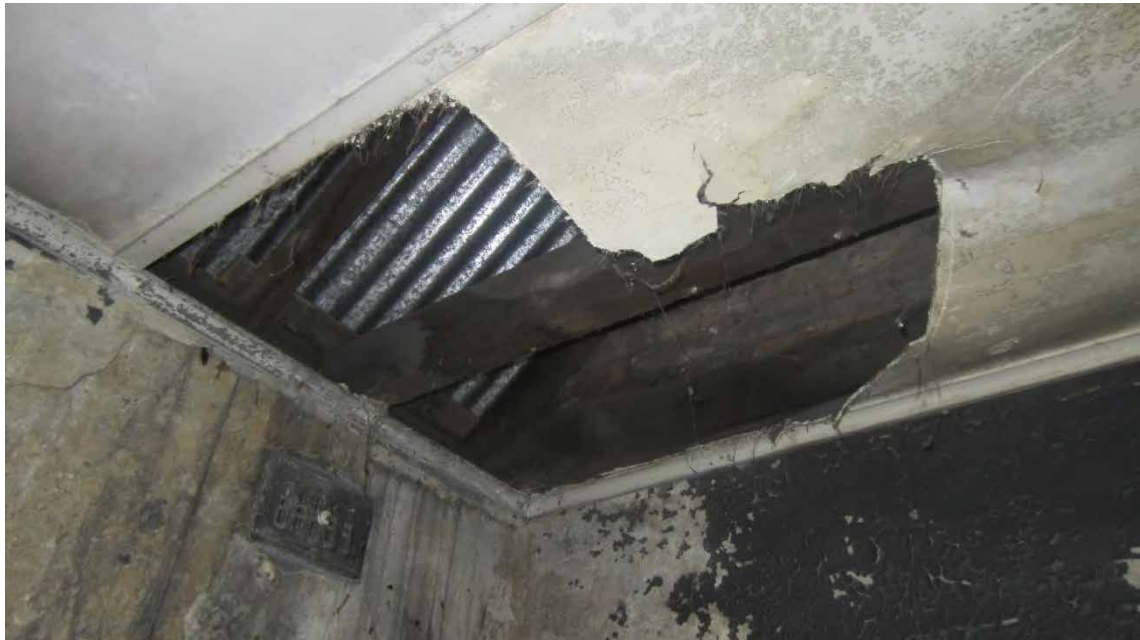
Figure 80. Water damage to kitchen ceiling.

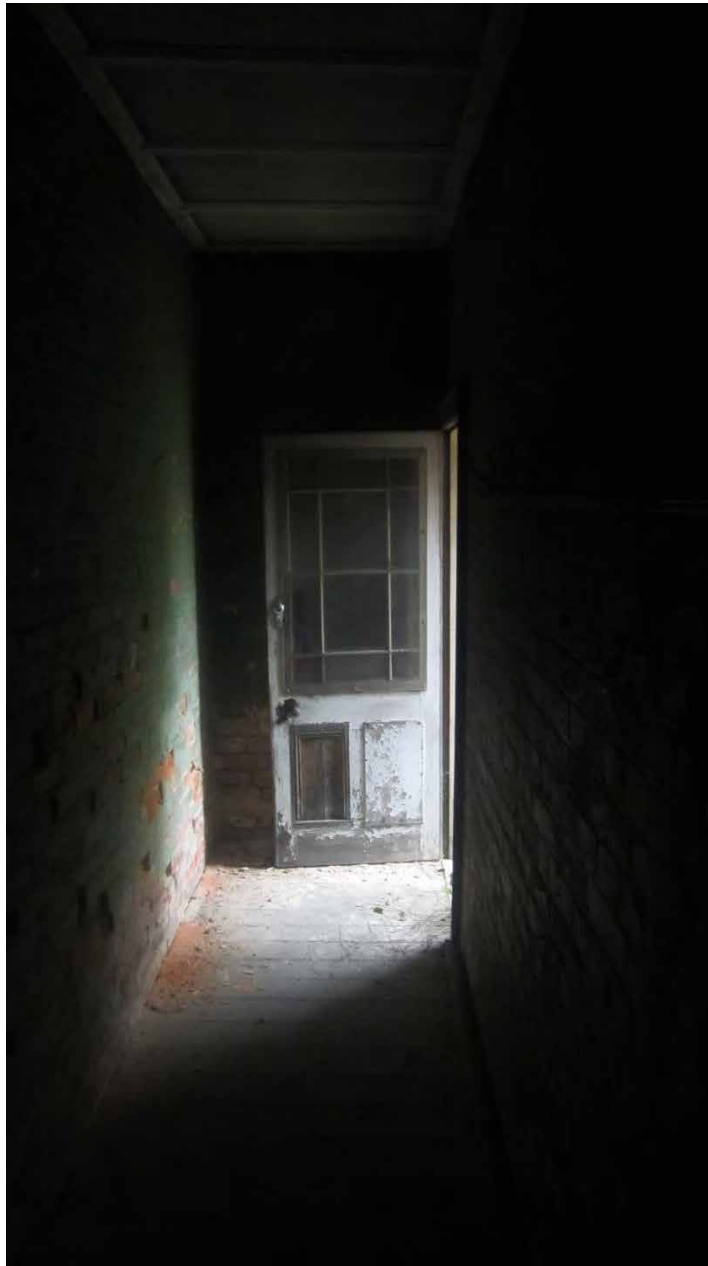
Figure 85. Hallway leading from rear entry, showing need for door glazing for natural lighting.

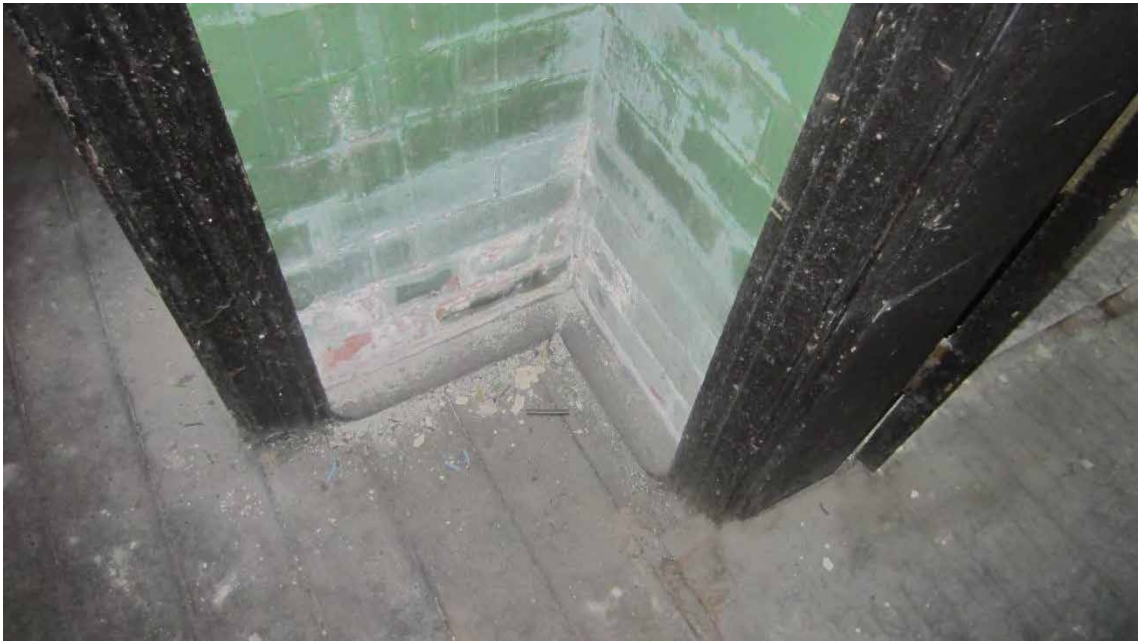
Figure 93. Damp damage at skirting level.

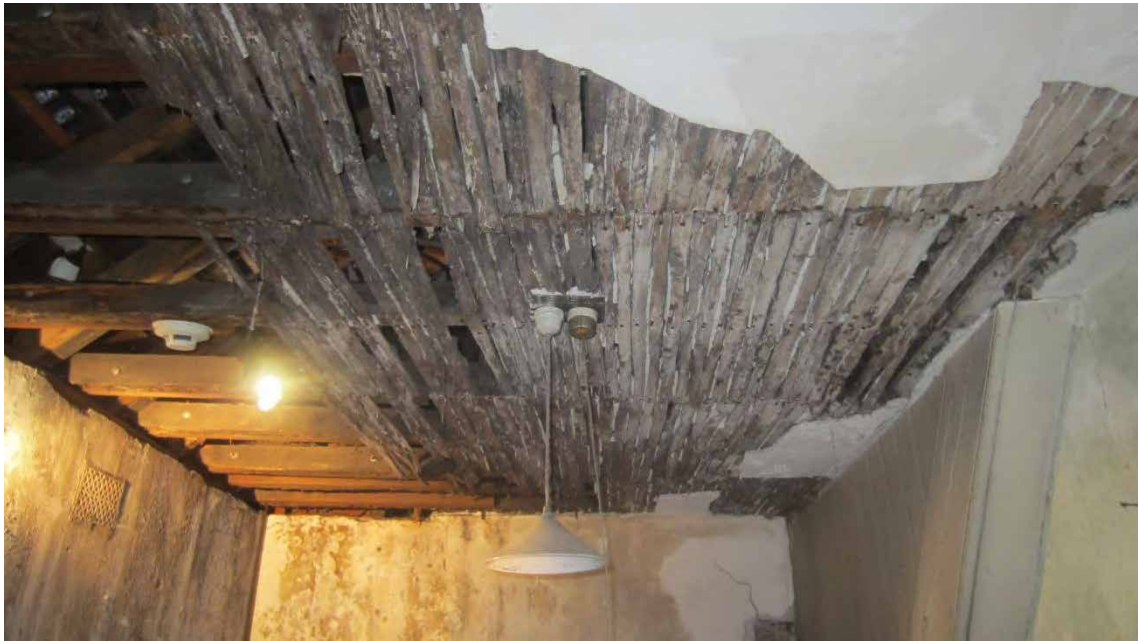
Figure 100. Ceiling of south-west bedroom, showing historic water damage.

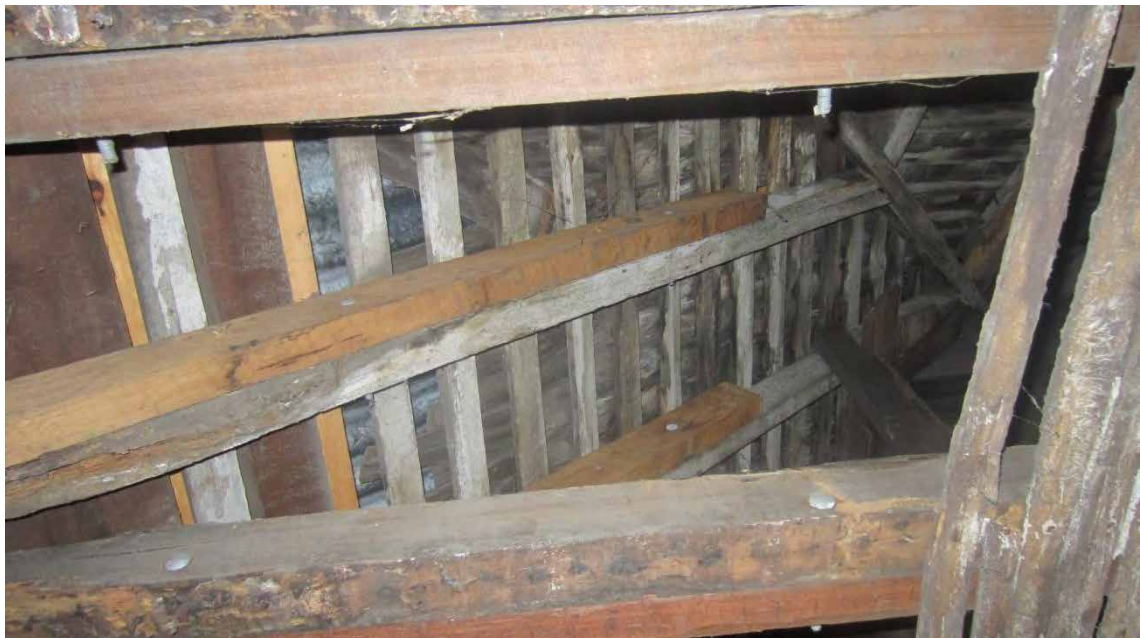
Figure 105. Depleted tongue in groove ceiling permits view of ceiling; note recent hardwood cleated to rafters and joists.

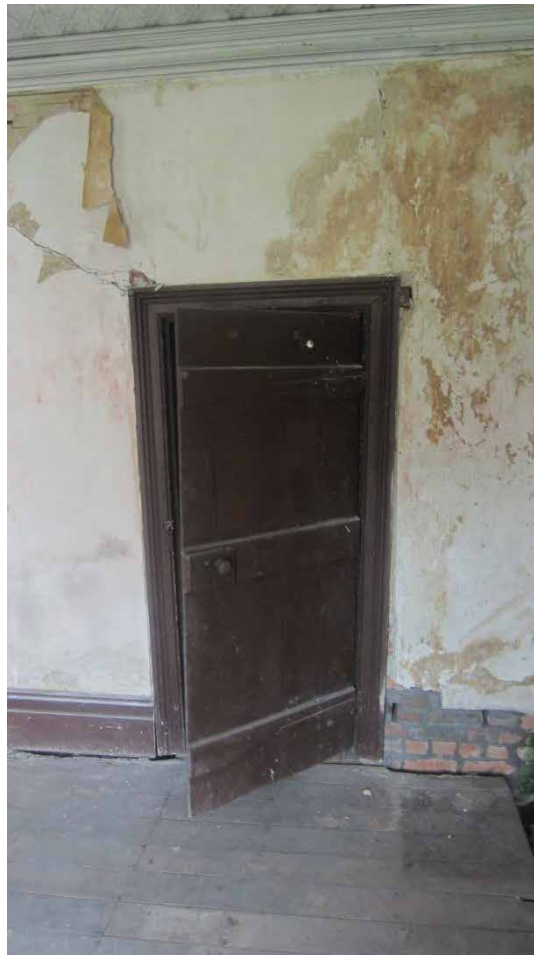
Figure 108. Sitting room: western doorway; note missing skirtings and void at right.

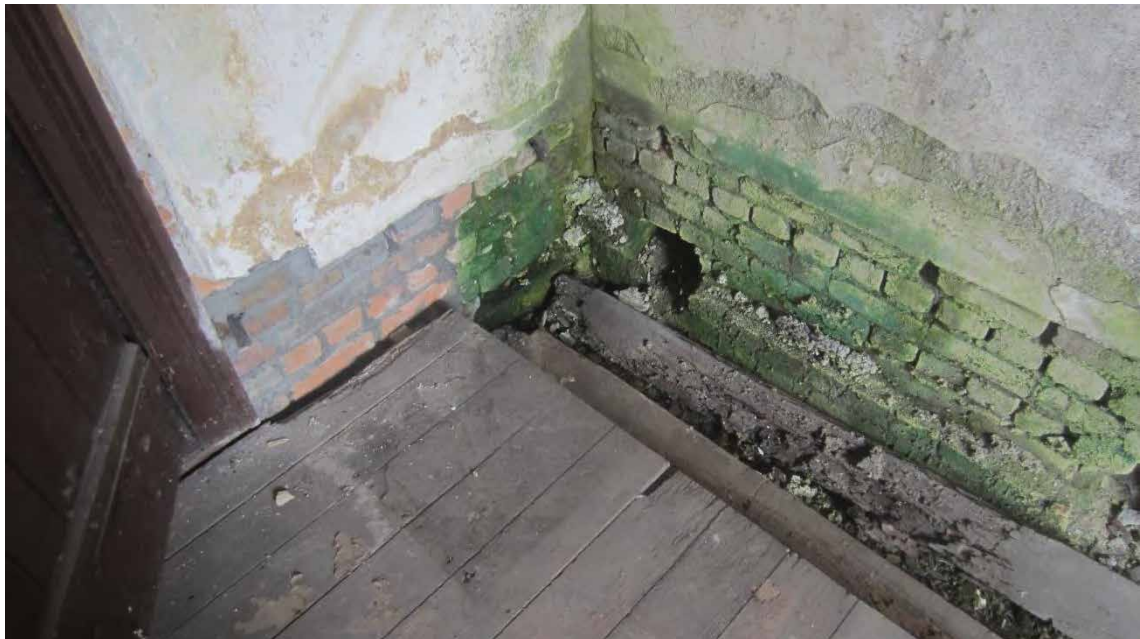
Figure 109. Sitting room, showing damp and depleted lime plaster at base of western wall (originally external); note that damage to hallway wall on left has been made good.

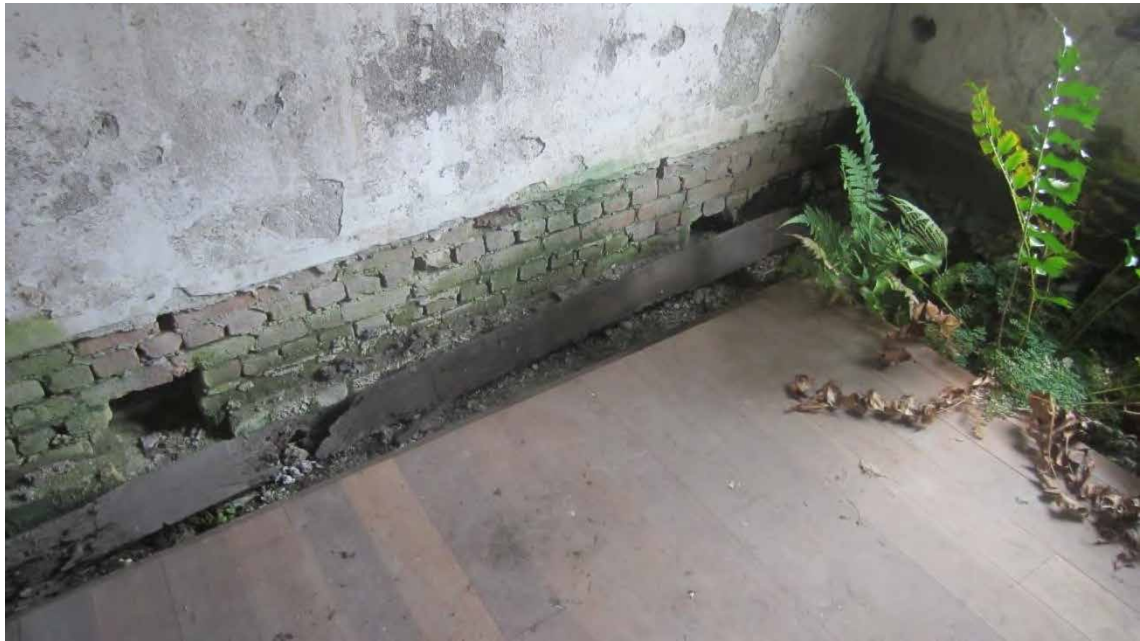
Figure 110. Western wall of sitting room; northern wall at right; note new floor, which is cannot yet be continued to wall until damp problems are addressed.

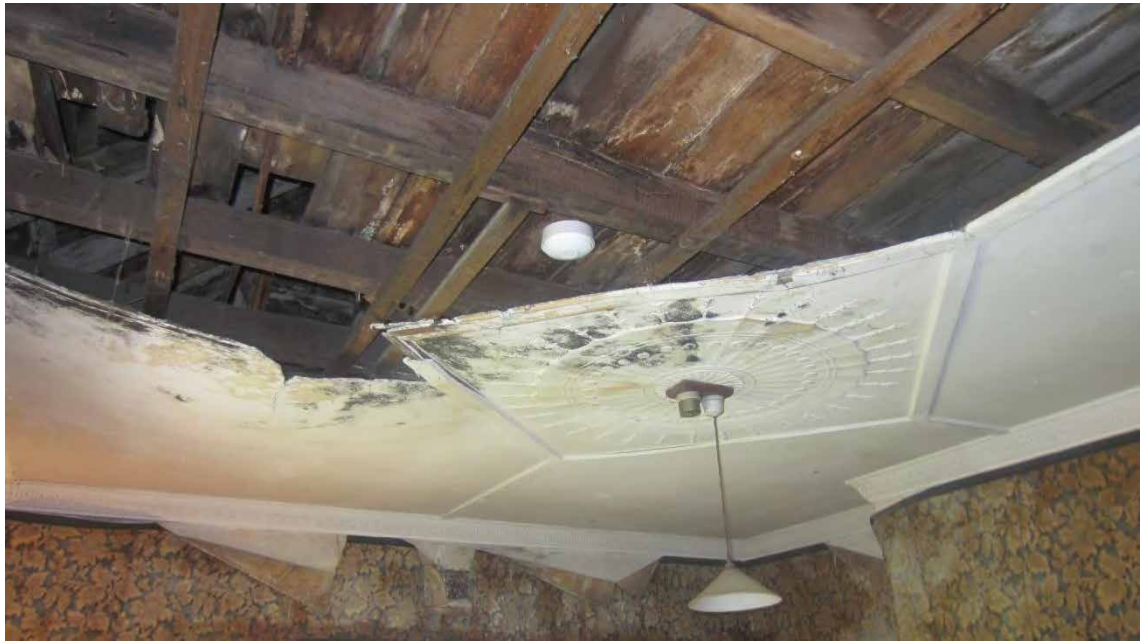
Figure 120. Damaged and depleted ceiling of south-eastern room (once also used at need as an office); ceiling dates from c. 1930s; nothing remains of original tongue in groove ceiling. Attic floor is visible.

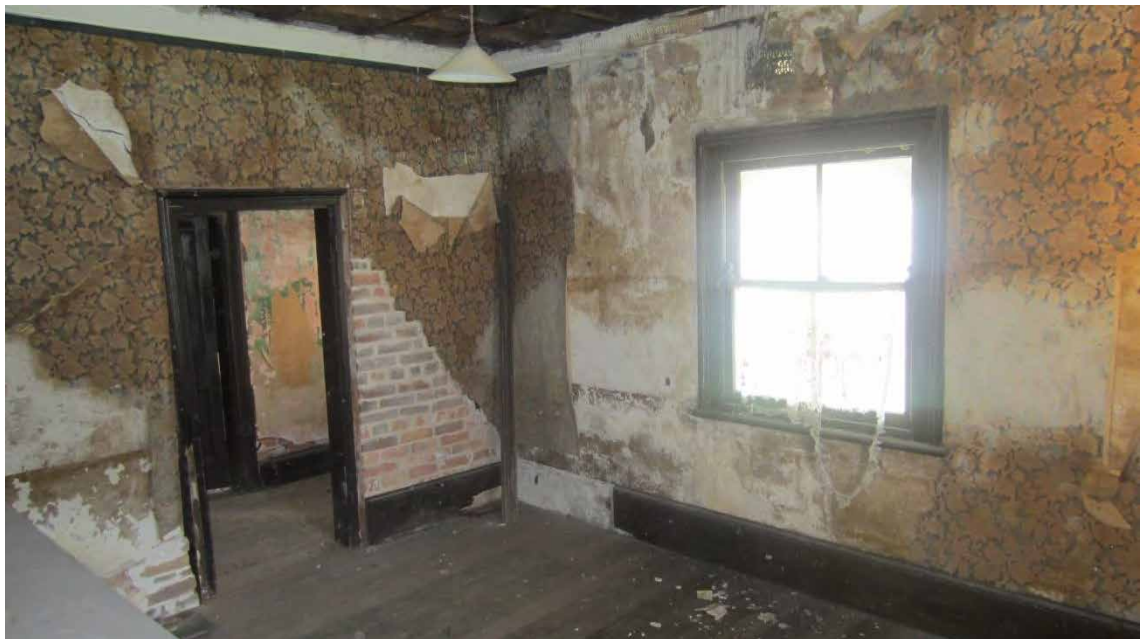
Figure 123. Looking north-east to hallway, showing partial wall reconstruction on both sides of doorway making good earthquake/ground movement damage.

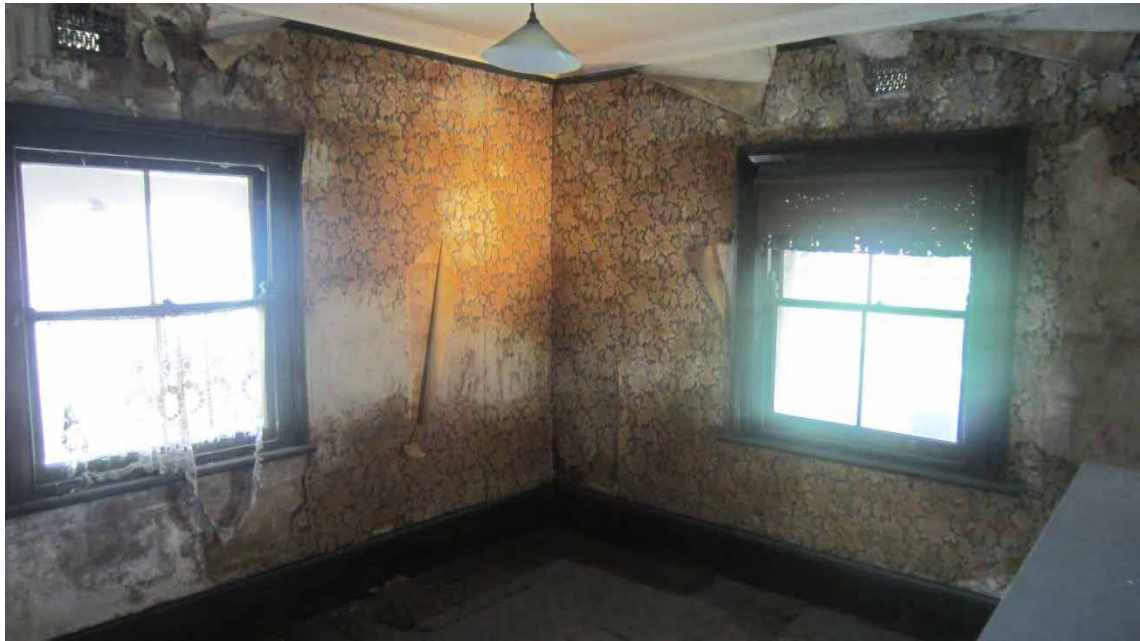
Figure 124. Looking south-east, showing windows; note peeling wallpaper and remnant curtain and blind.

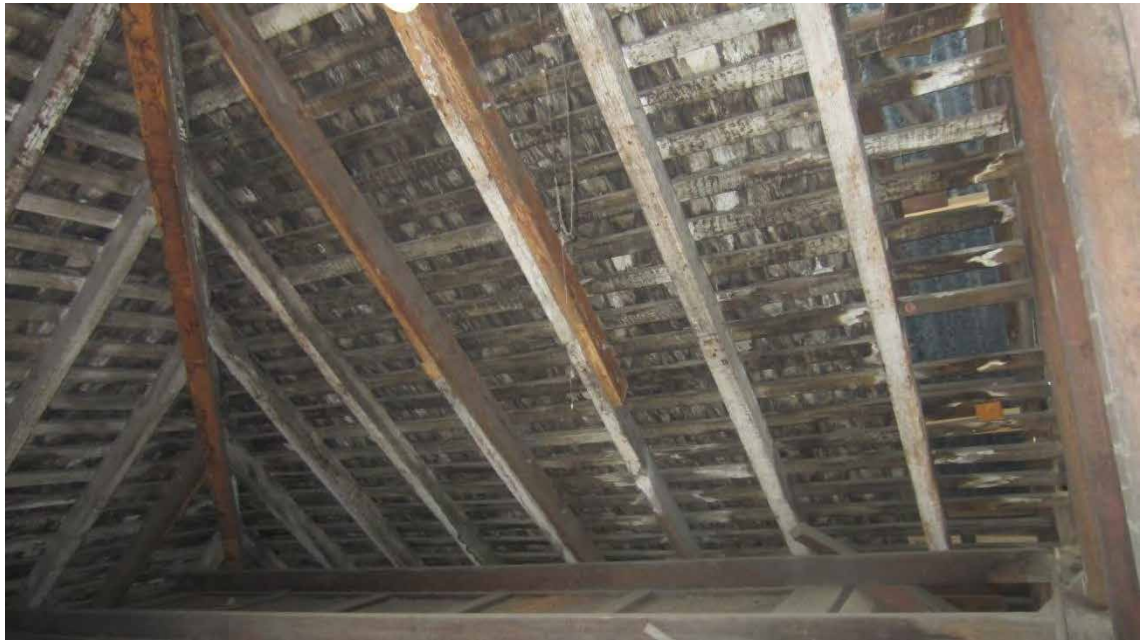
Figure 139. Roof cavity above dining room; new hardwood has been cleated to rafters following historic termite damage.

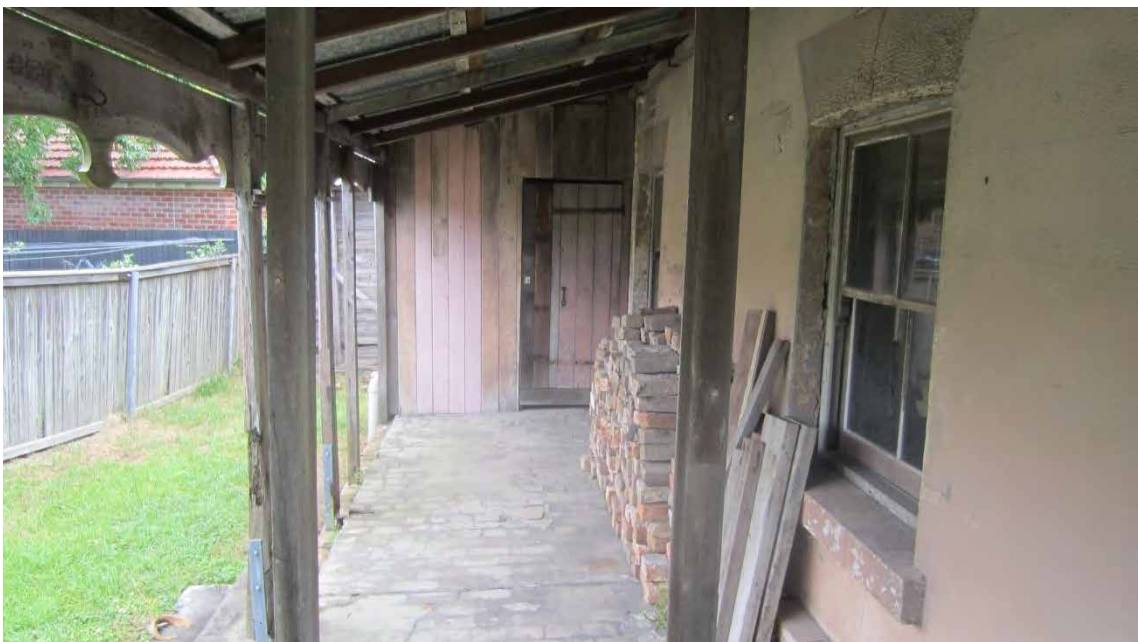
Figure 165. Southern verandah; note poor condition of verandah posts, and stockpile of bricks and timber.

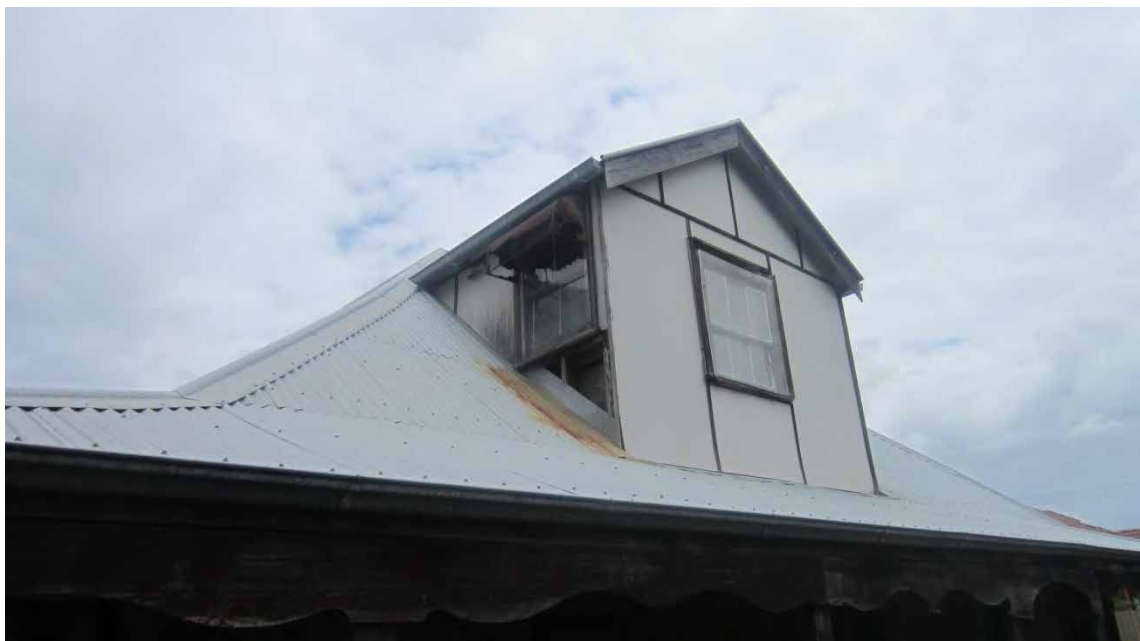
Figure 173. Corrosion marks from decaying dormer window sun canopy.

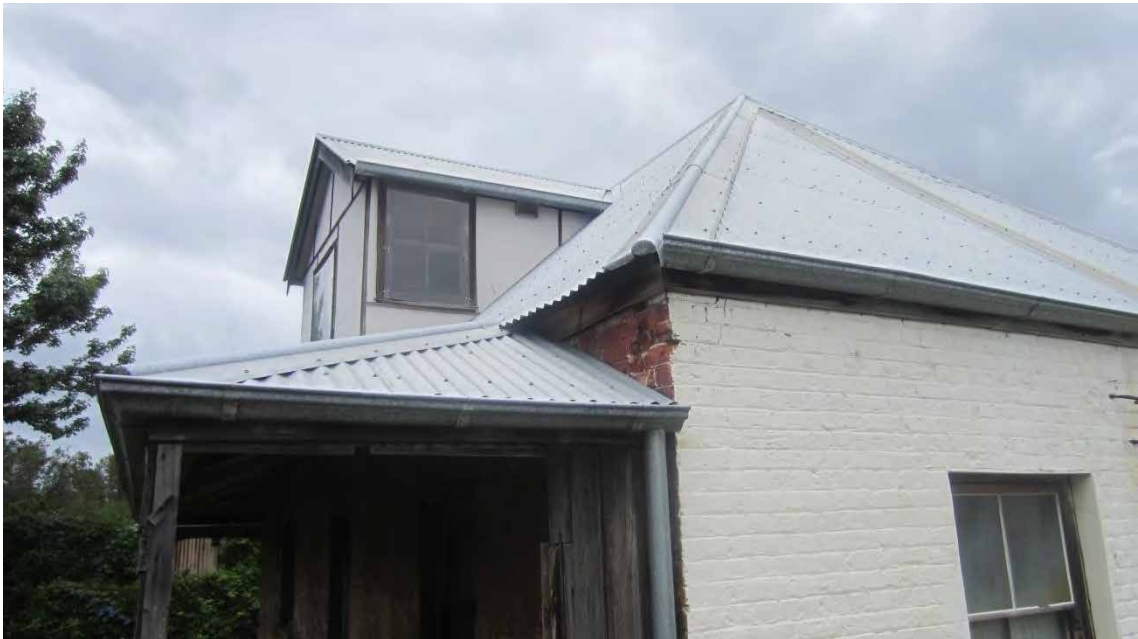
Figure 178. Missing length of gutter beneath main roof eave.

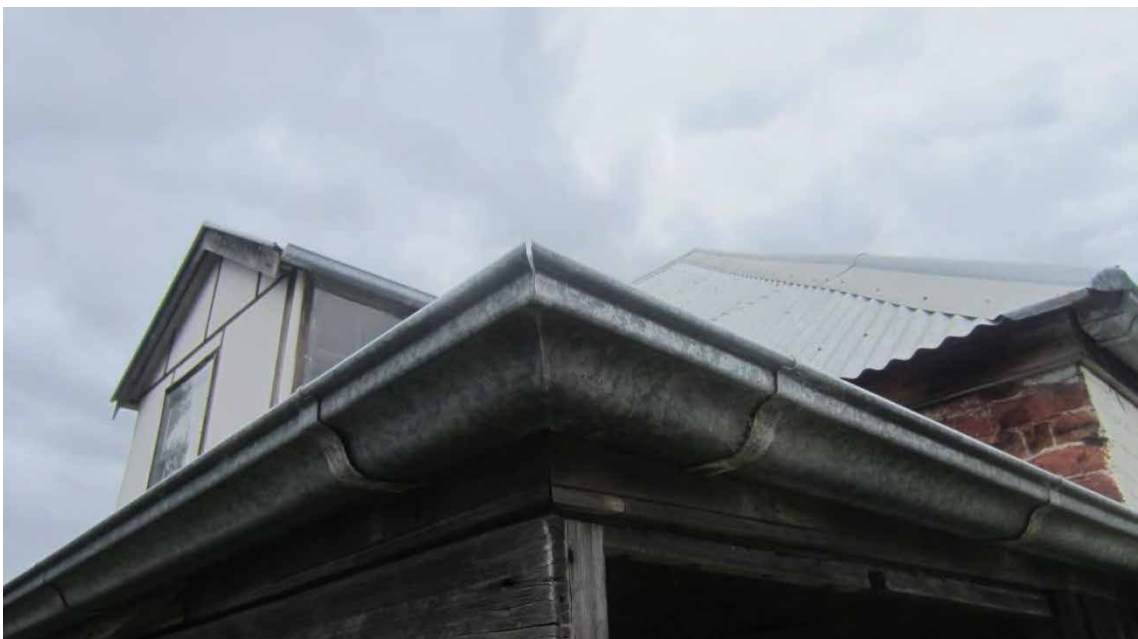
Figure 179. Unsoldered corner gutter join.
