Stockton Beach

Works Update

Managing Stockton's Coastline

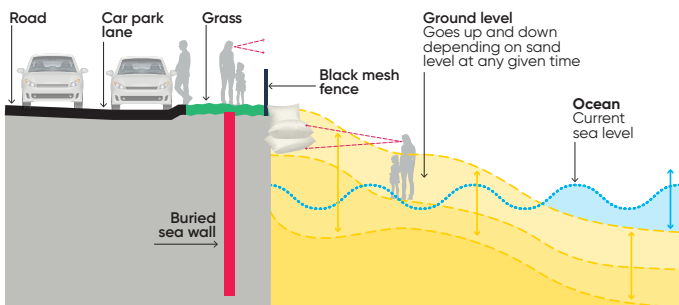
Cross-section of proposed buried protection structure, Southern end of Mitchell Street seawall

The first of these structures is a new buried seawall at the southern end of the Mitchell Street rock seawall. This buried seawall will be constructed with vertical, overlapping concrete beams. When completed, the top of the wall will be buried as shown above. It will be 126 metres long, and the base of the overlapping beams (piles) that form the wall will extend 8.5m below ground.

Southern end of the Mitchell Street seawall - New buried seawall

- The sandbags at the southern end of the Mitchell Street seawall have been repaired and an additional two layers of rock bags placed at the base of the structure.
- Construction of a permanent buried protection structure is expected to start in April 2023.

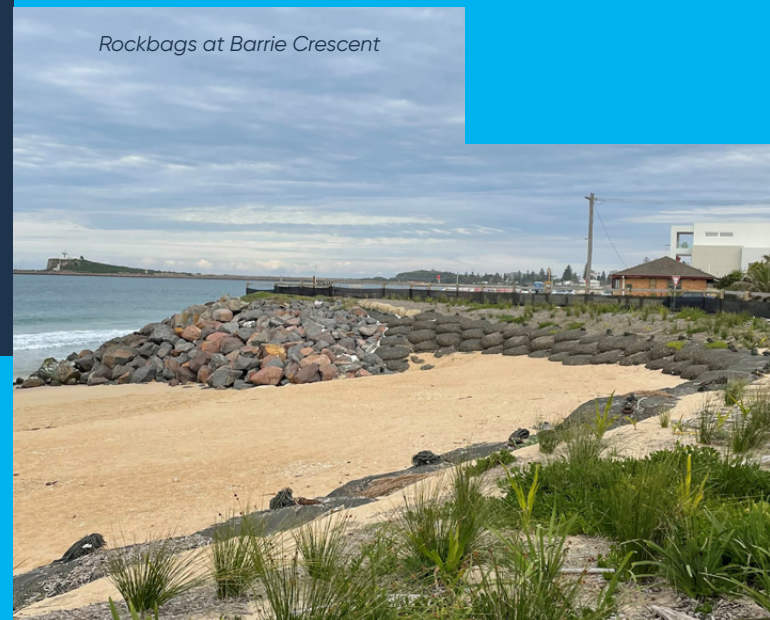
Rockbags at Barrie Crescent

Barrie Crescent - Rockbags

- 1,294 Kyowa rockbags were placed along this 210-metre section of coastline in 2021.

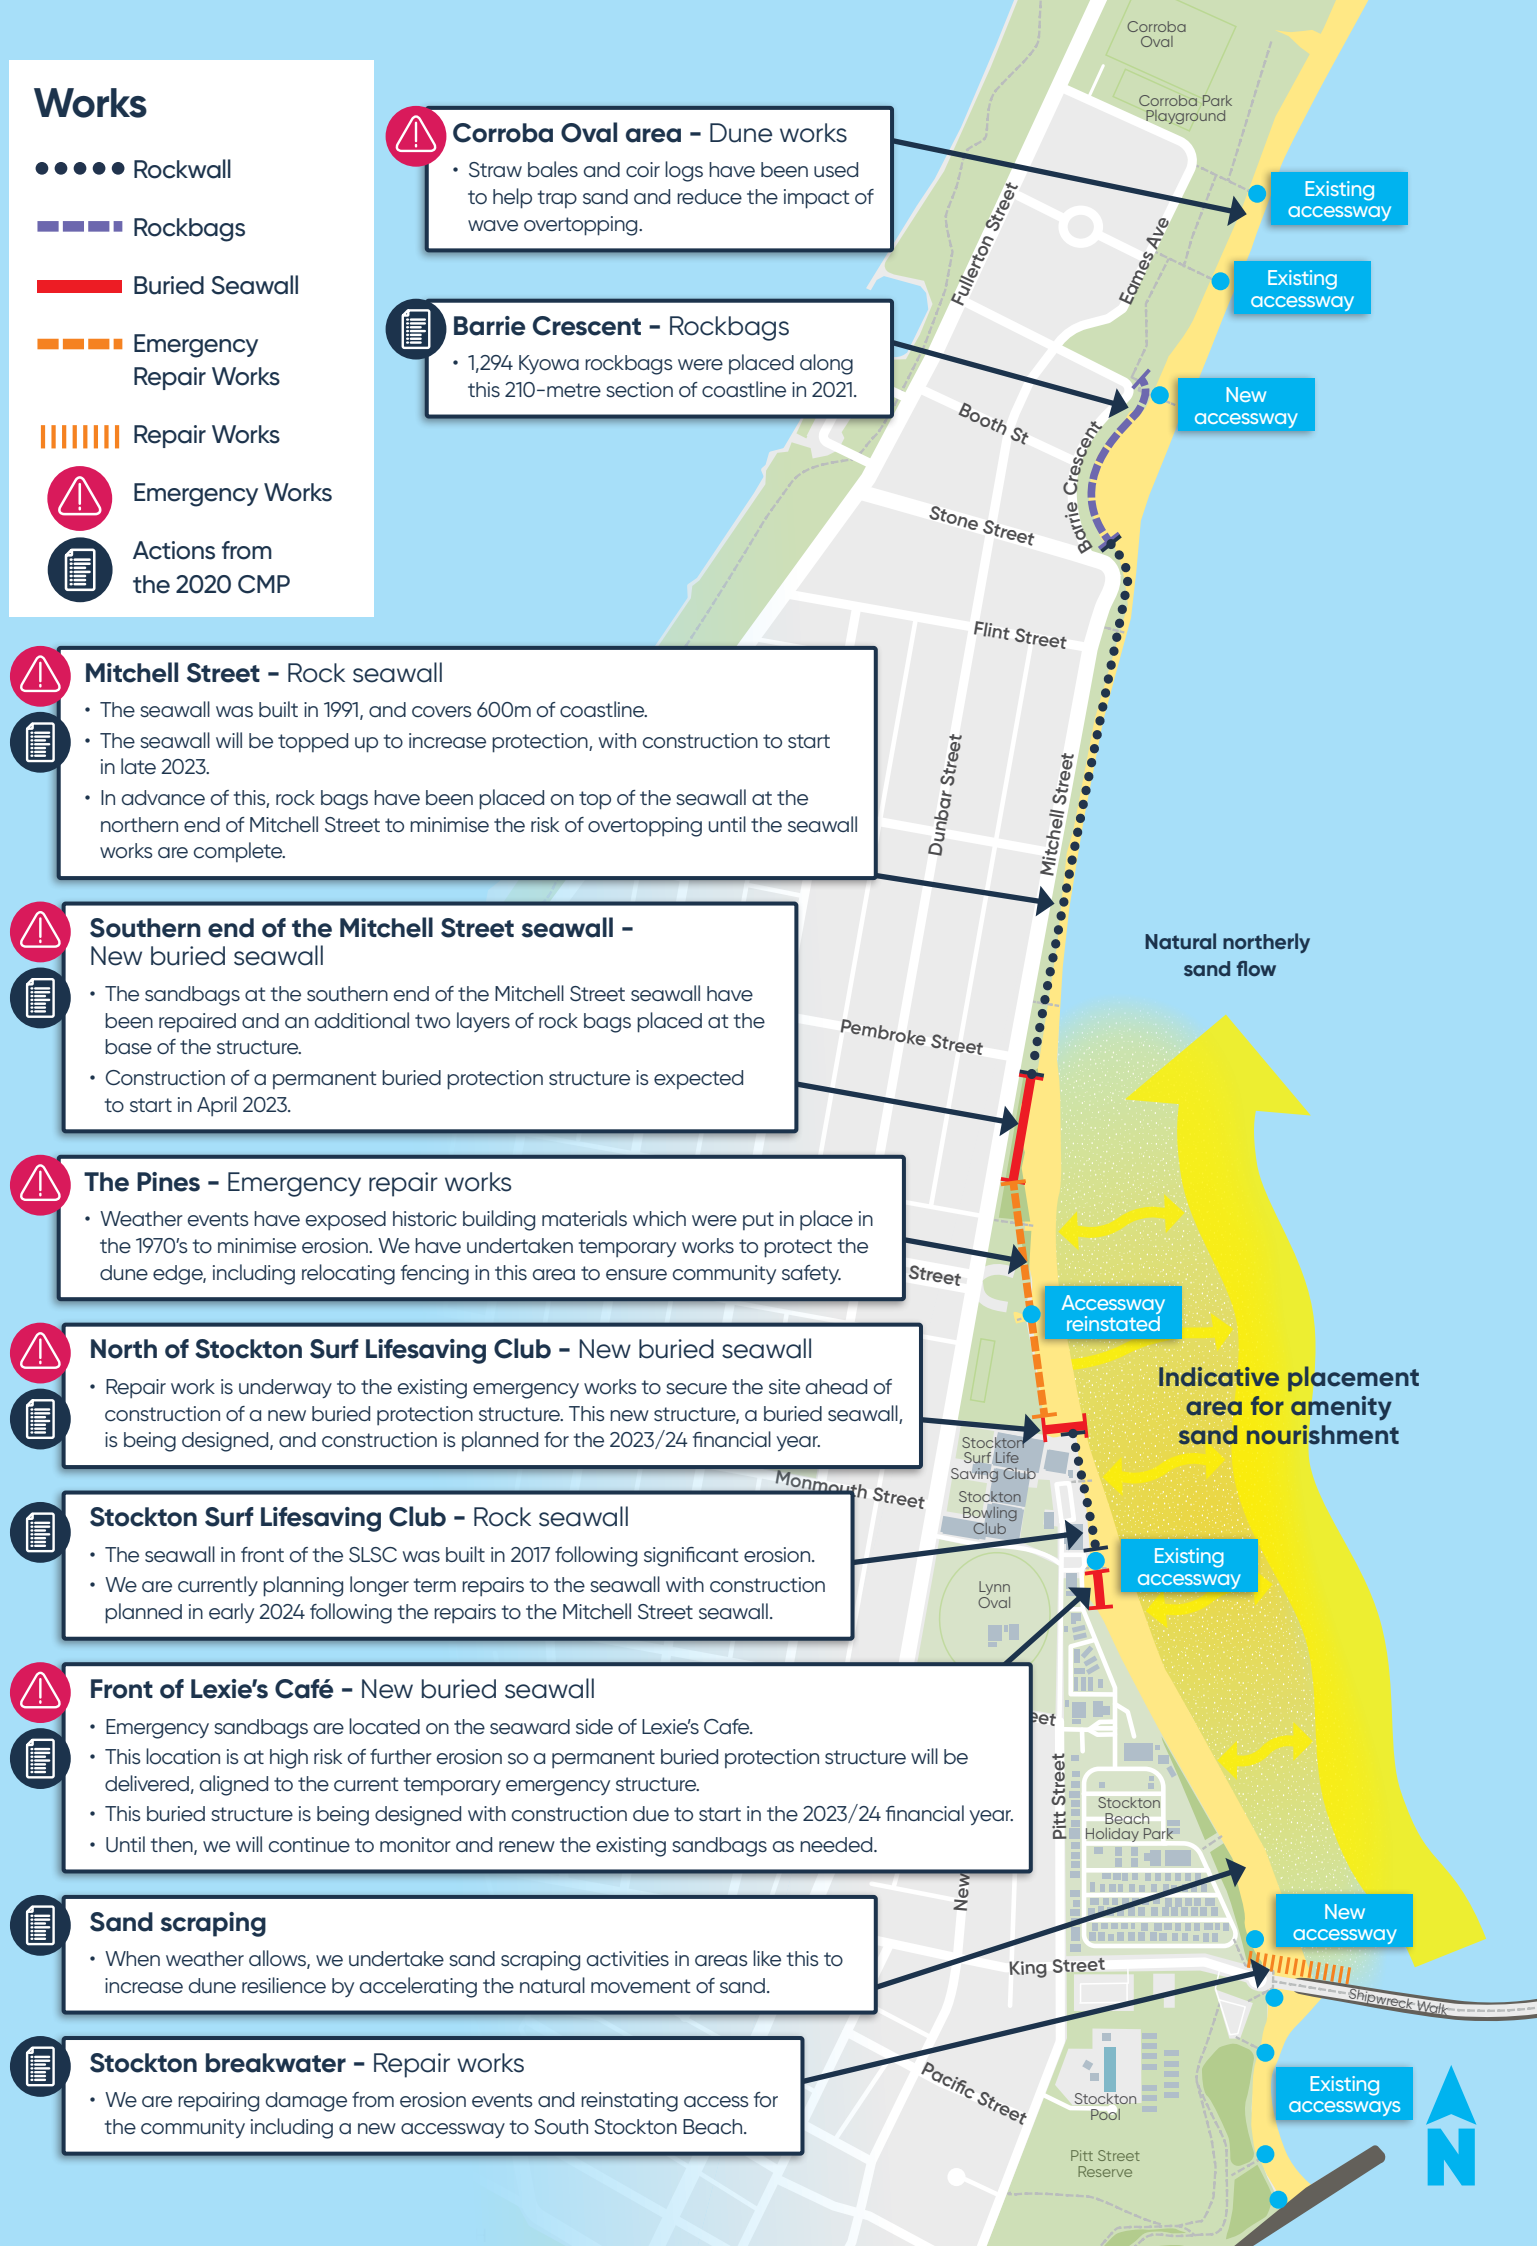
Works

- ● ● ● ● Rockwall
- ■ ■ ■ ■ Rockbags
- Buried Seawall
- ■ ■ ■ ■ Emergency Repair Works
- || || || || || Repair Works
- ⚠ Emergency Works
- 📋 Actions from the 2020 CMP
