Hunter Estuary

(Including Kooragang Island, Fullerton Cove, some of City East and the suburb of Stockton.)

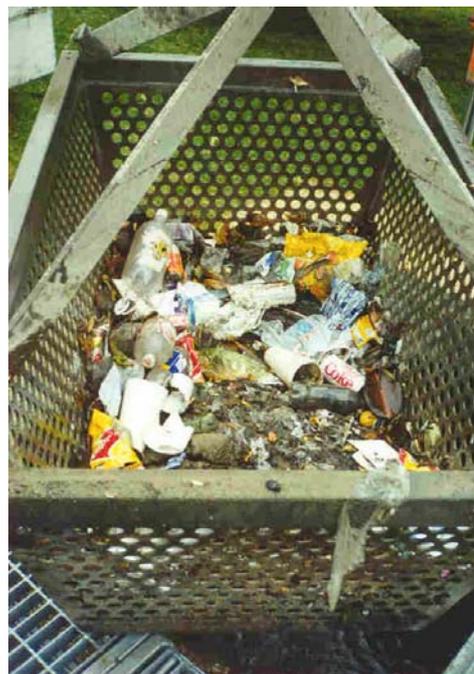
Photo 17:

Shows the typical array of litter and gross pollutants removed from the trash baskets (Foreshore Park) during the regular cleaning program conducted after rain events (on average every 6 weeks).

Council has had trash baskets/pits within the stormwater drainage system discharging to the Harbour since 1992. This has been in response to the large amounts of debris i.e. bottles, plastics, paper etc found within the drainage systems and is most evident where drainage lines discharge into waterways and open space areas. There are currently four trash baskets in place, one at Foreshore Park and three in Carrington at Hargreaves and Robertson Streets.
