Throsby Creek Catchment

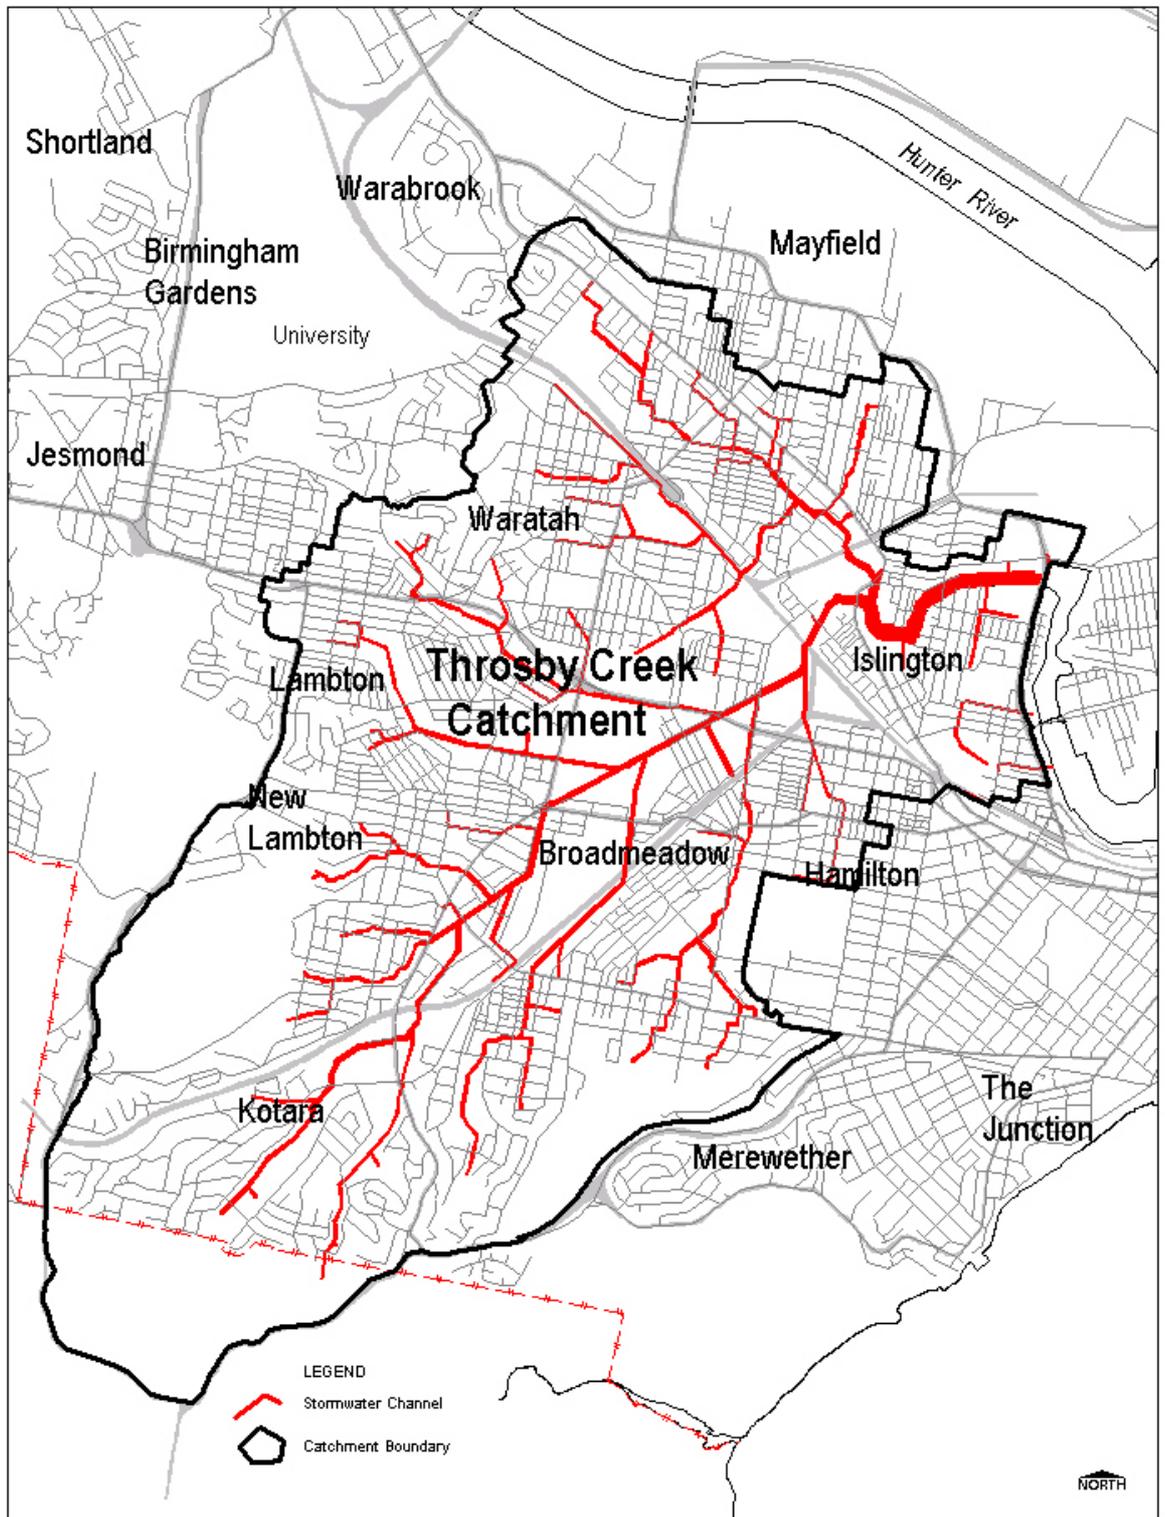
Figure 10: Throsby Creek Catchment

The upper parts of the catchment are bounded in south and south-west by Lookout Road, Charlestown Road and Pacific Highway (to Merewether Heights). The lower catchment is bounded to the north-west by Waratah and Mayfield (West through to East), to the north along a drainage line generally between Maitland Road and Industrial Drive, and to the east and south-east by the suburbs of Wickham, Hamilton and across Broadmeadow Racecourse. Figure 10 shows the extent of the Throsby catchment, major suburbs, transport networks and Hunter Water's stormwater channels.

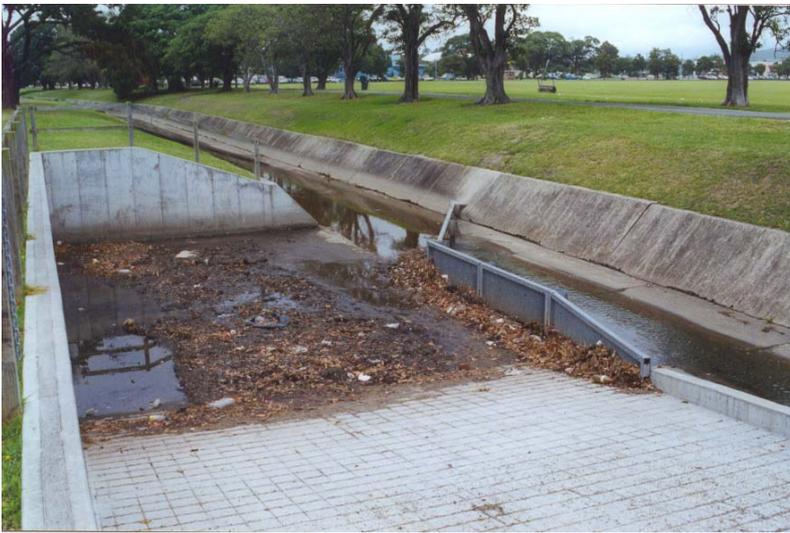
Photo 15:

The Adamstown Branch stormwater channel within Throsby Creek catchment, showing the trash rack that has collected leaves, fast food wrappers, plastic bags, tyres, soft drink bottles and paper. Sediments in the form of mud and dirt also collect behind the grids of the rack. Regular cleaning is required to prevent litter load further down the catchment clogging the grids and hence, sending stormwater over, rather than through the grids, and so carrying its litter.

- One trash rack on the Adamstown Branch, between District Park Tennis Centre and the Westpac Rescue Helicopter headquarters;
- One "CDS" unit or end of line pollution trap located on the Lambton Branch of the creek, between Energy Australia Stadium and the Hockey Centre, and
- One sediment trap, with a floating boom in the Throsby Creek system located in the Main Channel, between Chin Chen St and Maitland Rd, adjacent to the Tighes Hill TAFE. The floating boom efficiency has been the source of continual improvements as Hunter Water seeks to reduce the impacts of large items such as shopping trolleys and tyres snagging the boom when they reach this point in the channel.

- Trash Rack - inspect weekly, clearing material from the screens into the collection area, empty collection area monthly. Est. 3 cubic metres/ mth material collected;

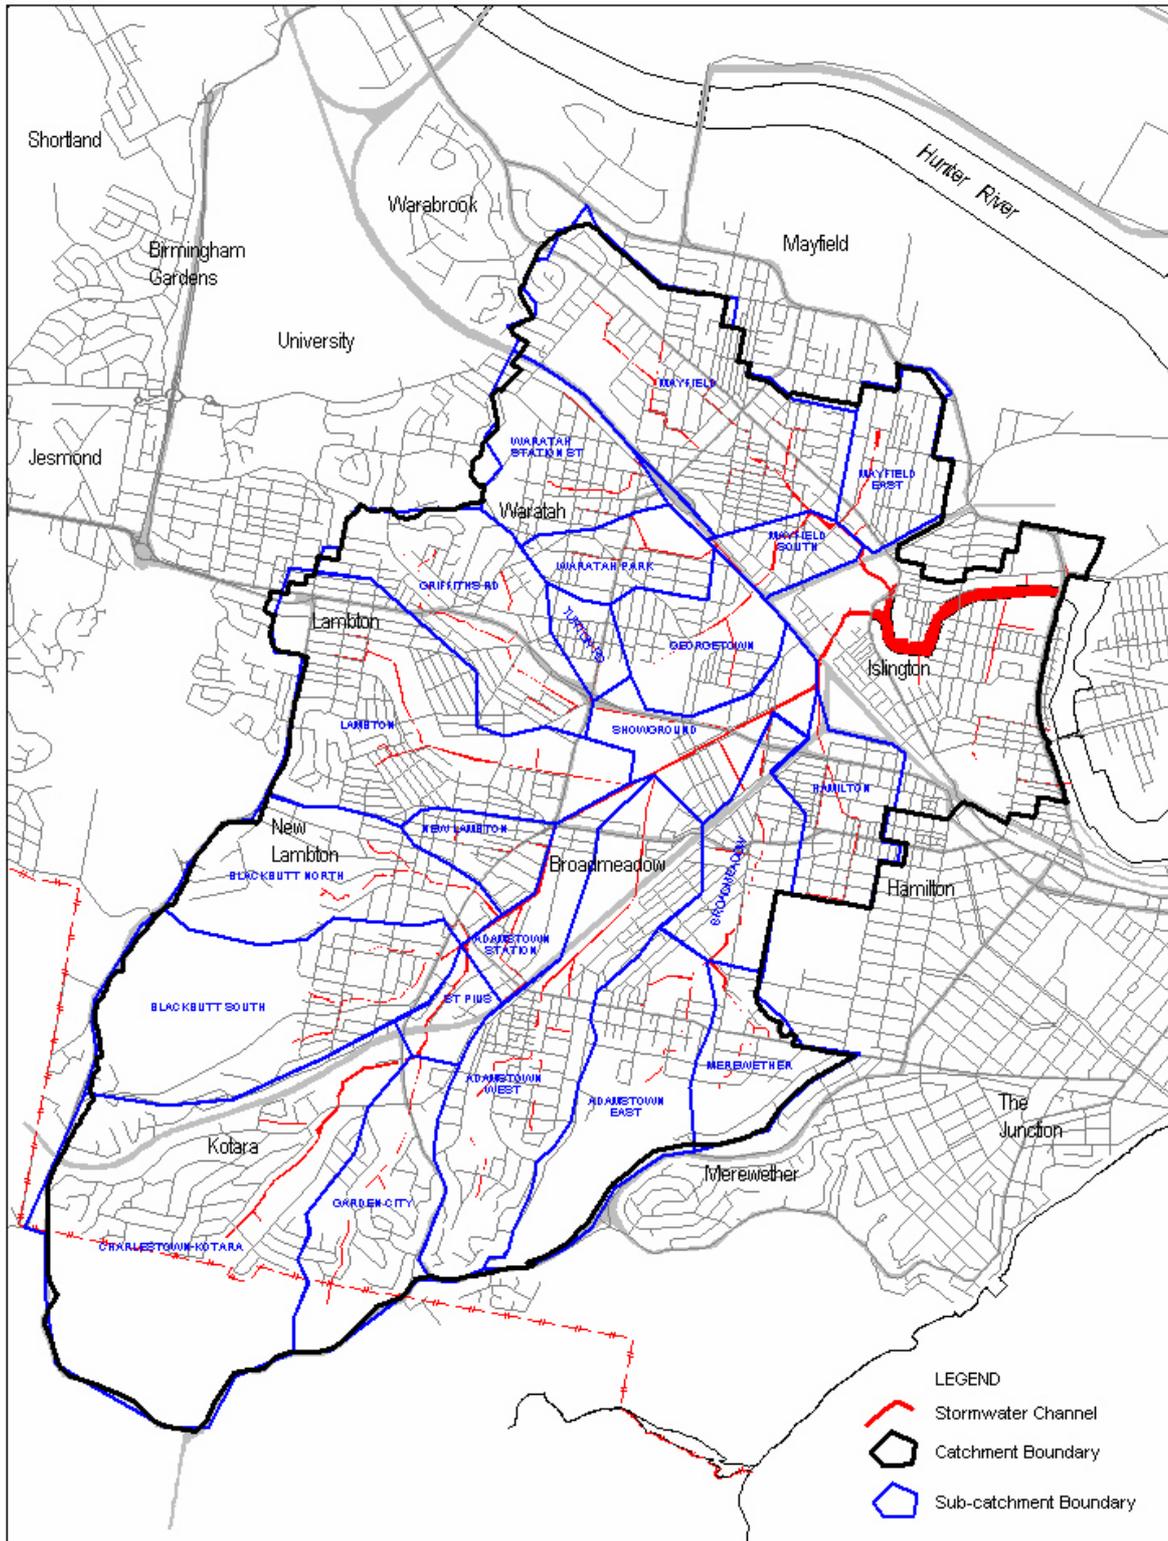
Figure 11: Throsby Creek Catchment - breakdown into 22 sub-catchments

The delivery of such projects has been influenced by the strategic direction chartered by Council in the preparation of an Urban Water Cycle Management Policy for Newcastle (2004). In addition the outcomes of the Throsby Creek Catchment Gross Pollutant Study (WBM Oceanics, 2000) provided valuable data on the indicative gross pollutant generation across 22 distinct sub-catchments identified for Throsby Creek. See Figure 11.
