# **Sediment transport study within Stockton Bight**

Report #: P19028\_PartA-StocktonBightStudy\_TN0.0A

## Technical Note

# **Stockton Beach coastal erosion hazard assessment**

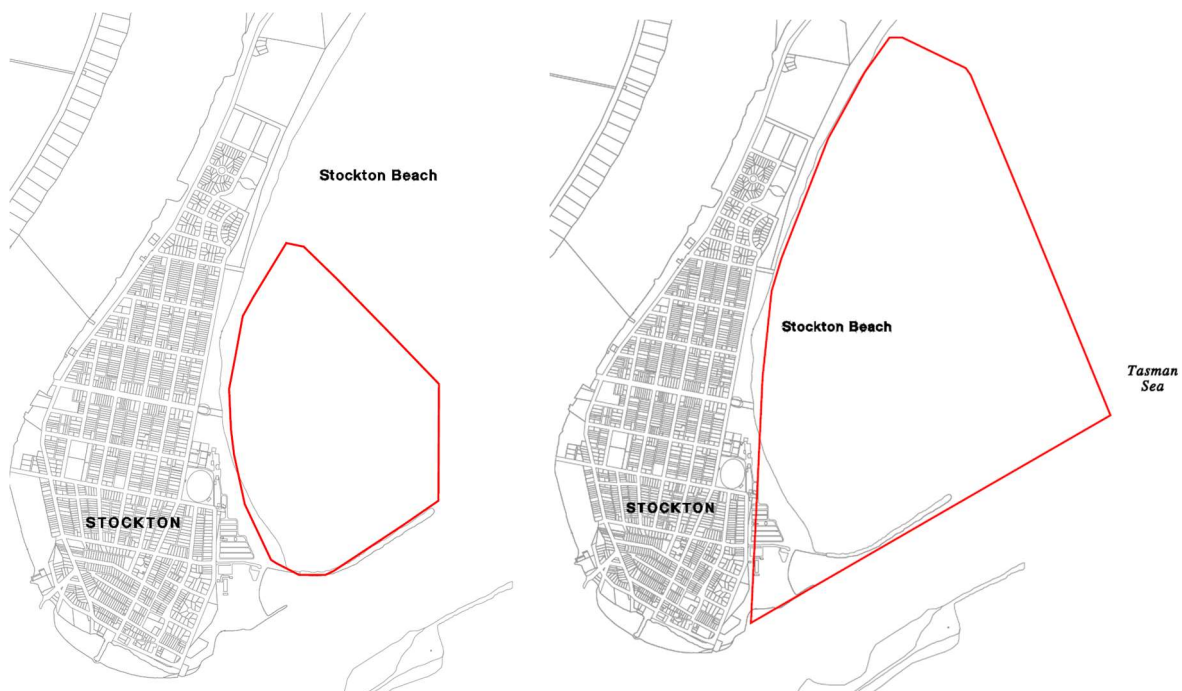
*Figure 3: Sand loss analysis areas used in the Umwelt (2002) report – (left) Area 1 and (right) Area 2.*

The long-term loss rate calculated by Umwelt for Area 2 is consistent with the sand loss rate from 1866 to 1988 calculated herein (70,000m<sup>3</sup>/yr). However, the rate of 370,000m<sup>3</sup>/yr given for the period from 1988 to 2000 is much higher than the rate of 100,000m<sup>3</sup>/yr estimated herein for the period between 1988 and 2018. It is noted that the lower rate presented herein does not discount the beach nourishment quantities. However, when these are included (i.e. equivalent loss rates of 134,000m<sup>3</sup>/yr) the rates are still lower than Umwelt's 1998 to 2000

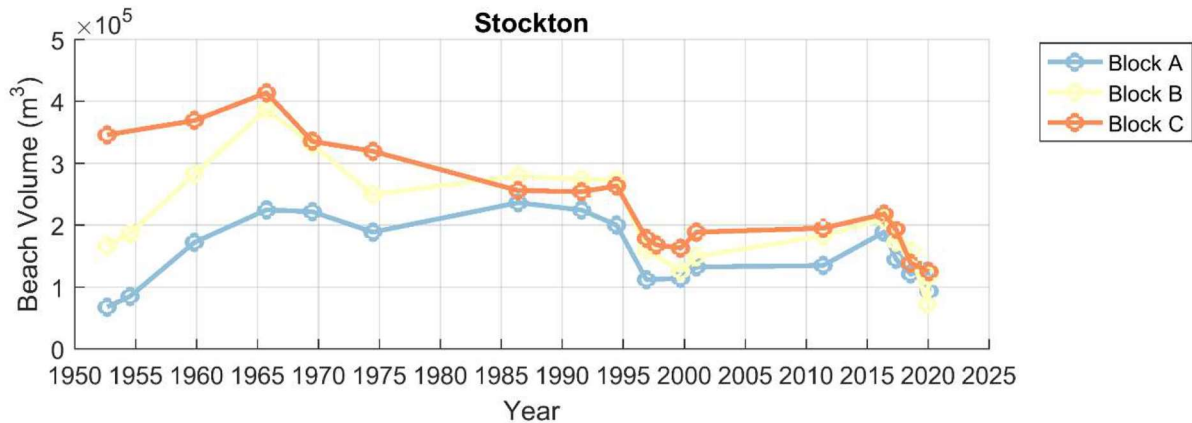
Figure 4: Timeseries of sub-aerial beach volumes for Stockton Block A to C.

Based on beach profile data from the NSW photogrammetry database, Figure 4 presents a timeseries of sub-aerial beach volumes for Stockton Block A, B and C (see Figure 5). Similar to sub-aqueous extents, the Stockton CMP area (i.e. northern breakwater to Meredith Street) is conservatively considered to cover Block A, Block B and Block C. Between 1985 and 2020 the combined beach volume in these blocks has reduced by approximately 420,000m<sup>3</sup>, an average loss rate of 12,000m<sup>3</sup>/yr.

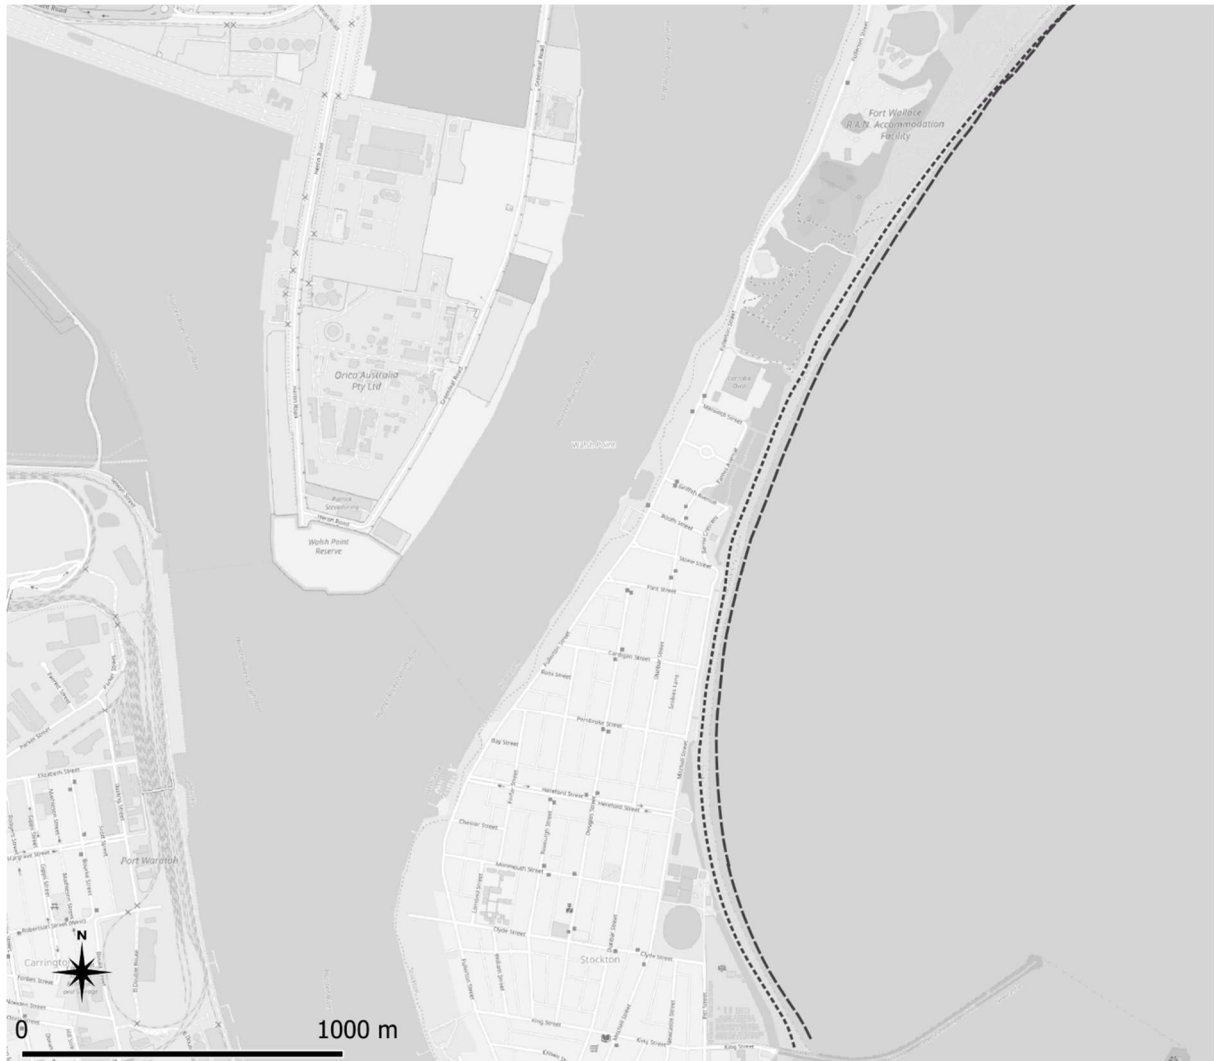
*Figure 12: Mean sea level (0m AHD) shorelines from 2018 (inner) and 1994 (outer) showing realignment of the southern embayment.*

- Erosion of the inner surf zone is still observed in compartment 4 inshore of the dispersed sand nourishment, this may be due to the response of the shoreline to erosion occurring to the north (i.e. realignment of the zeta shaped embayment in response to lack of sediment supply), see Figure 12.

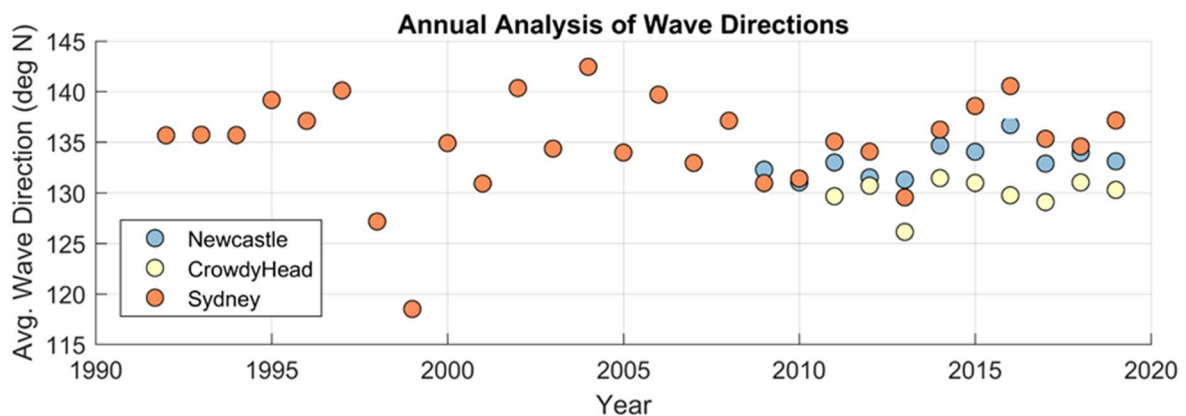
Figure 17: Annual average wave direction at Newcastle, Crowdy Head and Sydney WRB.

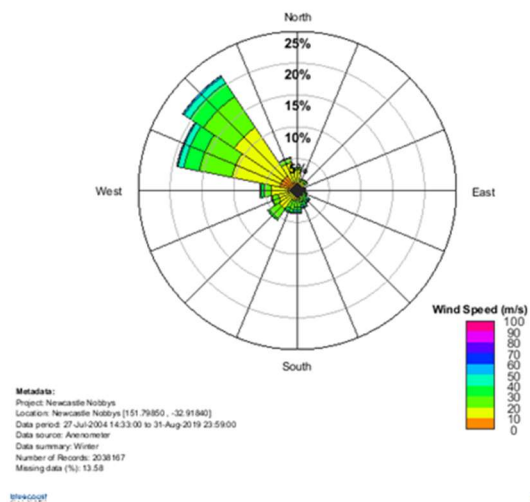
Figure 29: Annual (top) and seasonal wind roses at Nobbys Newcastle BoM station from one-minute data between July 2004 and March 2020.

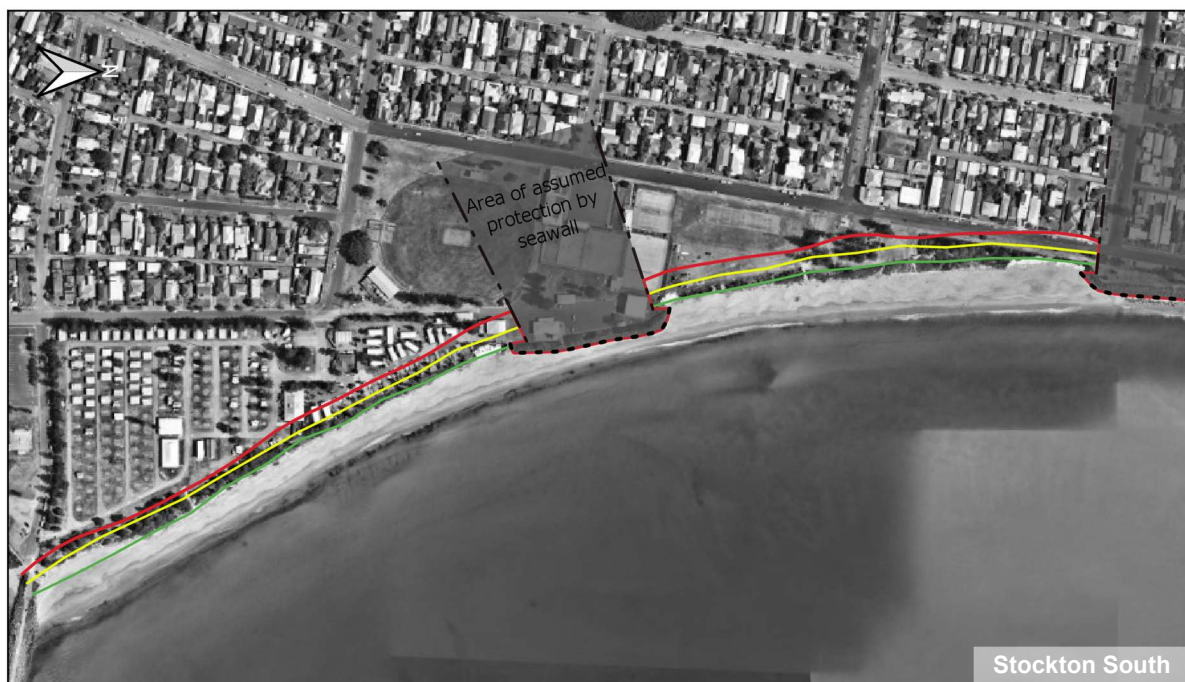
Figure 11: Hazard lines for the erosion hazard in year 2020.

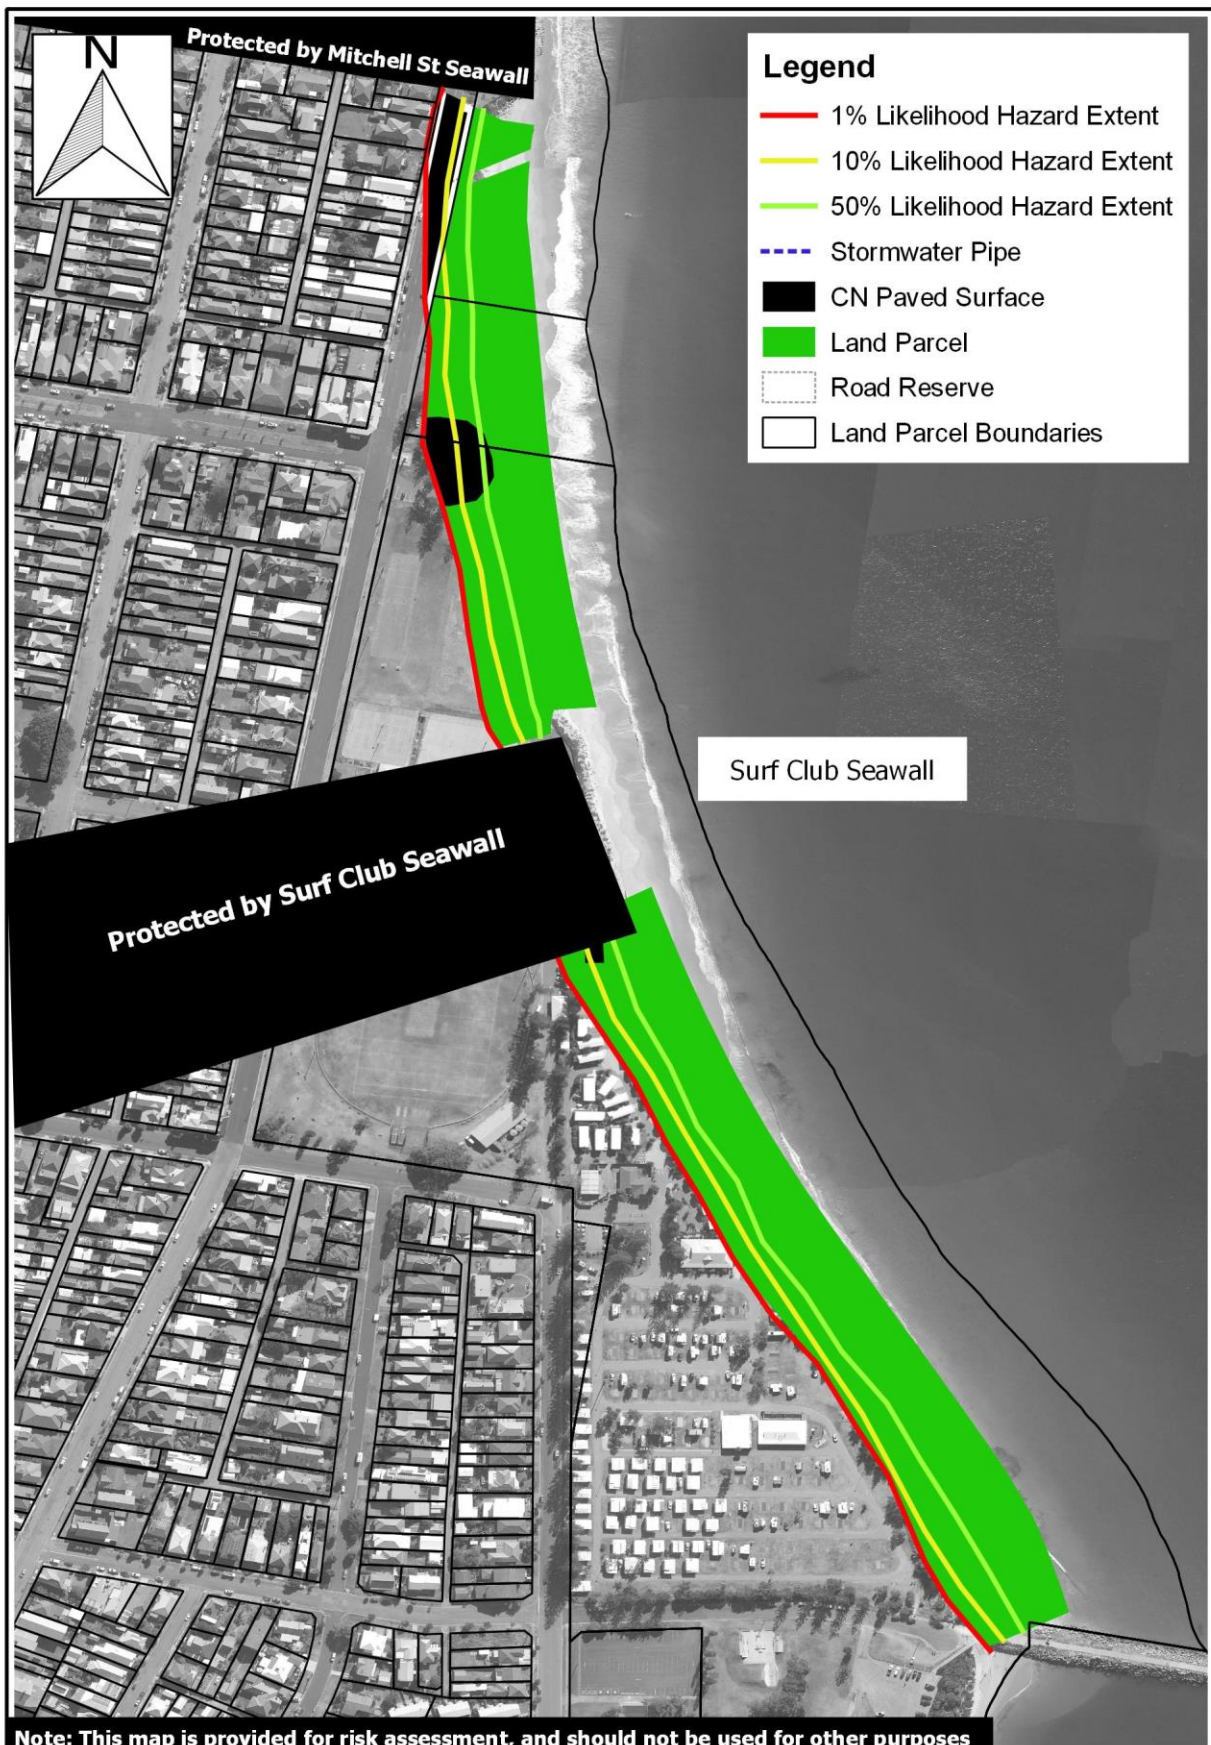
**Figure 5: Affected Surface Assets for 2020 (South)**

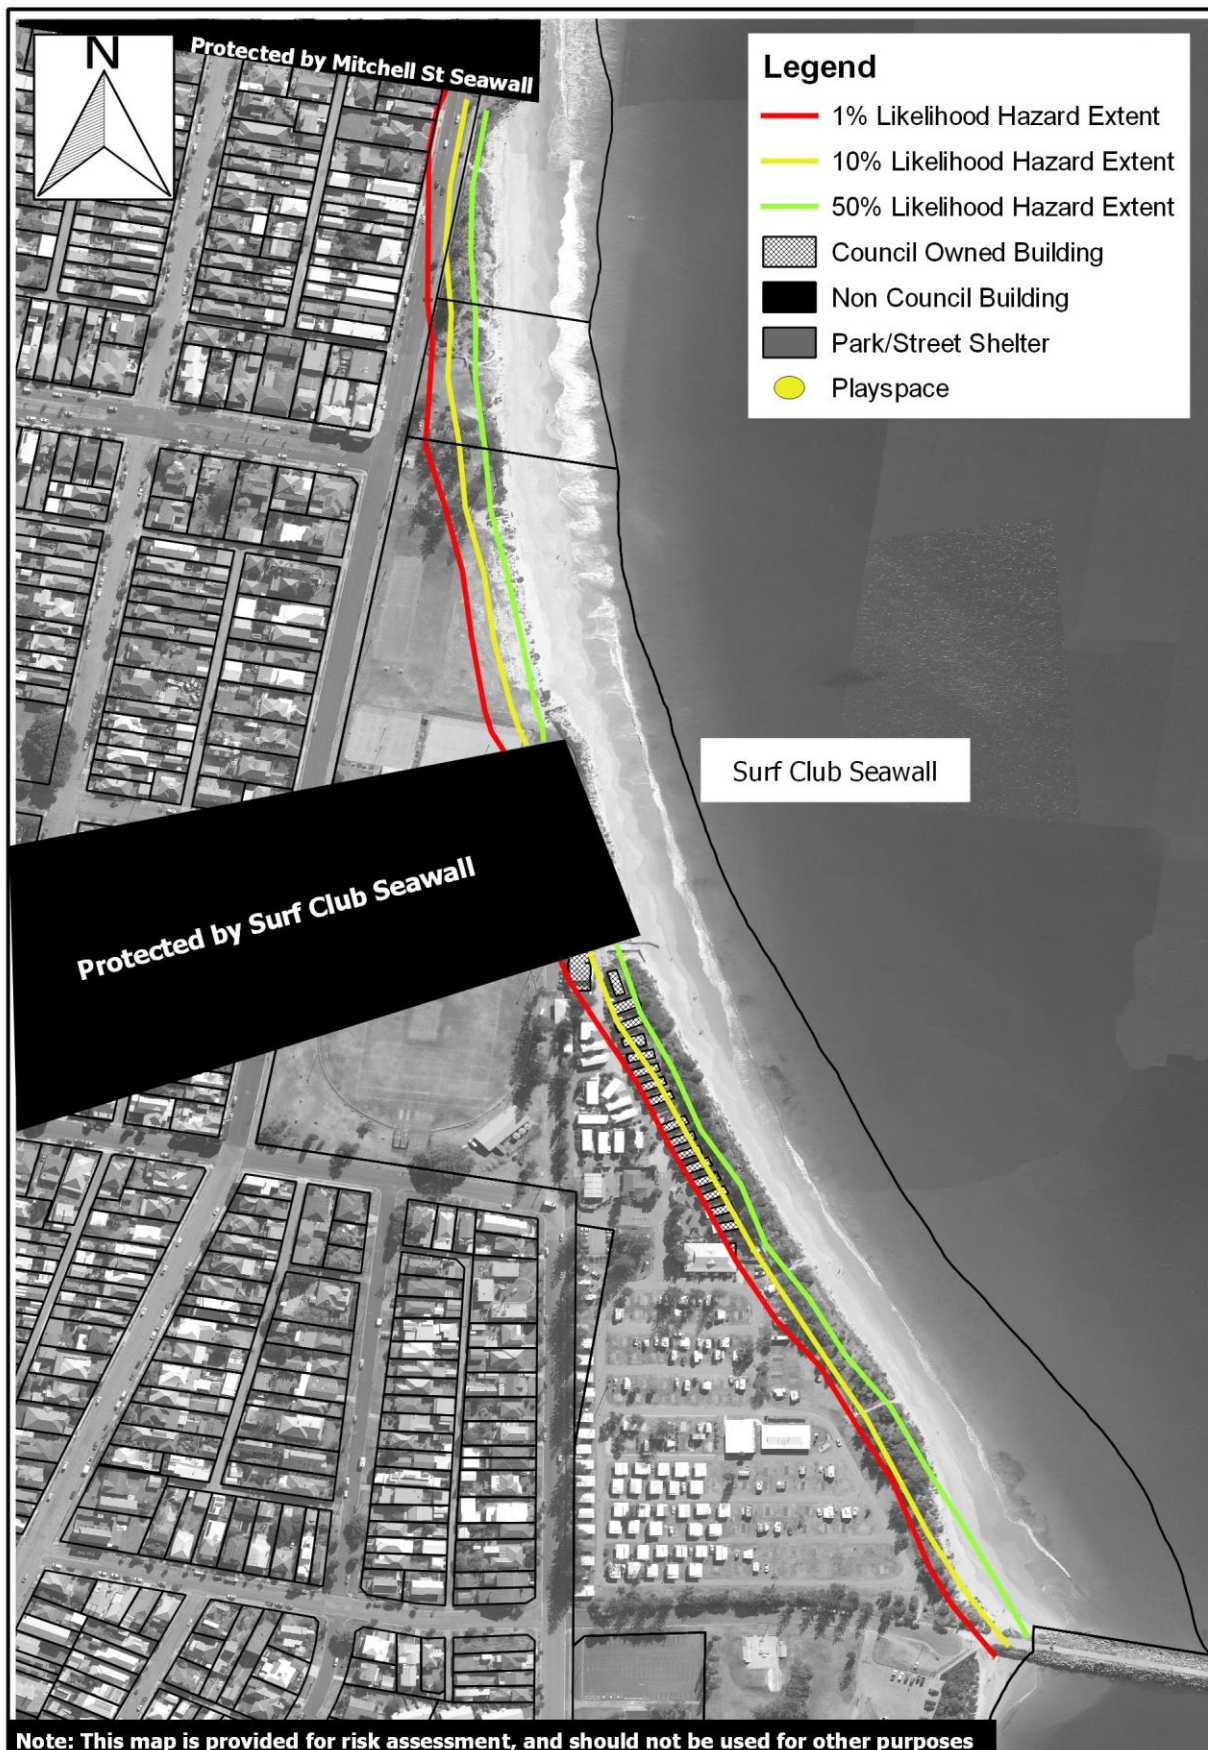
**Figure 6: Affected Above Ground Assets for 2020 (South)**

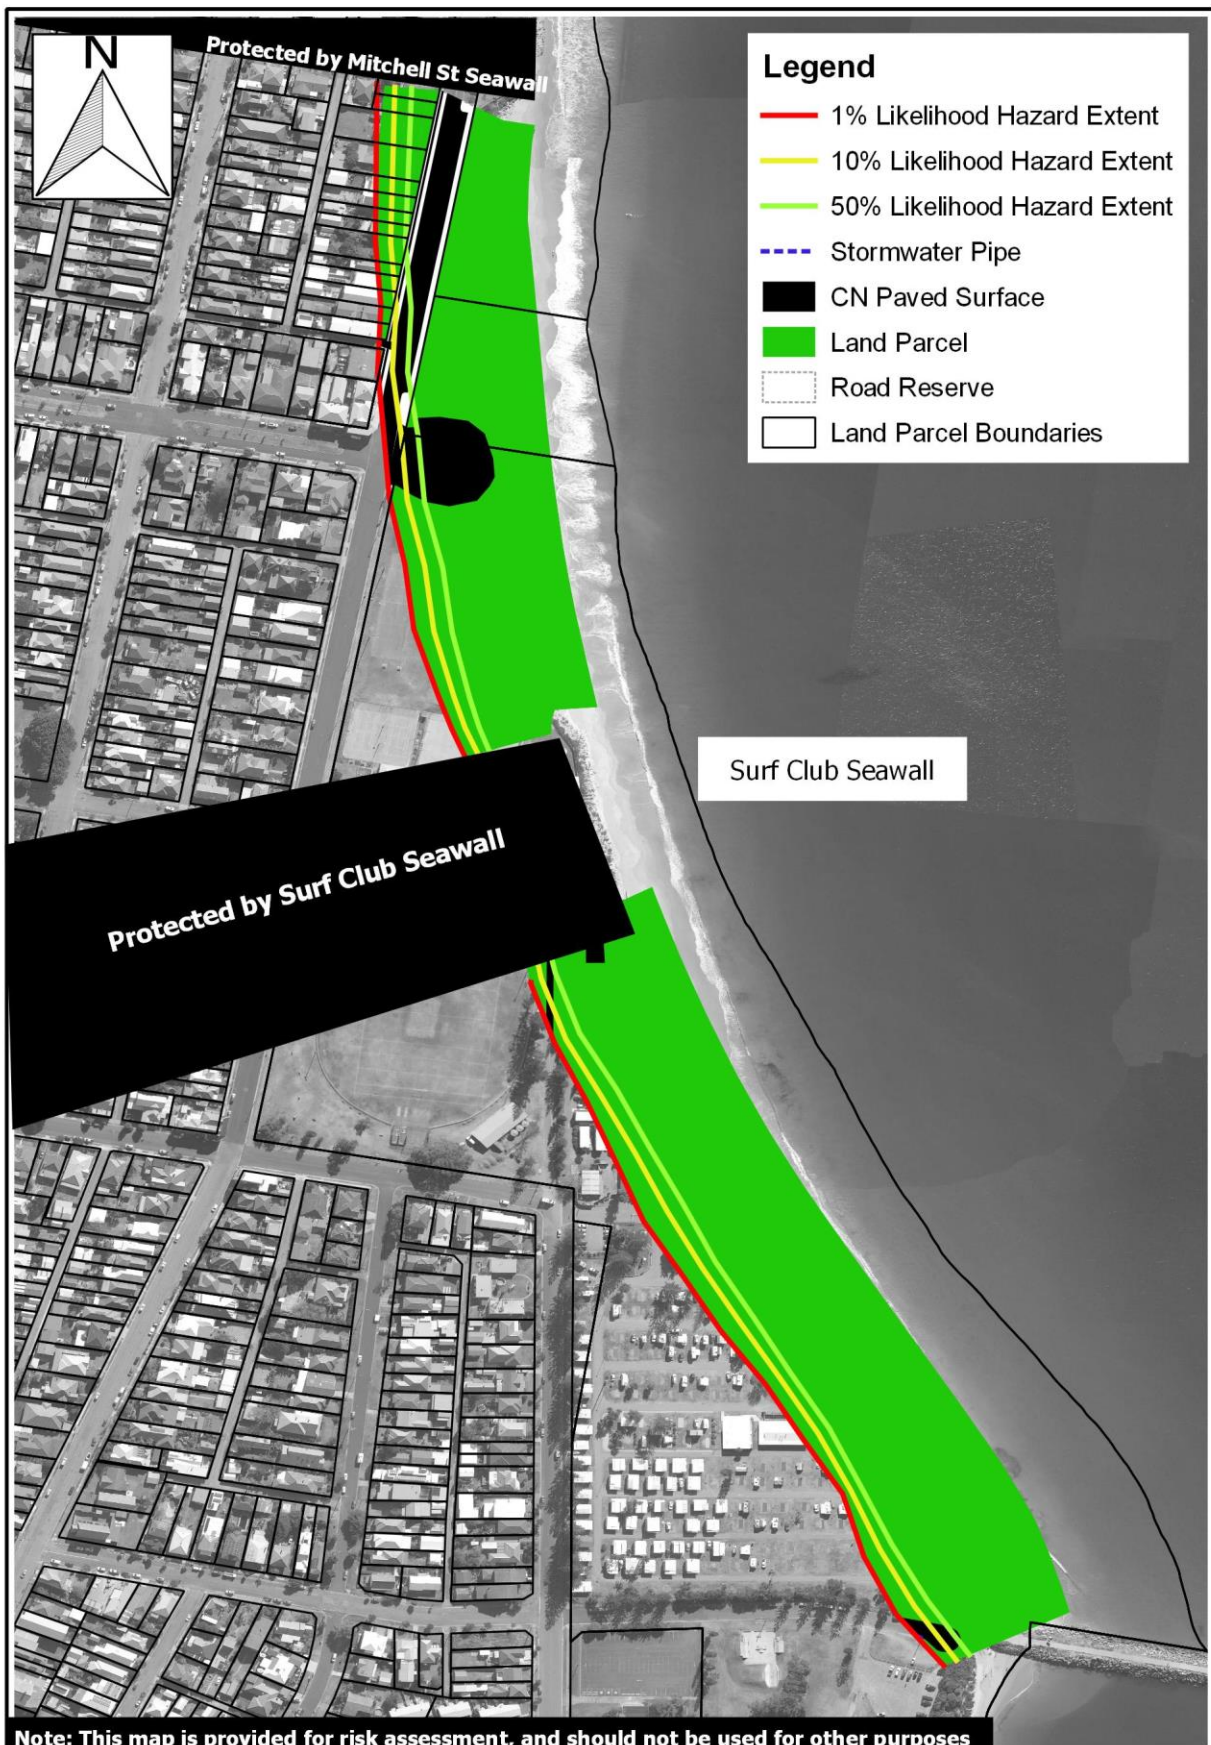
**Figure 9: Affected Surface Assets for 2040 (South)**

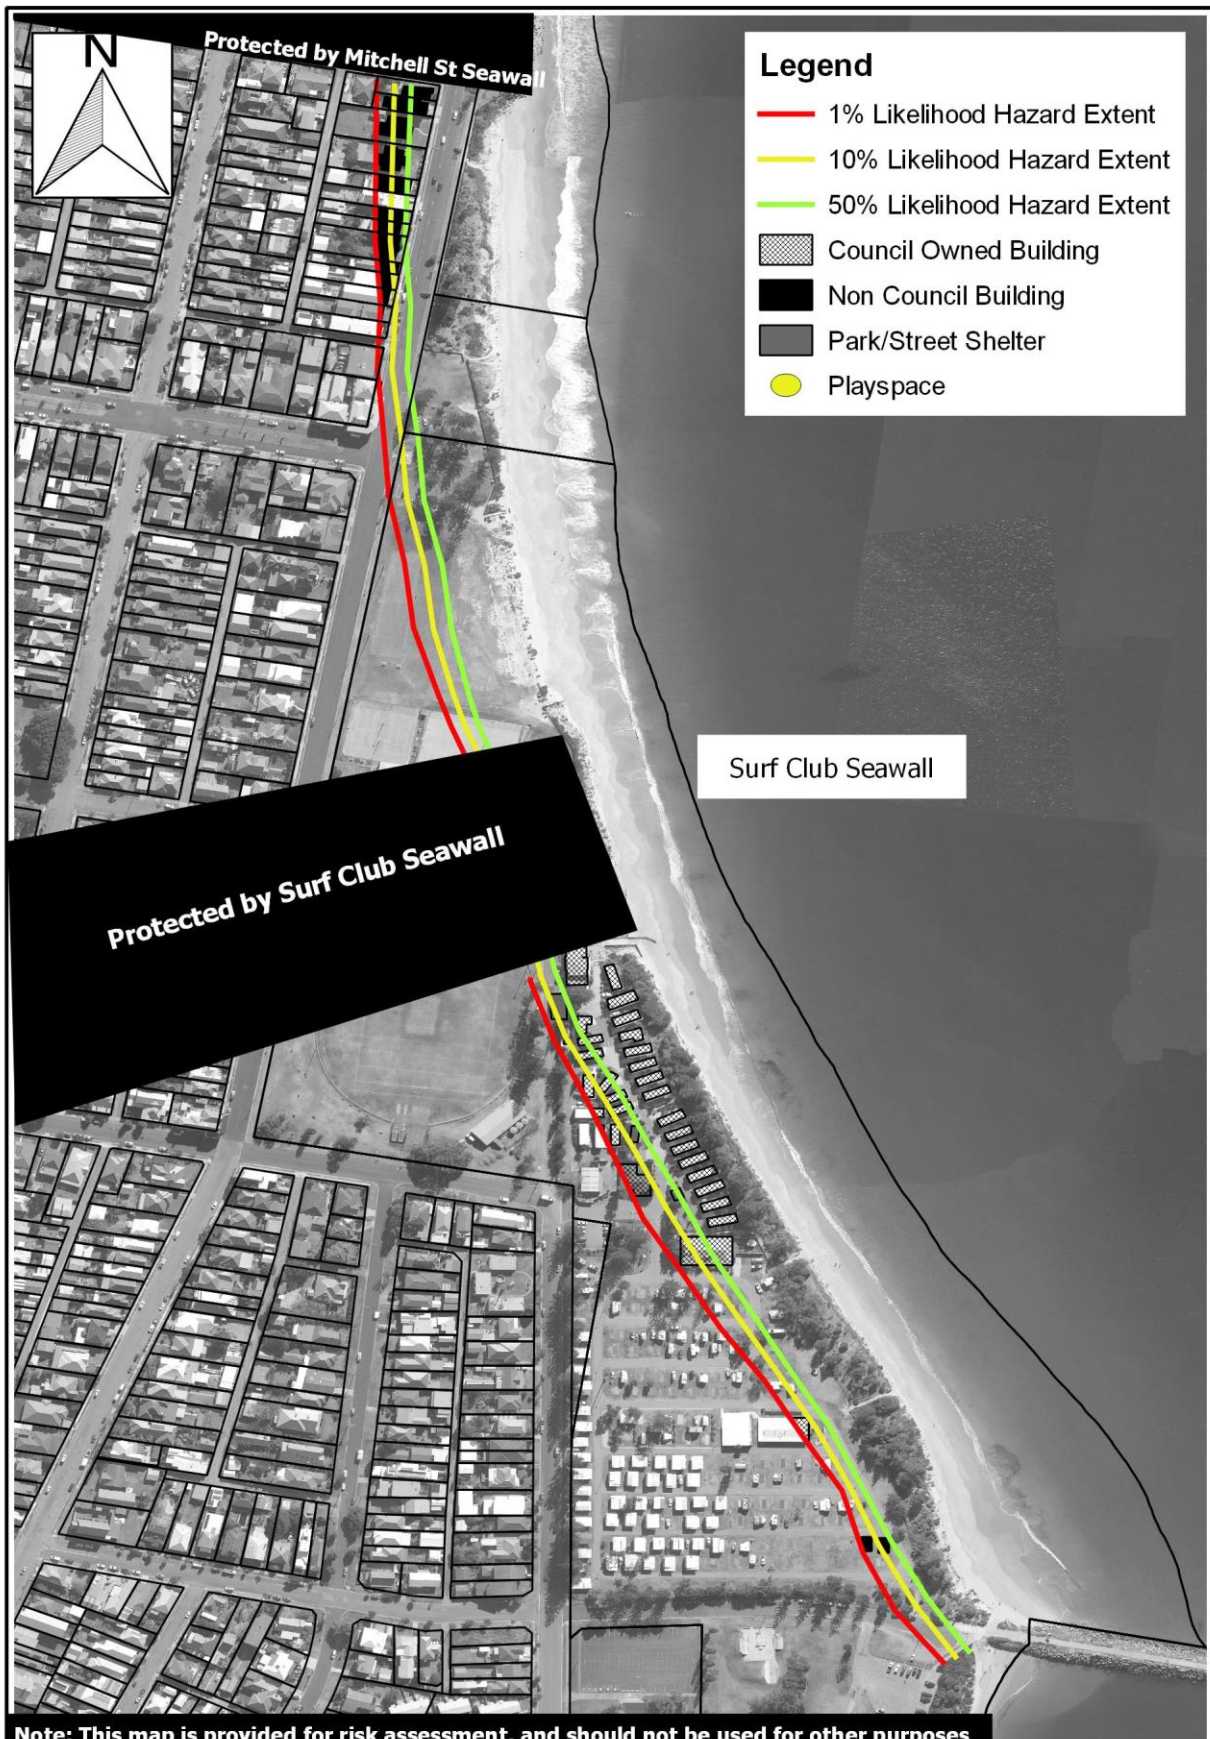
**Figure 10: Affected Above Ground Assets for 2040 (South)**

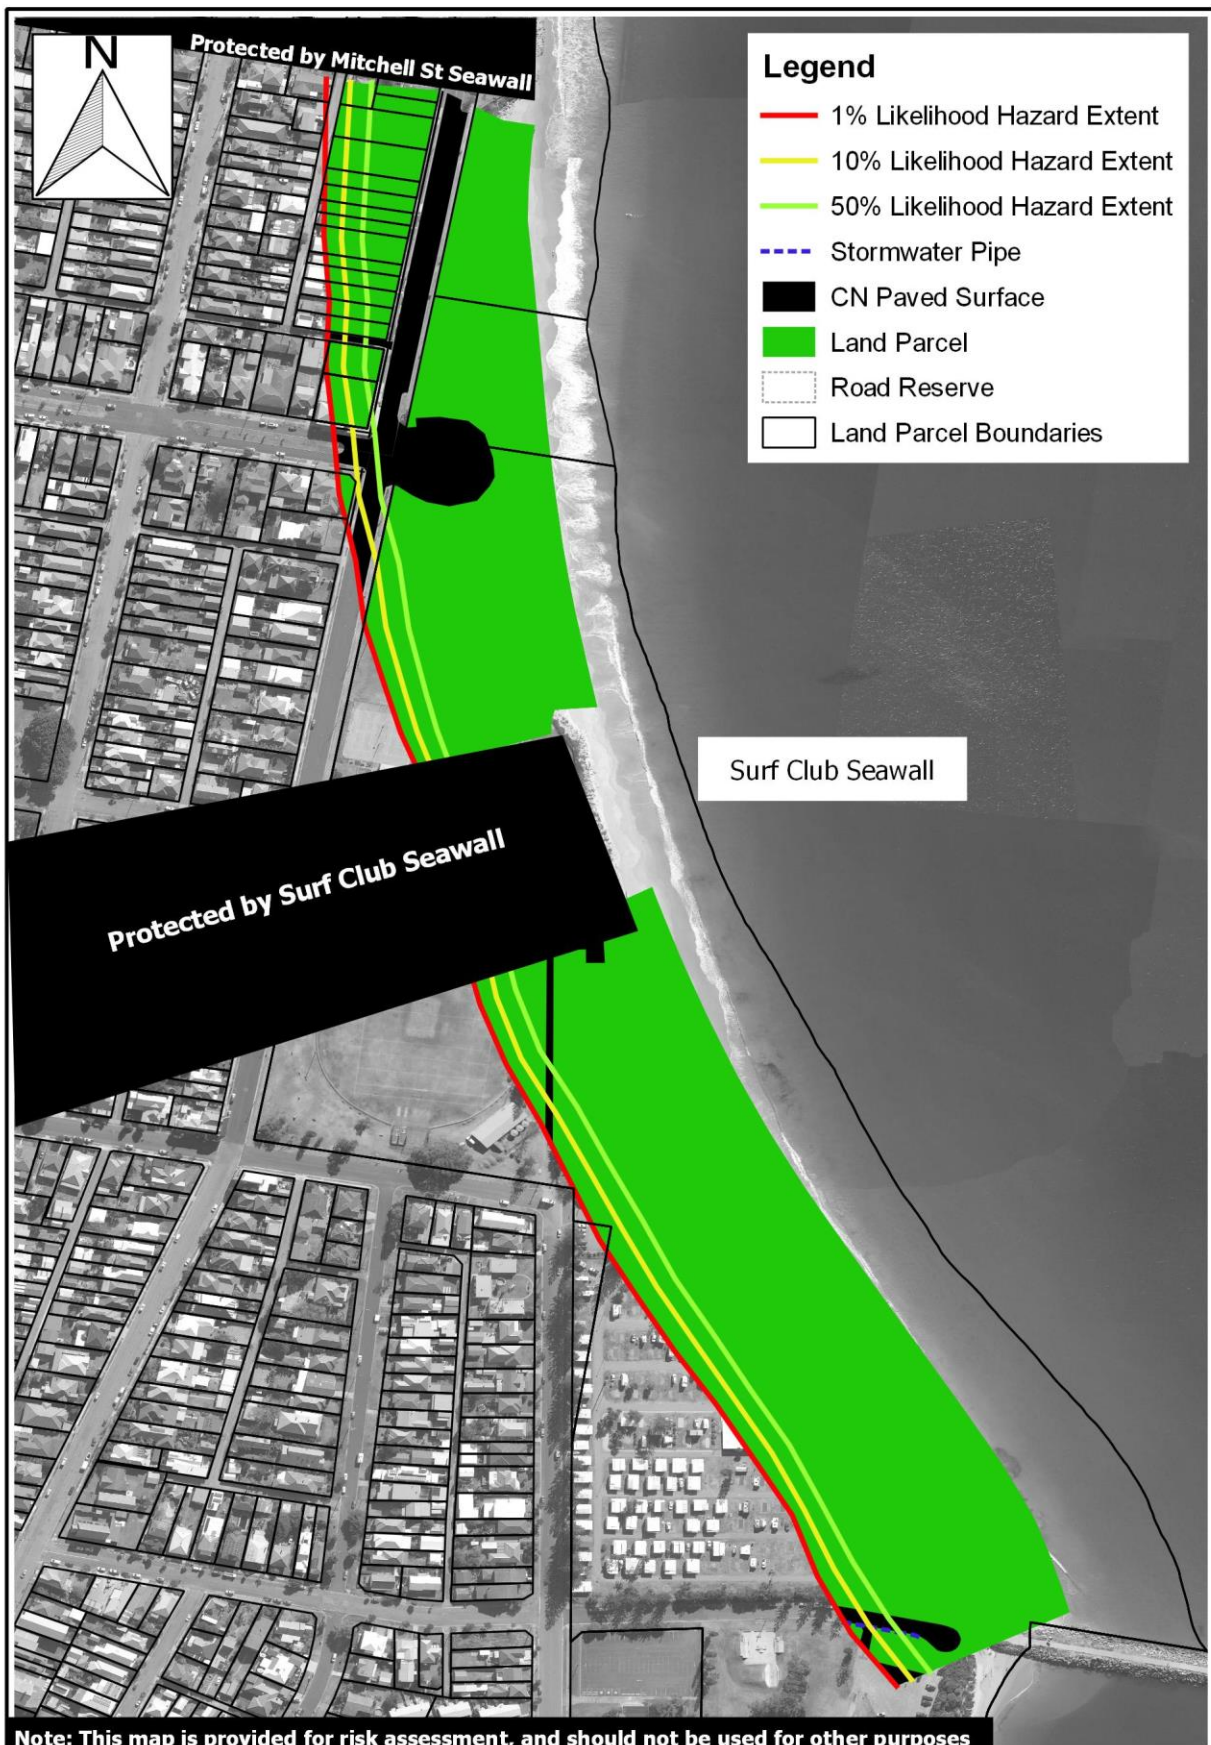
Figure 13: Affected Surface Assets for 2060 (South)

Note: This map is provided for risk assessment, and should not be used for other purposes

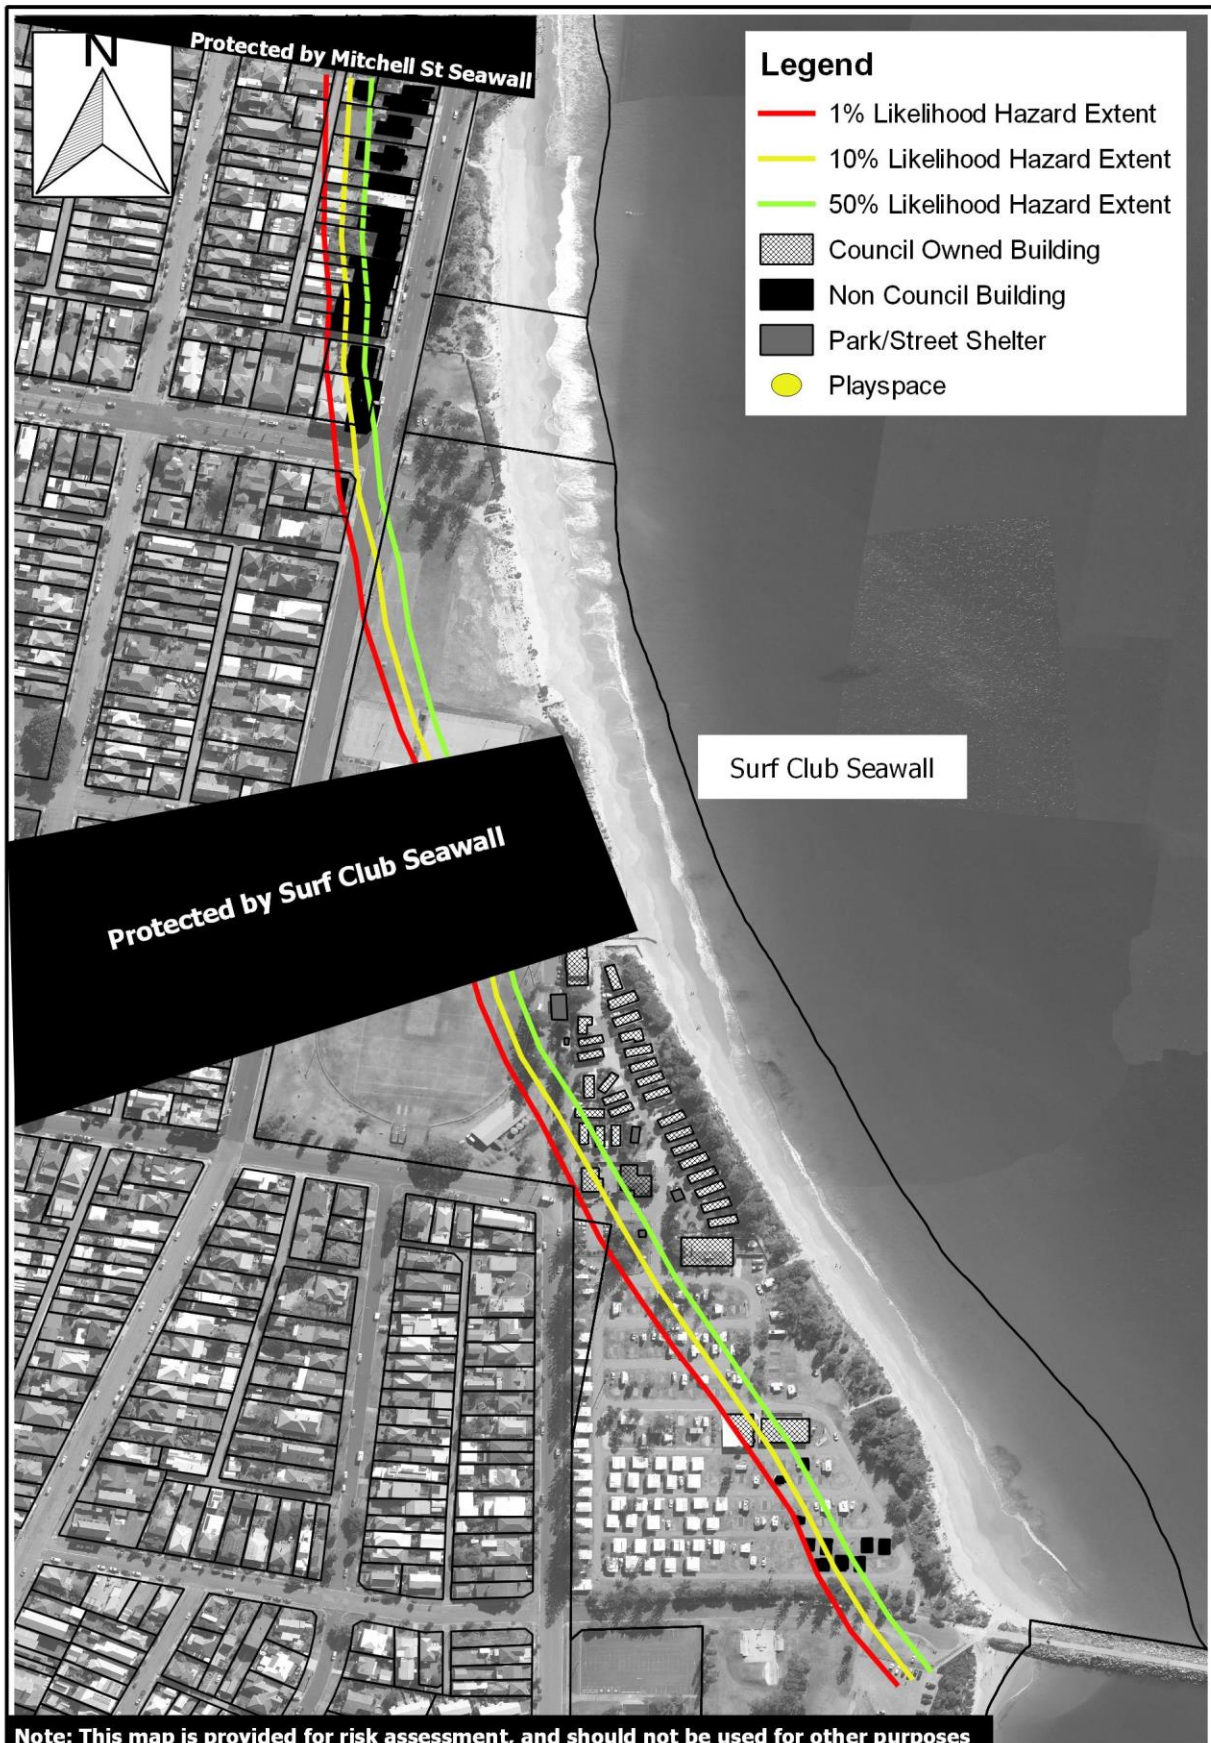
**Figure 14: Affected Above Ground Assets for 2060  
(South)**

Note: This map is provided for risk assessment, and should not be used for other purposes

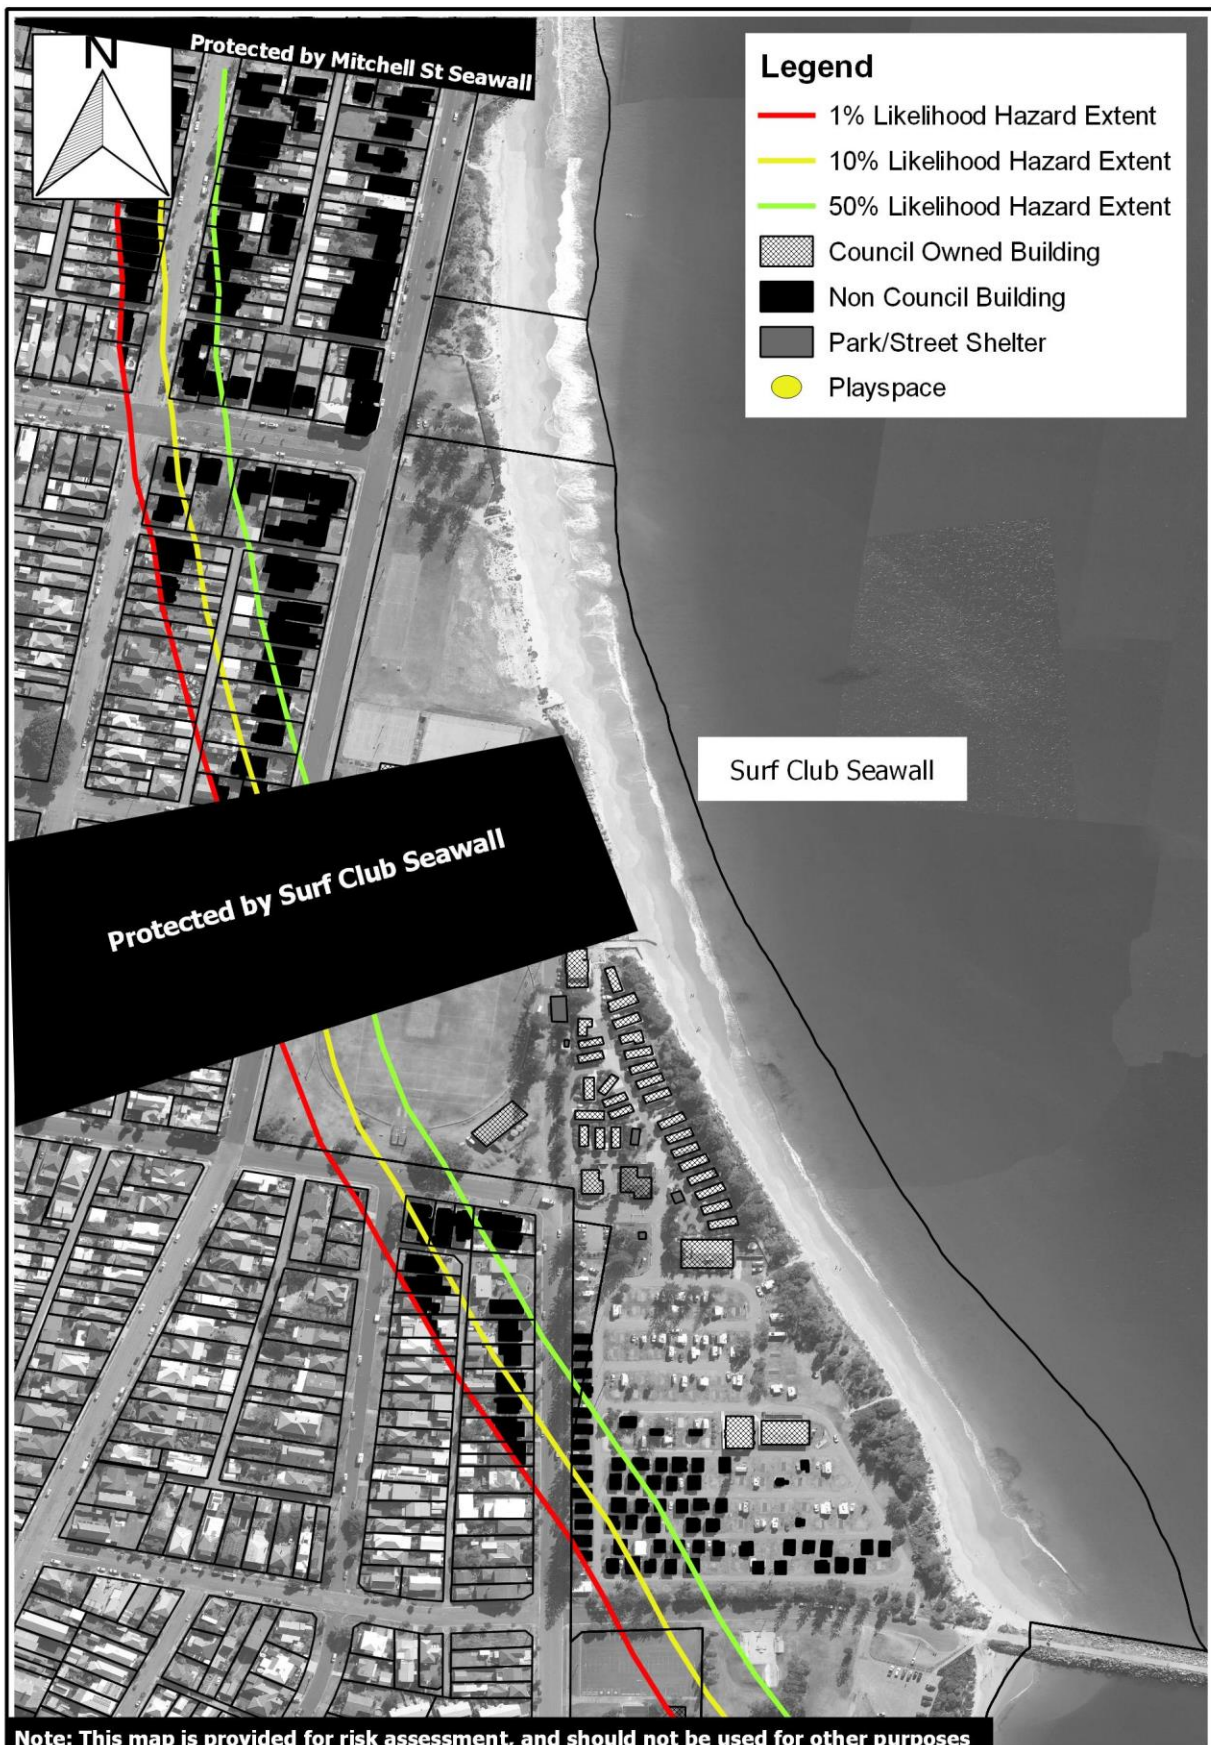
**Figure 18: Affected Above Ground Assets for 2120 (South)**
