Wickham Wool Store Fire Emergency Asbestos Management Plan

Wickham Wool Store Fire Local Recovery Committee

Date: April 2022

Document number: Wickham Wool Store EAMP

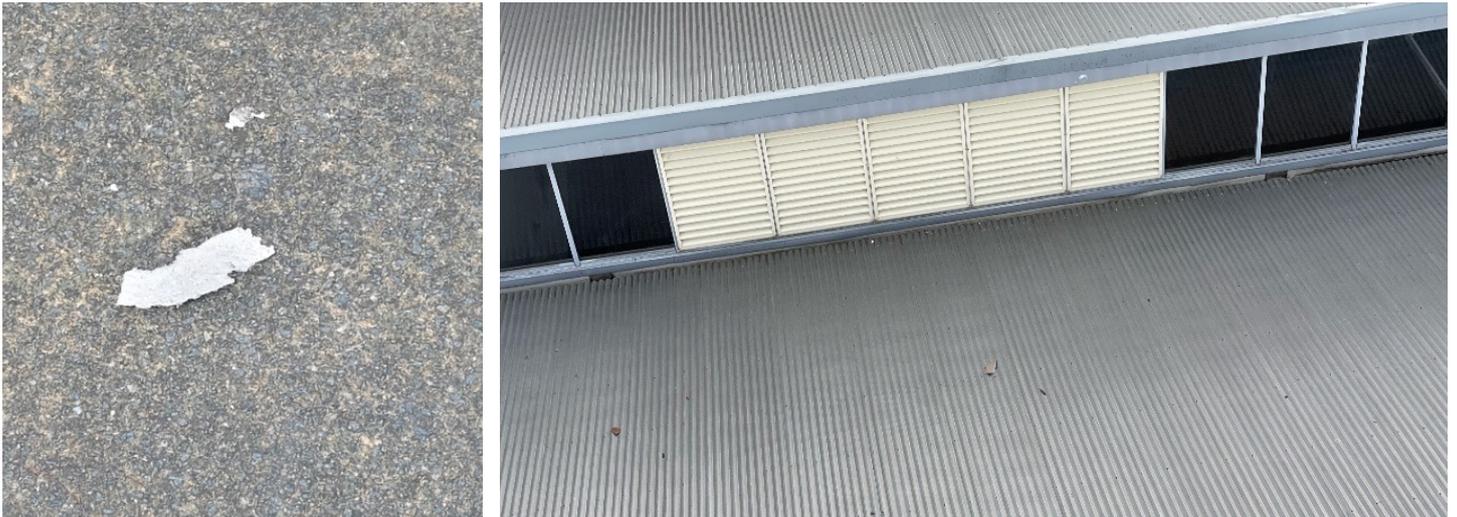
Figure 3 – Typical Asbestos Containing Debris (ACD) from the Woodshed fire.

In a fire event, ACMs which were typically utilised for their fire protective and non-combustible properties can suddenly crack and break causing the product to degrade as the result of loss of moisture from the high temperatures. Under these fire conditions, ACMs can 'explode' or spall into smaller pieces such as flakes. These smaller pieces were found in the Wool Store Fire site and were dispersed from the smoke plume.

The concentration and size of deposited ACD decreases with distance from the Wickham Wool Stores. The heaviest concentration of ACD is likely to be on the third adjacent Wool Store building that was not burned down. The building owner is undertaking clean-up work of the remaining Wool Store building roof. Heavy rain during and immediately after the Wool Store Fire resulted in most of the smaller ACD being washed down road drains and pipes. There is a risk that drying out of ACD and windy conditions can continue to blow ACD from building roofs and gutters. An unexpected finds protocol has been developed to address this recontamination of cleaned areas.

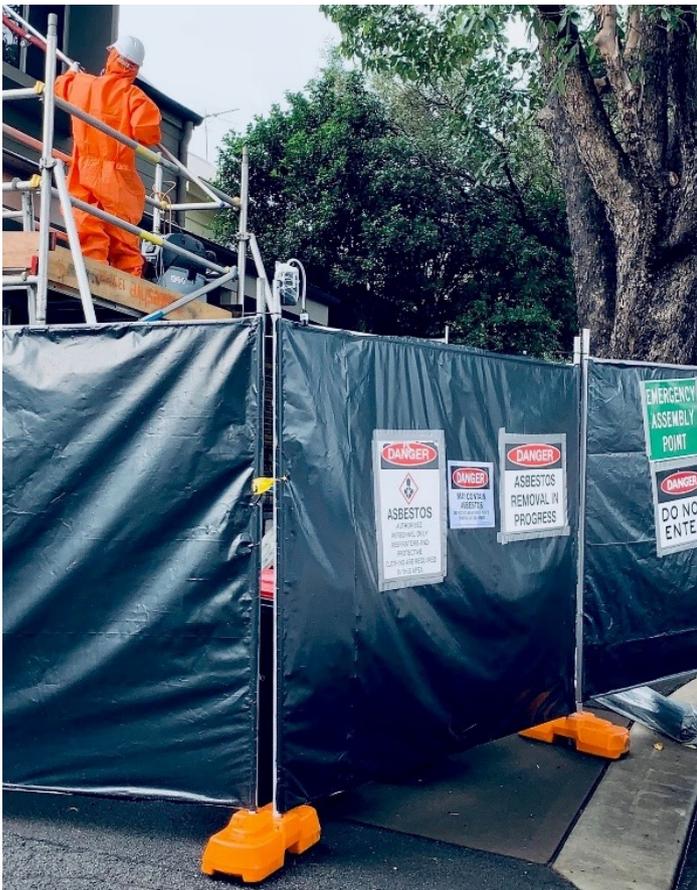
Figure 4 – Photo of Class A Contractor Undertaking ACD Clean-up Work

In New South Wales under the Protection of the Environment Operations Act 1997 the polluter is responsible for cleaning up following a pollution incident. In some emergencies, like this one, clean-up action must start as soon as possible to protect public health and safety and not wait for the responsible entity be identified and to pay. Investigations into the responsible party and cause of the fire are ongoing. The City of Newcastle and Public Works Advisory have engaged specialists who have already started the clean-up (see Figure 4).

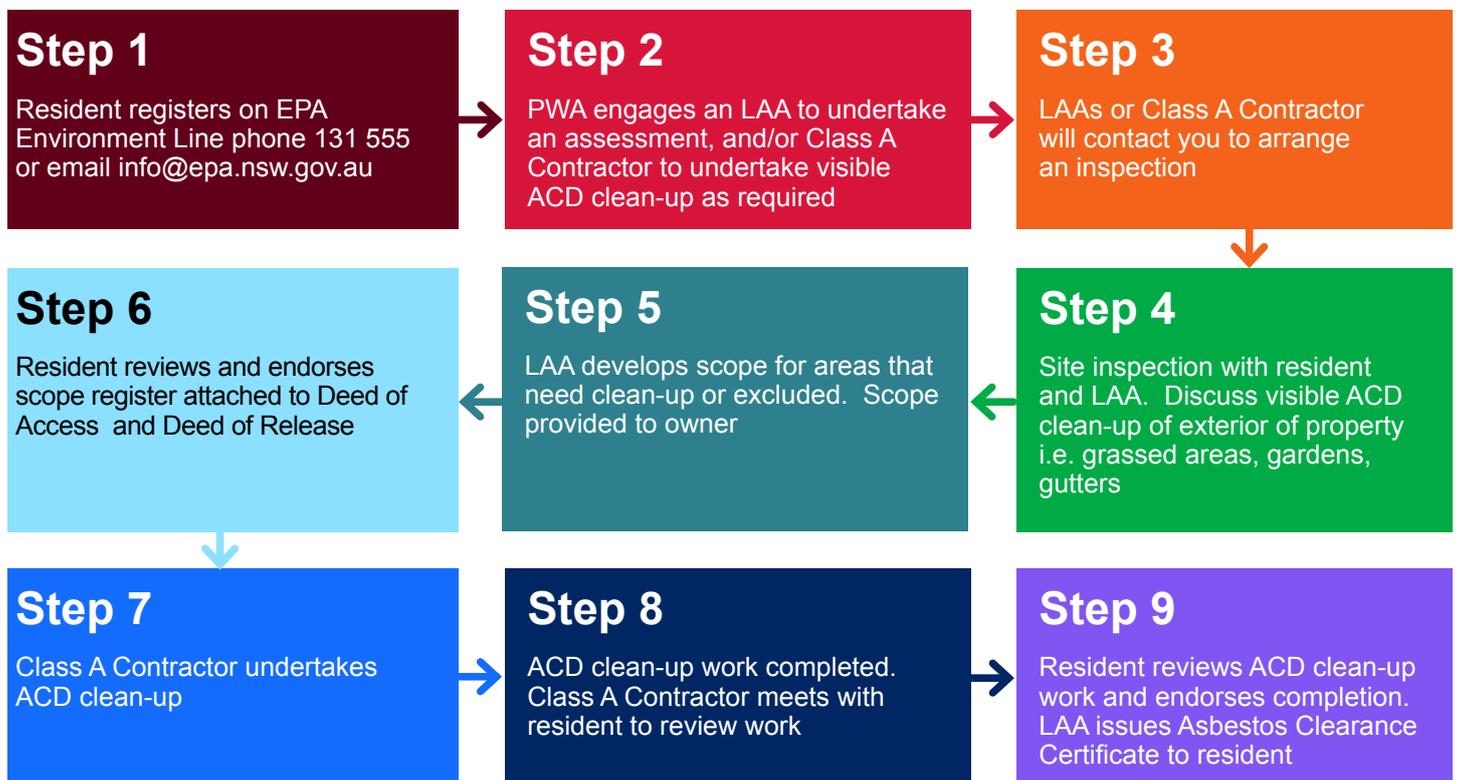
Figure 8 – Wickham Wool Store Fire ACD Clean-up Flowchart for Properties Assessed as Having Level 1 or 2 Impact

The Wickham Wool Store Fire ACD Clean-up flowchart for property owners is provided in Figure 8 below.

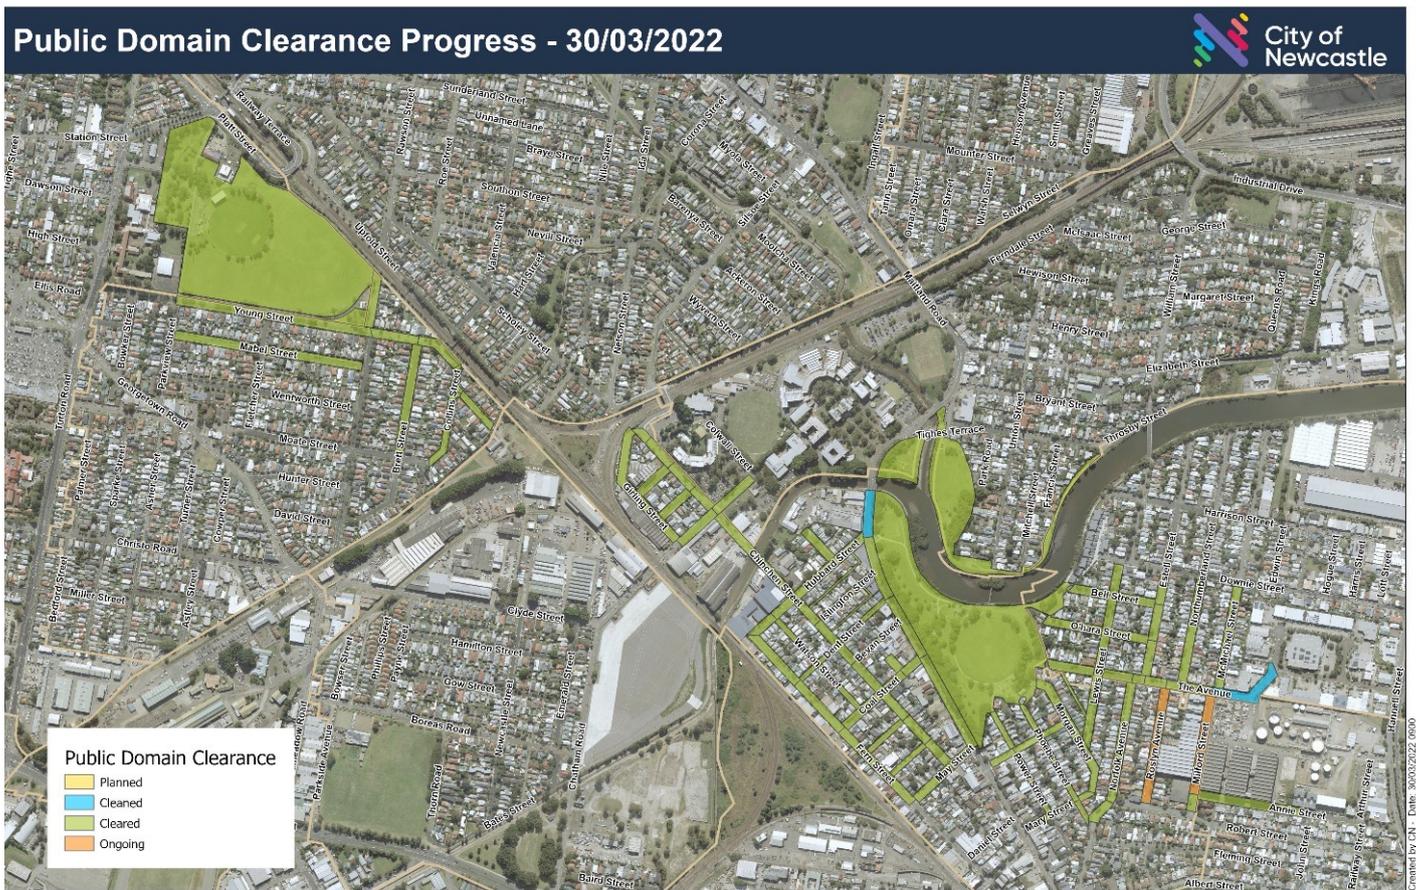
Figure 9 – Asbestos Clearance of Public Domain Areas as at 30 March 2022

ACD clean-up and Asbestos Clearance Certificate have been received for all ACD impacted public streets and public domain areas in the ACD impacted areas (see Figure 9).
