# Fort Scratchley Historic Site Heritage Management Plan

**Australian Government  
Department of Finance and Deregulation**

Fort Scratchley Newcastle, NSW  
Cnr Nobbys Road and Fort Drive  
Newcastle East

27 May 2008

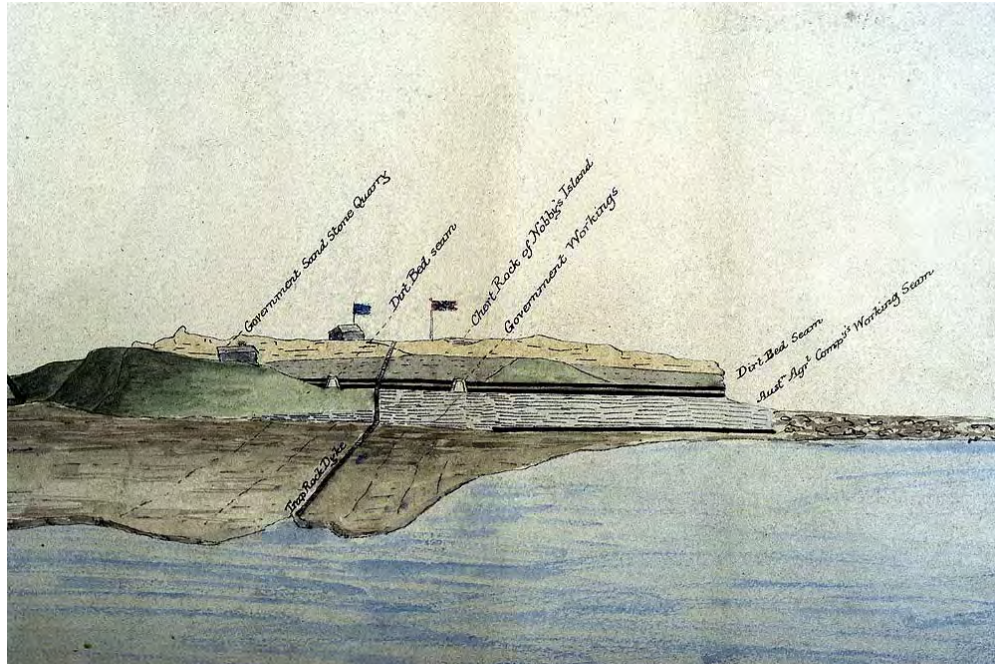
**Figure 3.7.** Cross-section of Signal Hill in 1854 showing mine workings (William Keene, Copy of Stratigraphic sketch from Nobbys Island Newcastle to Burwood, showing coal seams and their Order of Superposition, Flag Staff Hill Detail, 31 May 1854, State Records SZ325 N.1.1553)

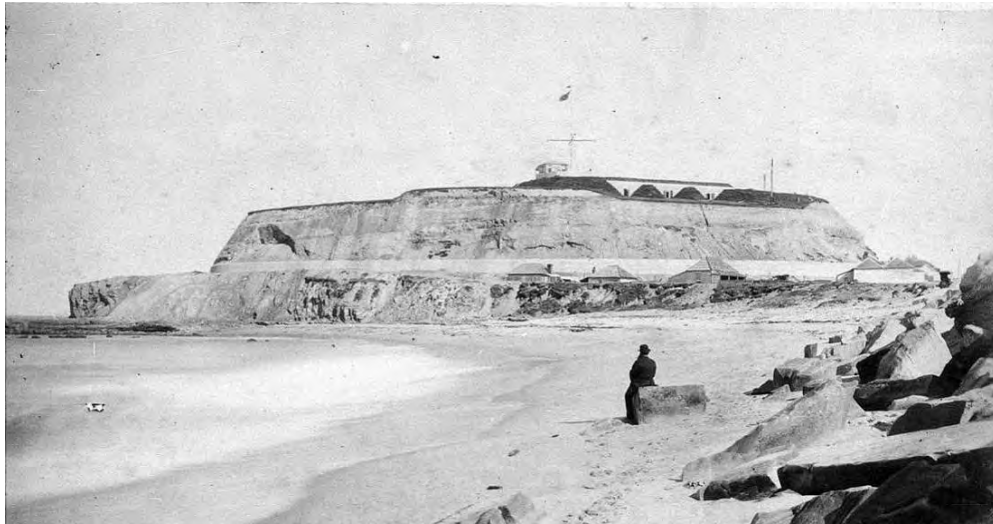
**Figure 3.13.** This view of Fort Scratchley in c1885, taken from the pier to Nobbys Head, shows the imposing concrete walls of the fortification, the casemates and the extant signal station (H B Ballard, Newcastle c1885, State Library of NSW, At World and Play BCP 05281)

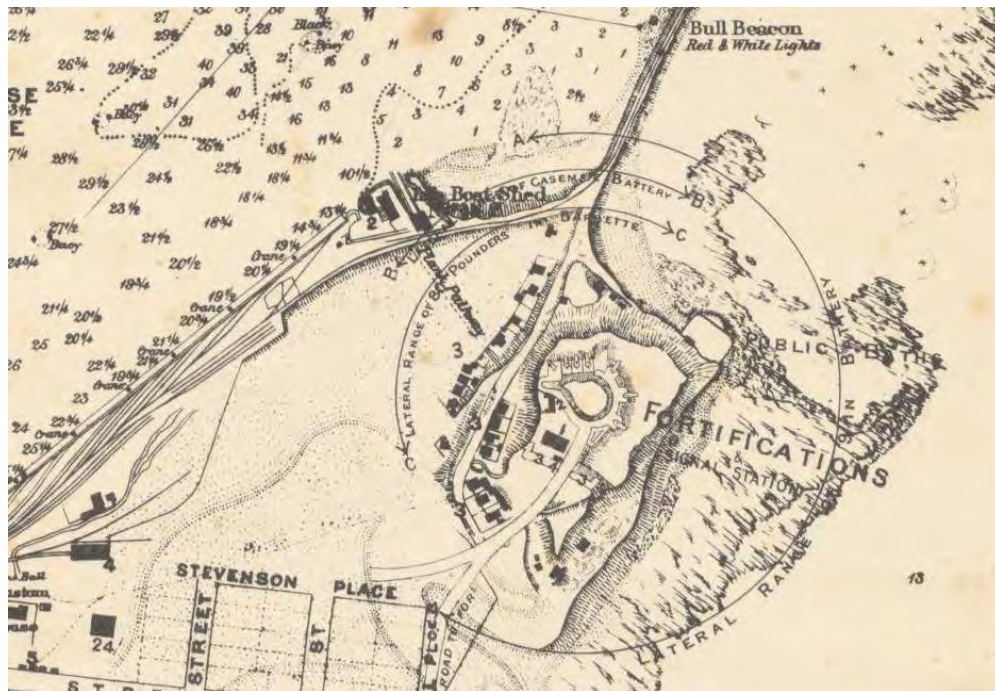
**Figure 3.17.** Detail from an 1887 harbourmasters plan of Newcastle showing Fort Scratchley, with the positions of the guns and their lateral range; a well-defined road leads to the site (Capt FW Sidney, RN, Plan of the Port of Newcastle, 1887, MAP RM 1588: <http://nla.gov.au/nla.map-rm1588>)

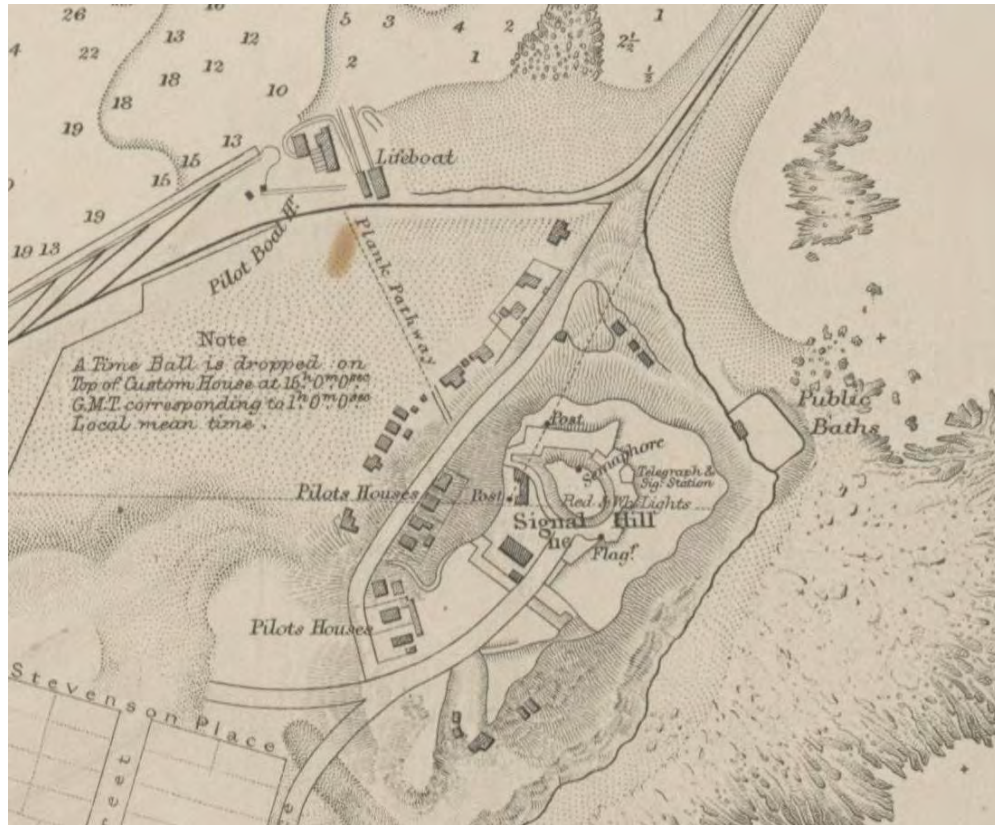
**Figure 3.19.** This detail from a c1880s-90s plan of Newcastle shows Fort Scratchley, with the officer's quarters and barracks, a semaphore, a telegraph & signal station and a flagstaff. The site is named Signal Hill. The 'ditch' or moat clearly demarcates the fortifications from the rest of the town (Great Britain Hydrographic Department, Newcastle Harbour 1881-1891. MAP RM 2989: <http://nla.gov.au/nla.map-rm2989>)

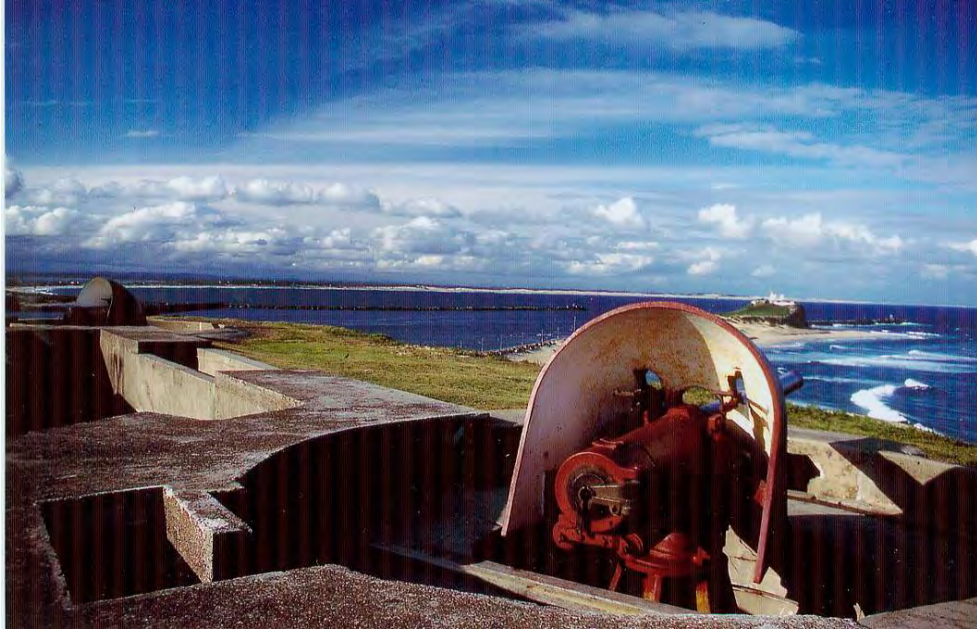
Figure 3.40. Barbettes after installation of Mk 7 gun pedestals

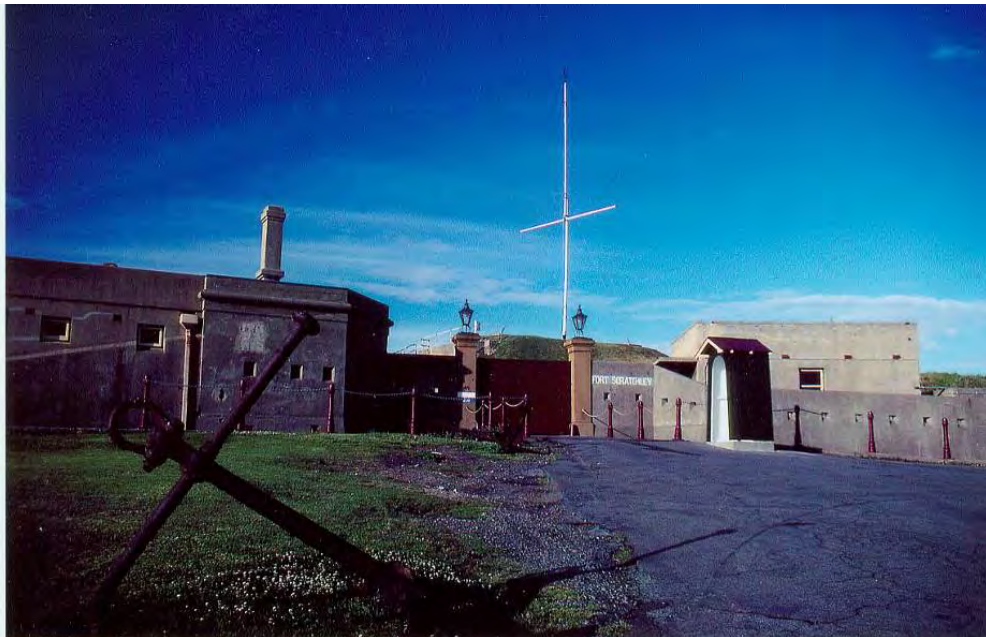
Figure 3.41. Completed restoration, 1984, including replica gates, sentry box and flagstaff

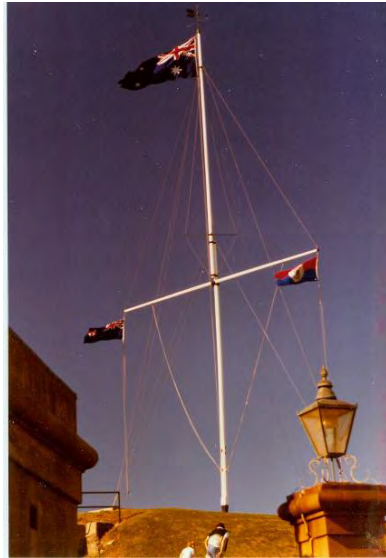
Figure 3.42. Replica flagstaff, on completion 1982

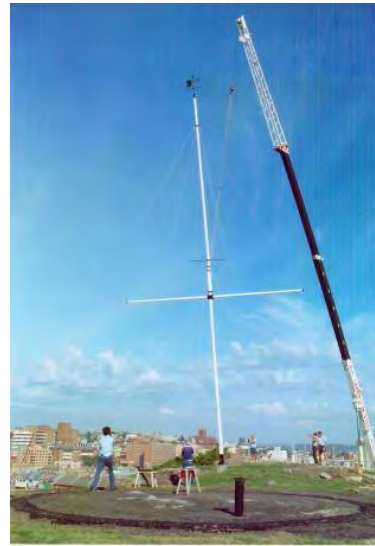
Figure 3.43. Erection of flagstaff 1982

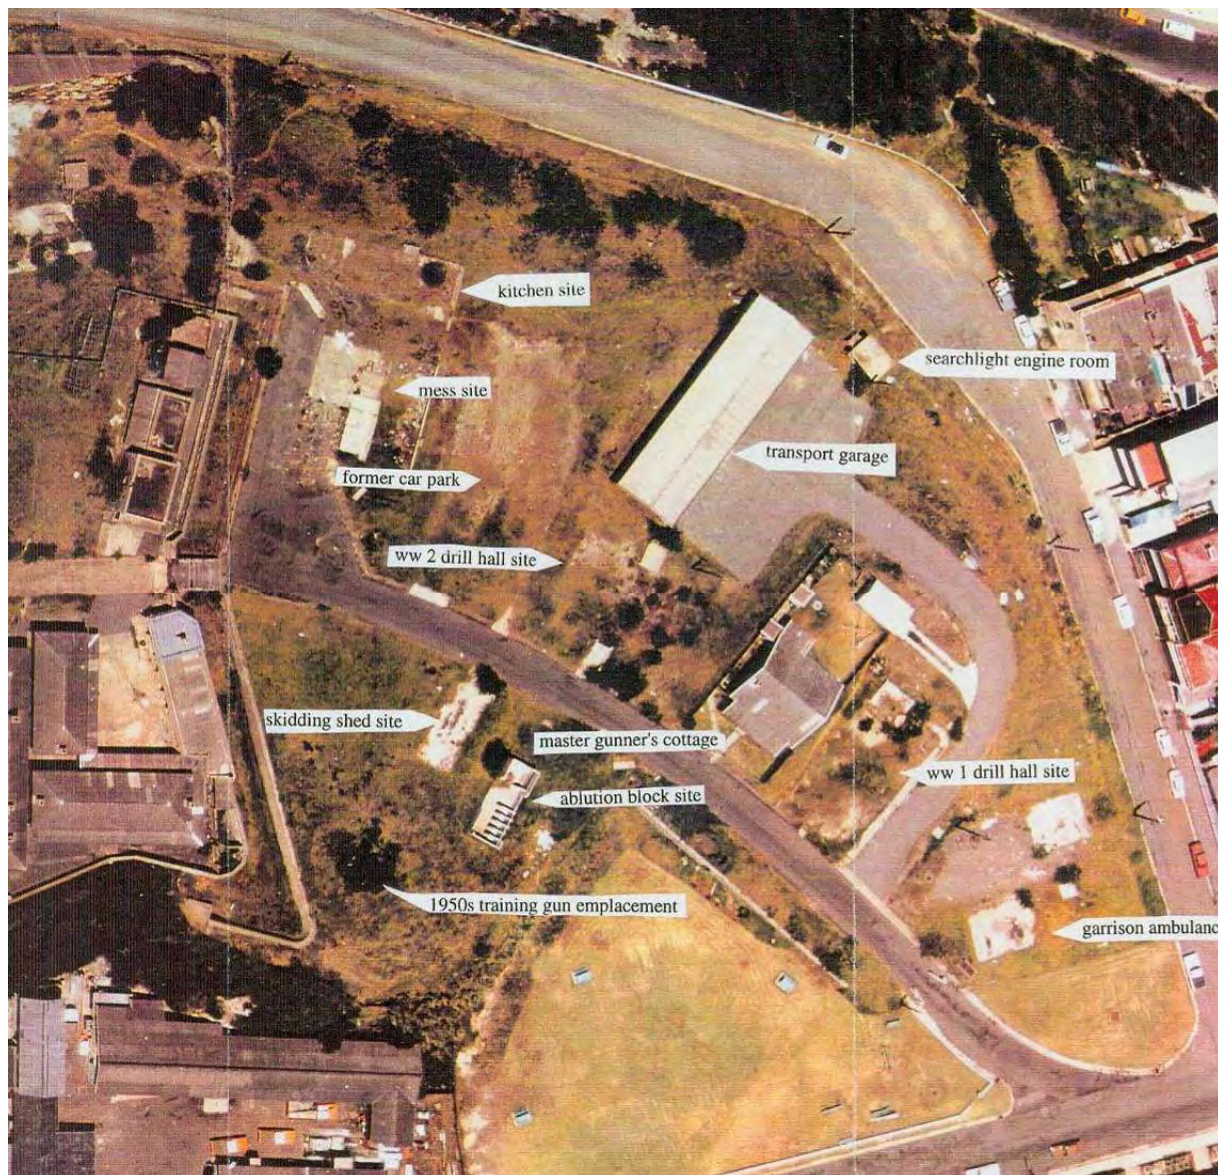
Figure 4.7. Aerial view of outer fort precinct in 1973, immediately after removal of annotated buildings (Austral Archaeology Pty Ltd)

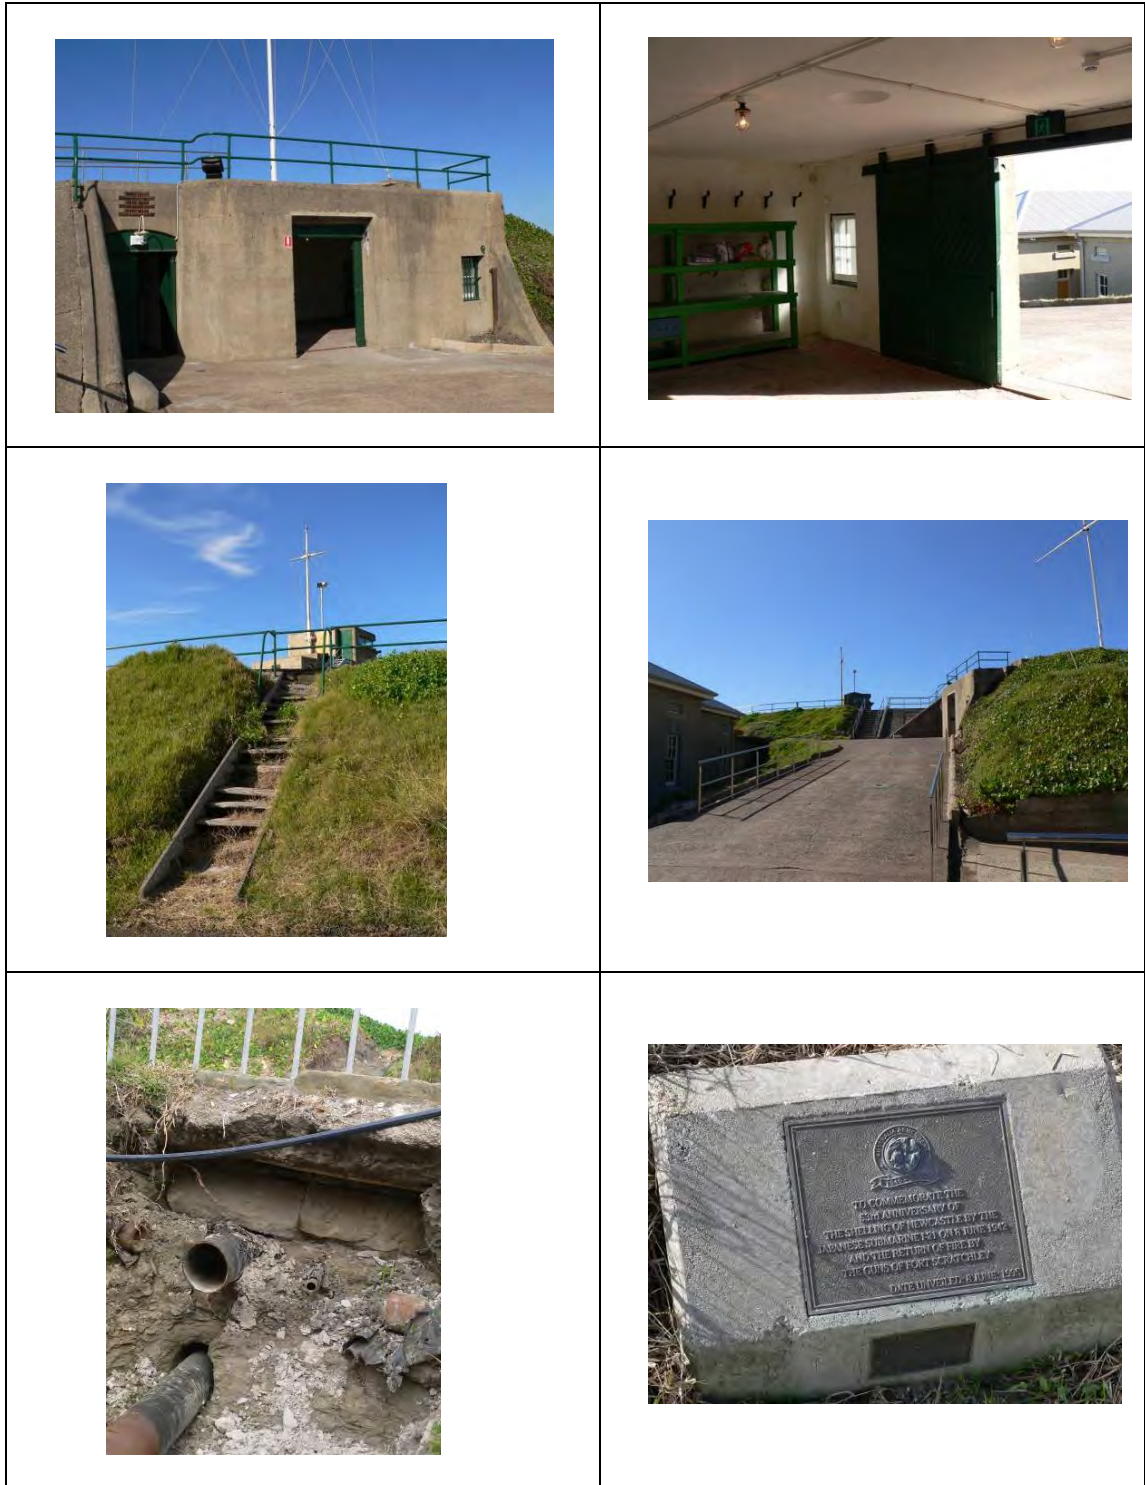
**Figure 4.20**  
**Driveway, and Artillery Store**

<b>Figure 4.20</b>	1 2 3 4 5 6	<b>Entrance to tunnels and Artillery Store</b> <b>Interior of Artillery Store</b> <b>Remnant replica steps to parade ground. Access between Commandant's Cottage &amp; BOP</b> <b>View up driveway from entry gates</b> <b>Remnant flagstones under concrete driveway</b> <b>Plaque in commemoration of Japanese attack near entrance to tunnels</b>
<b>Figure 4.21</b>	1 2 3 4 5 6	<b>Original WC pan and slate partitions in Gunners Ablutions</b> <b>Slate partitions to urinals</b> <b>Evidence of original skillion roof, Gunners Ablutions</b> <b>Gable to Gunners Ablutions</b> <b>Northern area of Laboratory and new Guardhouse</b> <b>Generator plinth, Generator Room</b>
<b>Figure 4.22</b>	1 2 3 4 5 6	<b>Ante-room and changing bench, Laboratory</b> <b>Laboratory, shell filling area. Note steel window shutters and fume vents</b> <b>Exterior, south side of Laboratory, Gunners Ablutions and Generator Room</b> <b>Laboratory, shell filling area</b> <b>Generator Room</b> <b>New Guardhouse</b>

The driveway has been sealed in later years and is historically significant as the location for the driveway since the earliest use of the site. The original driveway was sandstone flagging and a section of the stonework remains beneath the concrete paving (refer photo Fig 4.22)

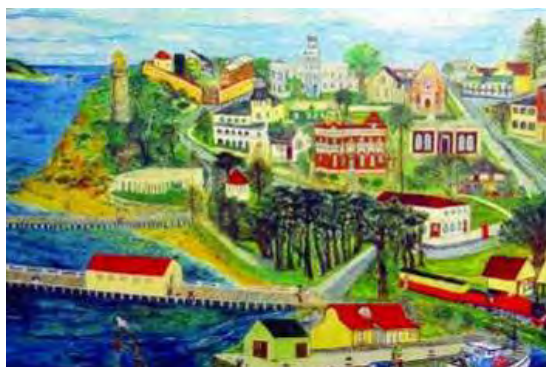
: *Fort Queenscliff* – Postcard, showing; Black Lighthouse (1863) and octagonal Signal Station (1888), Keep and Walls (1883), and 8 inch Disappearing Gun (1885) in gun position B1.

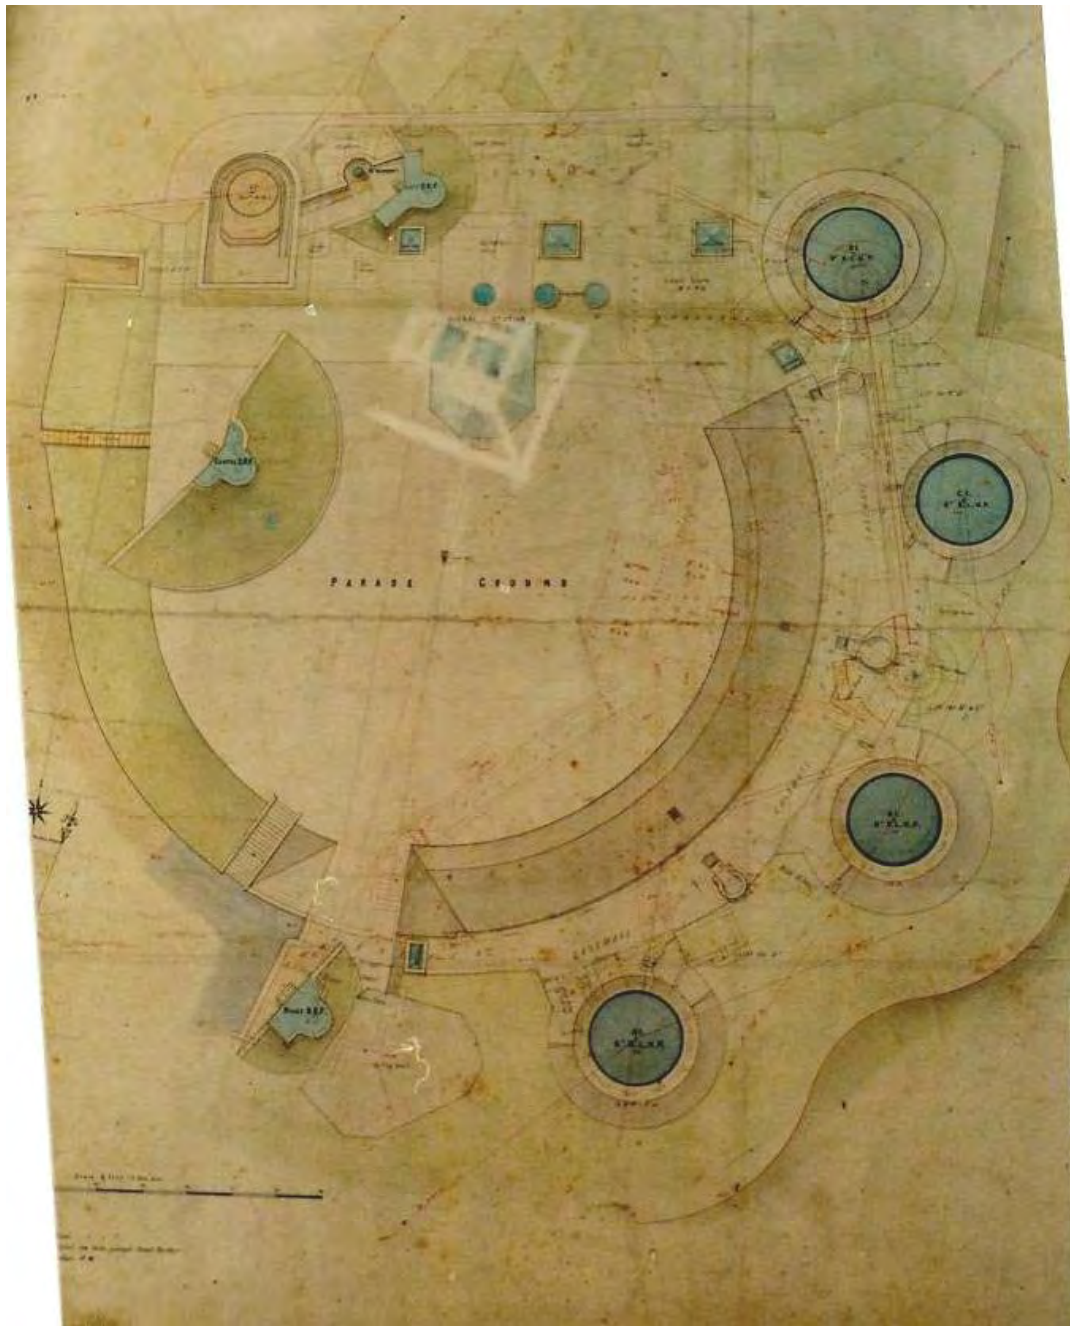
DRAWING NO 2

### **Fort Scratchley : Design Drawings dated 1878 and later alterations to Barbettes**

SECTIONAL PLAN
