NEWCASTLE CITY COUNCIL

SHIFTING SANDS AT STOCKTON BEACH

Umwelt (Australia) Pty Limited
Environmental and Catchment Management Consultants

1411/R04/V2

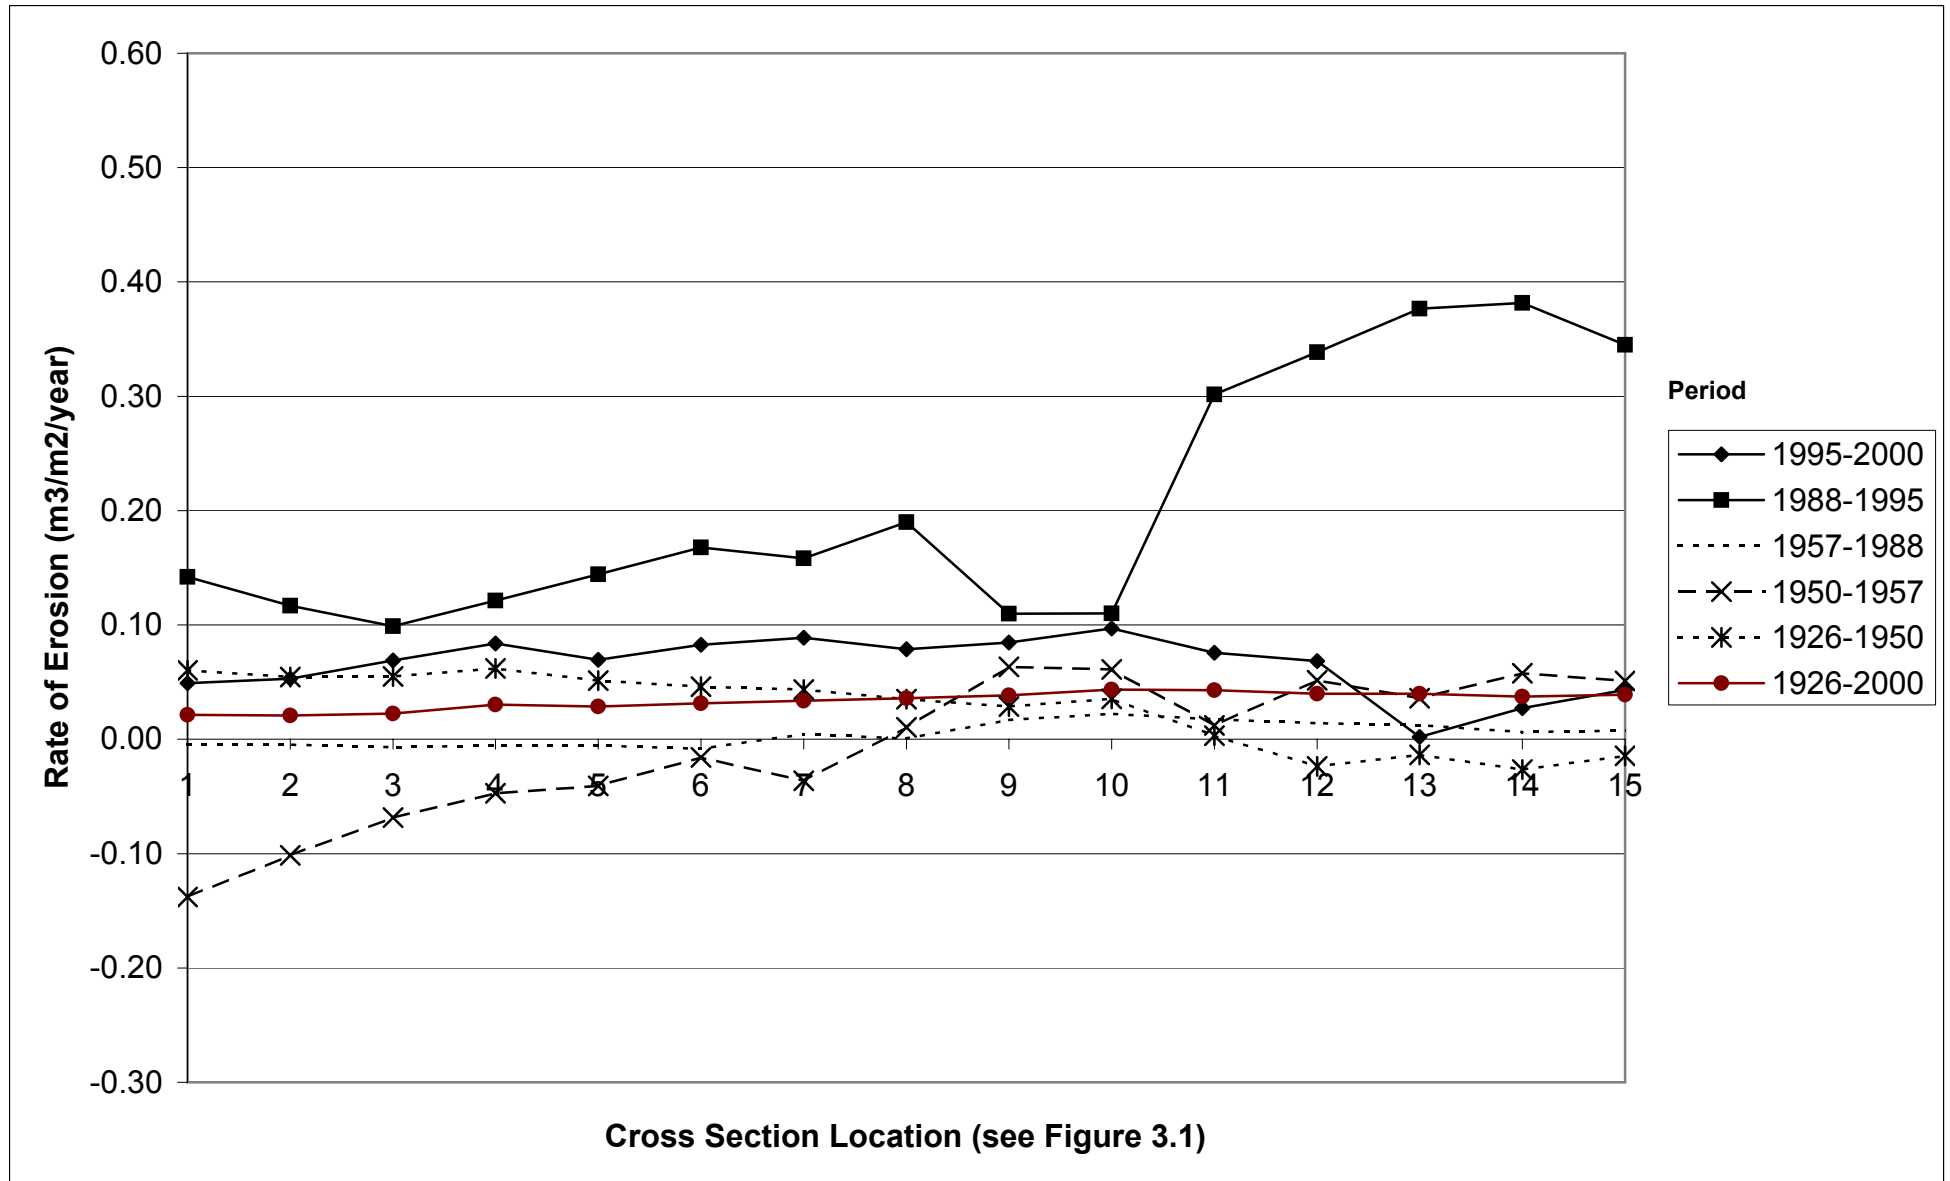
Figure 3.15

Average Erosion Rate for 500m Wide Strip off Stockton Beach

This analysis supports previous views that areas of erosion fluctuate along the beach with these fluctuations typically having a north-south or south-north trend. The analysis also demonstrates that since construction of the seawall in 1989, areas up to 1000 metres offshore from the seawall are not experiencing greater rates of erosion than other sections of Stockton Beach. On this basis it is considered that the seawall is not contributing to the significant erosion rates that have been recorded off Stockton Beach.

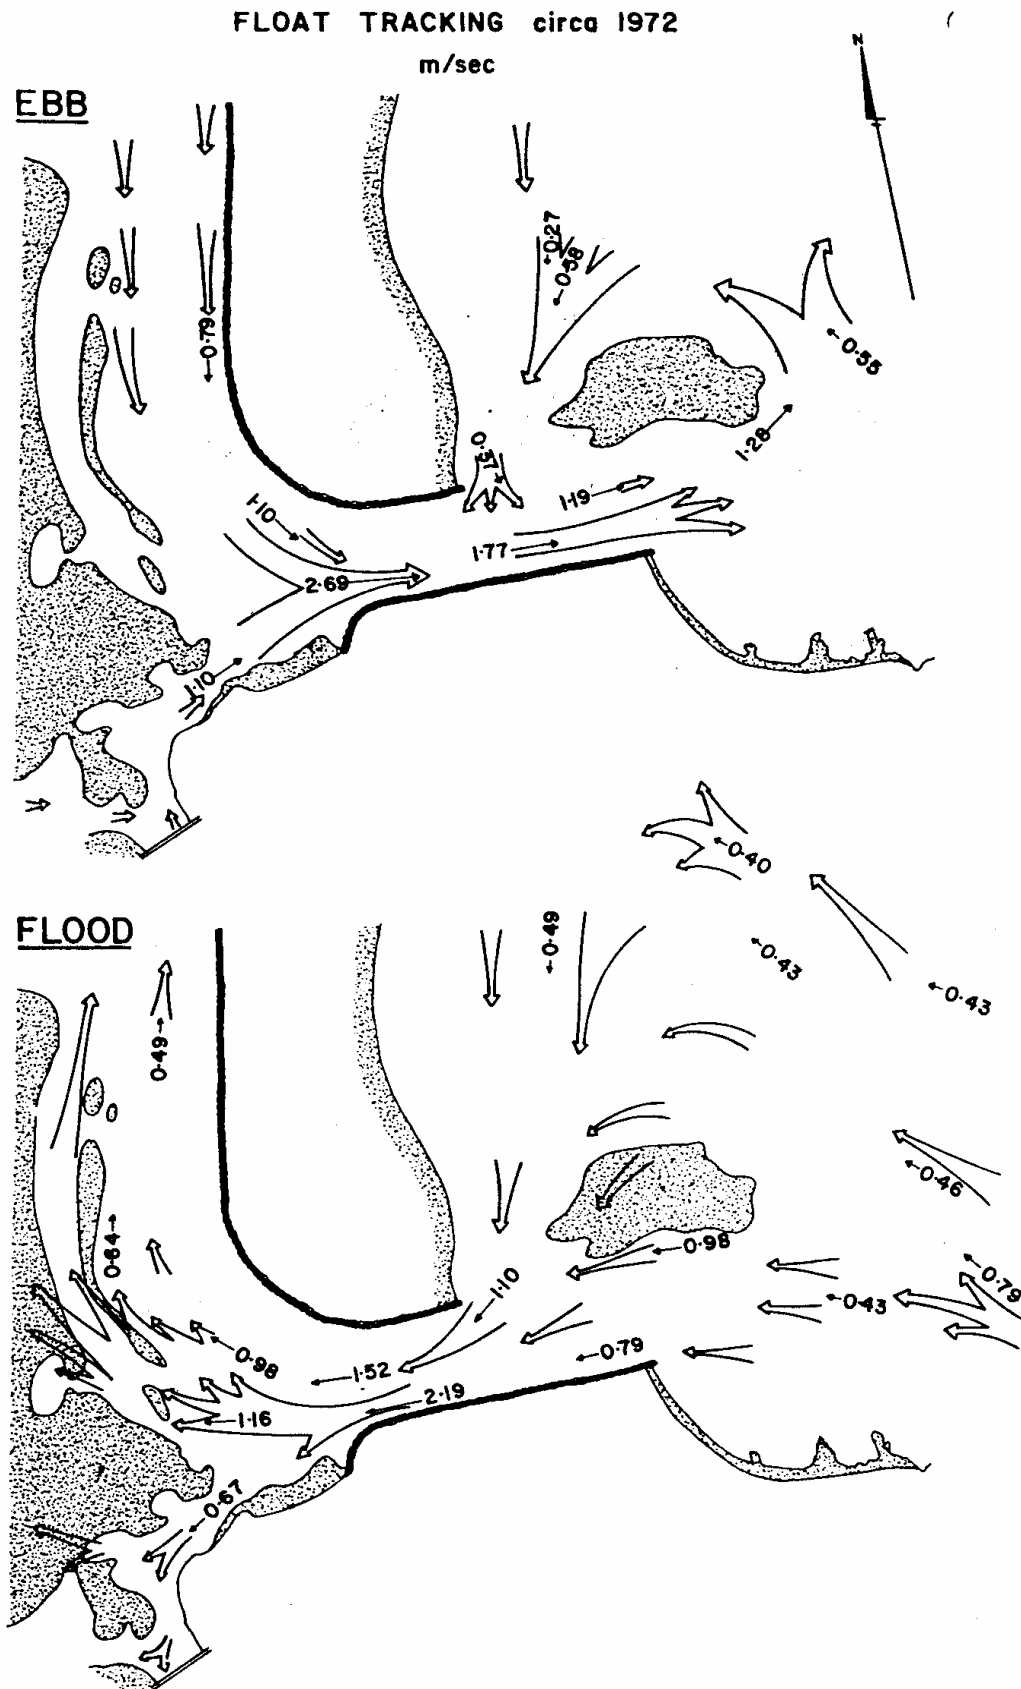
Figure 4.4: Schematic Representation of Flood and Ebb Tide Current Patterns at an Asymmetrical Inlet as Exemplified at the Hastings River Entrance, Port Macquarie (after Druery & Nielsen, 1980).

As indicated in **Figures 4.3** and **4.4**, which depict the flood and ebb tide current patterns at these two similar asymmetrical estuary inlets, this marginal flood tide channel conveyed an inlet directed current during all tidal stages, which would have brought littoral drift into the entrance channel. This material would have been transported either into the estuary on subsequent flood tides or deposited onto the ocean bars during ebb tide. Such a circulation of sediment transport maintained the large swash shoals (*Oyster Bank*) on the northern side of the inlet. The formation of ebb tide separation eddies, as implied by the distribution of sand shoals and field current measurements depicted on hydrographic surveys, is demonstrated also by hydrodynamic modelling studies, such as that done for the asymmetrical ocean inlet to the Songkhla estuary, Thailand (**Figure 4.5**).

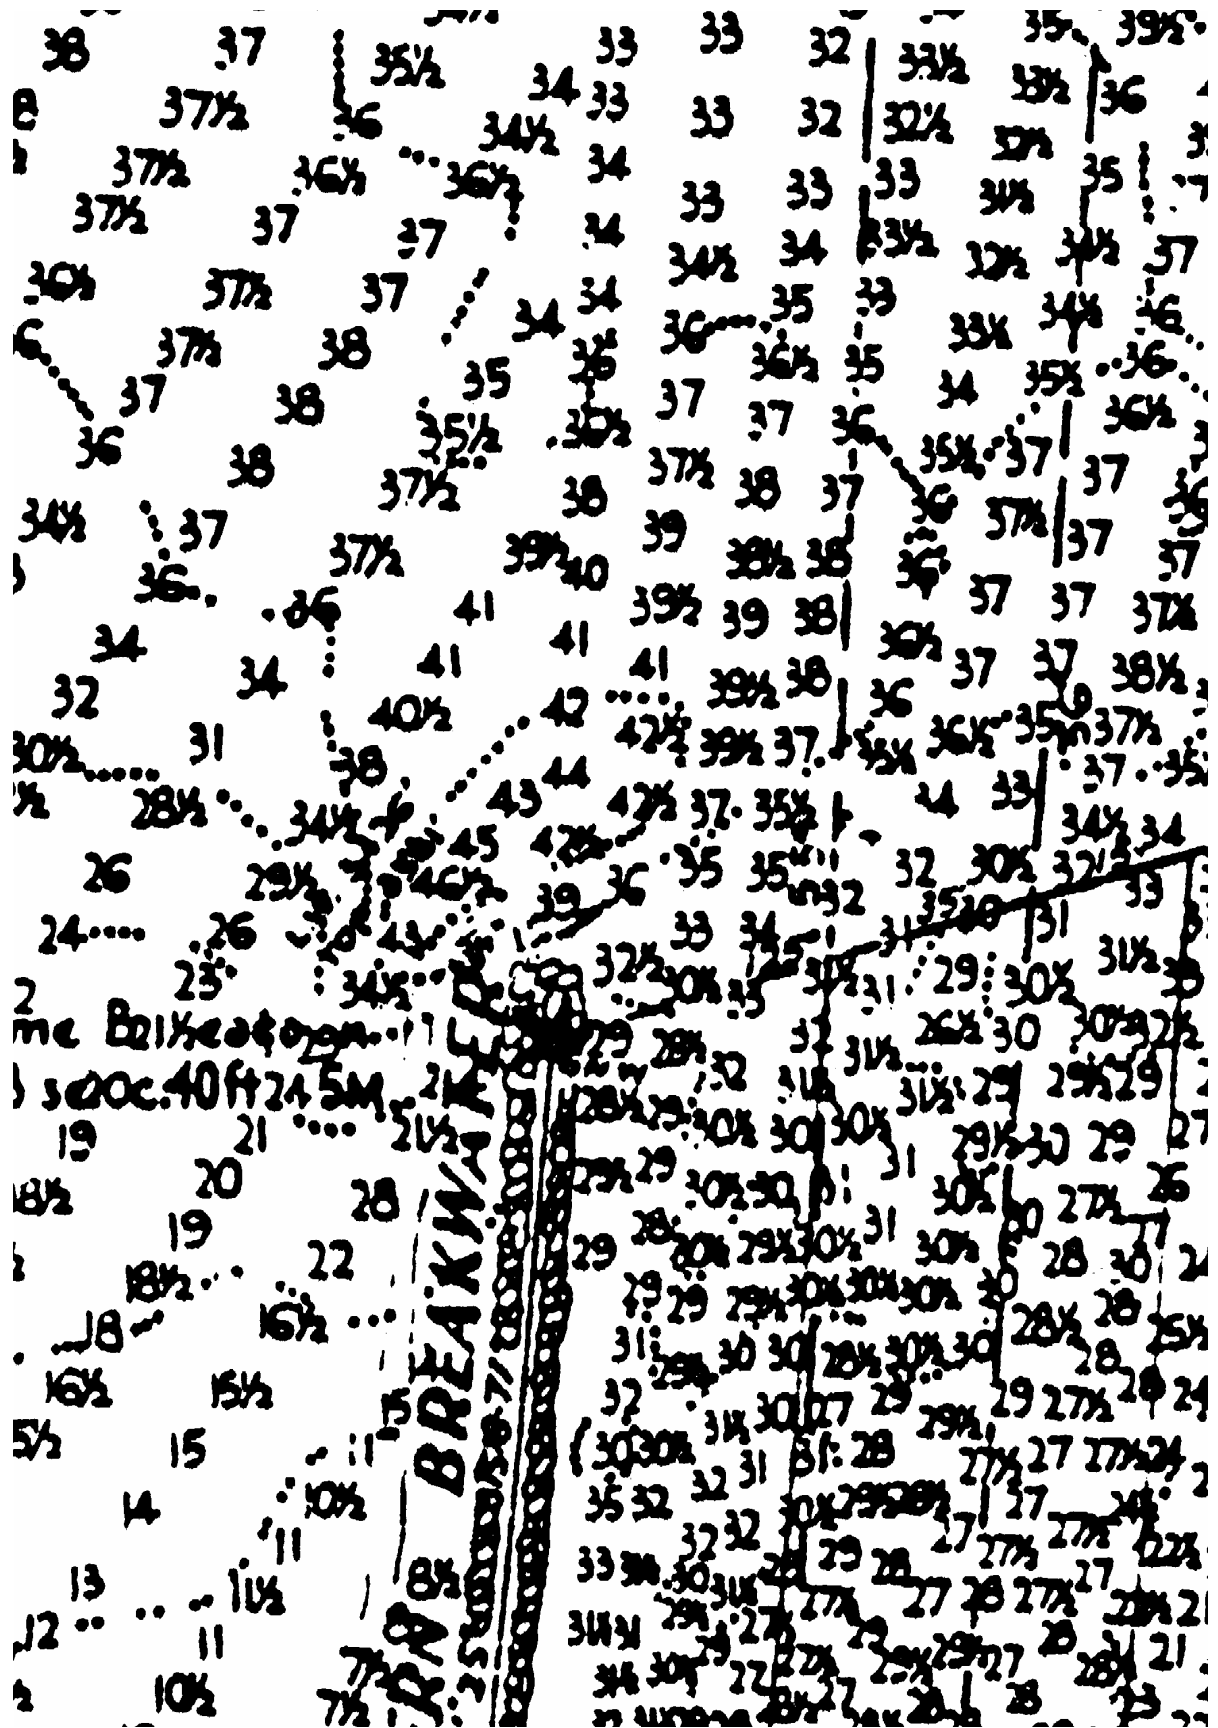
Figure 4.9 Enlargement of Bathymetry at the Tip of the Northern Breakwater from the 1957 Hydrographic Survey (depths shown in feet)
