# Community Update

The Local Recovery Committee is continuing the recovery effort following the Wickham Wool Store fire on 1 March.

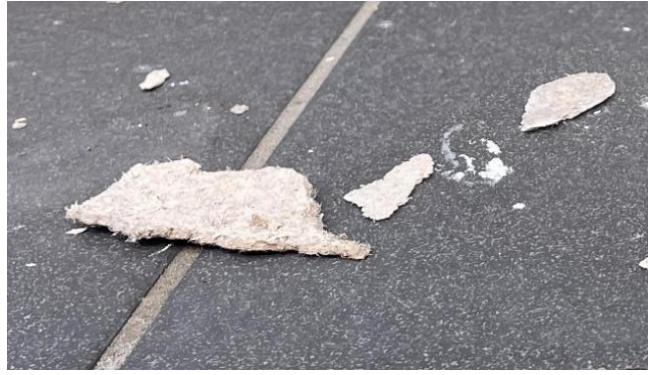
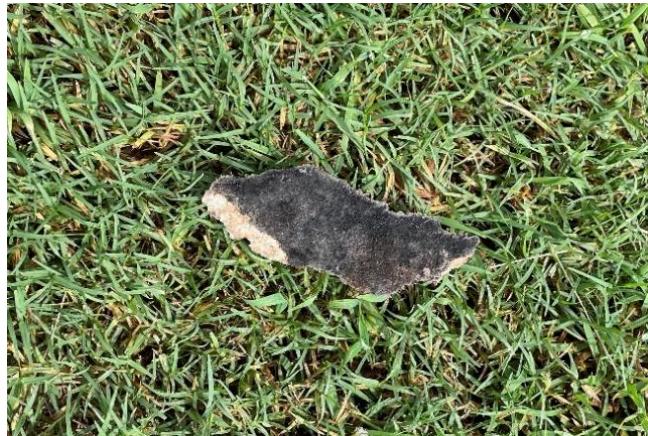
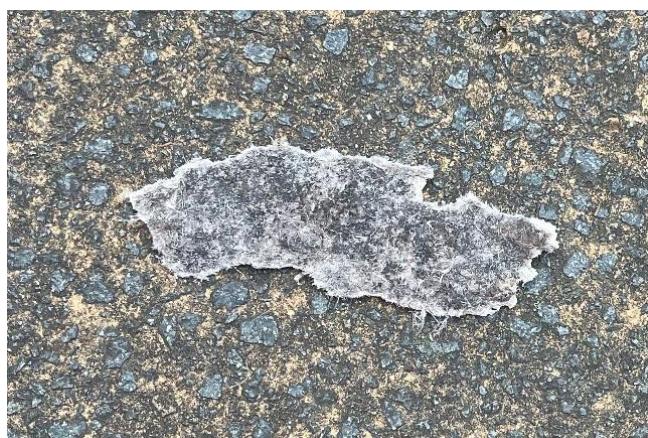
Asbestos specialists have advised that the asbestos is likely to be Super Six, which was previously a commonly used construction material in older buildings and is now banned. The images on page two show some of the asbestos debris from the Wickham fire.

Asbestos debris from the fire. Photo: Hazmat Services

During and since the fire, there has been prolonged rainfall, which has helped prevent fibres from becoming airborne. Information from Fire and Rescue NSW rapid assessment reports indicates that asbestos-containing debris from the fire that landed on properties were fragments of non-friable asbestos cement debris, with some loose fibres.

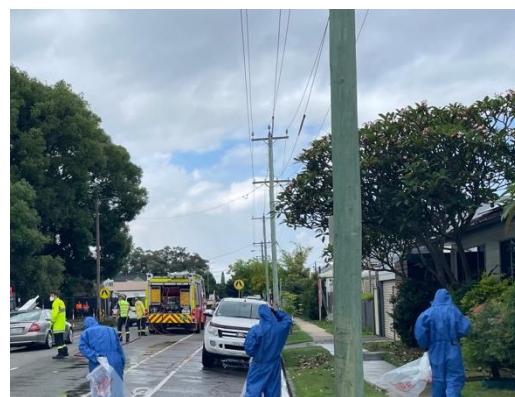
Specialist asbestos contractors cleaning up an impacted street.

City of Newcastle is responsible for the removal of asbestos-containing debris in public areas, including roads, footpaths, cycleways, parks, playgrounds and other public spaces and is well-progressed with the clean-up in these areas.
