REVISED CONSERVATION MANAGEMENT PLAN

FORMER AUSTRALIAN AGRICULTURAL COMPANY MINE MANAGER'S HOUSE HAMILTON NSW

195 Denison Street
Hamilton NSW 2303

Prepared by EJE Heritage
December 2015
10929-CMP-001 Rev D

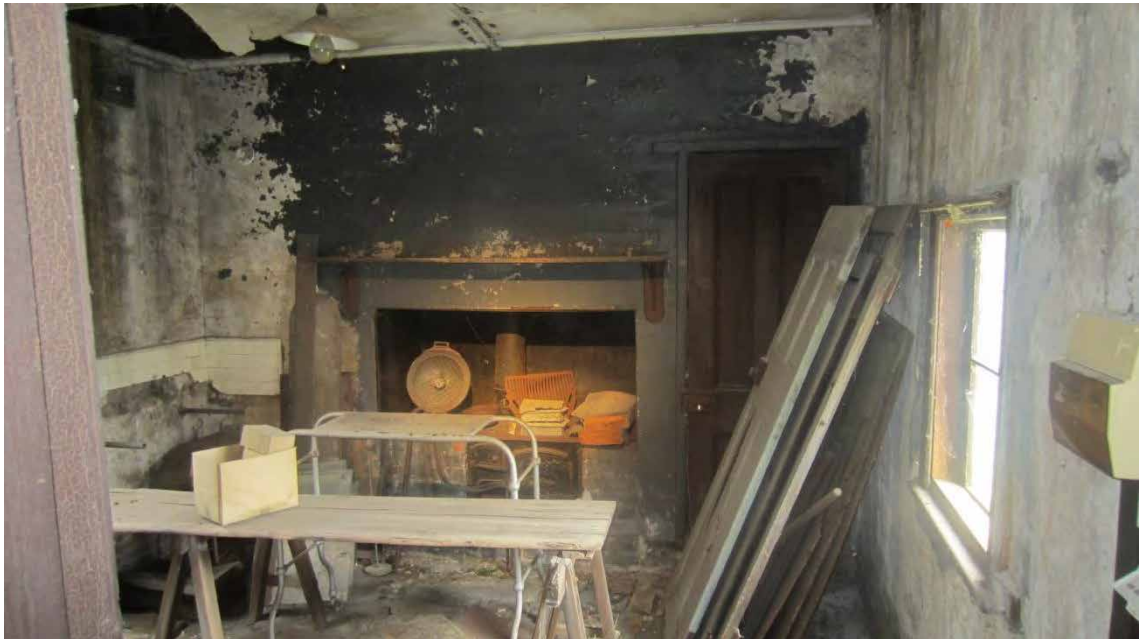
Figure 73. Kitchen, showing fireplace and stove; 1920s kitchen sink now missing.

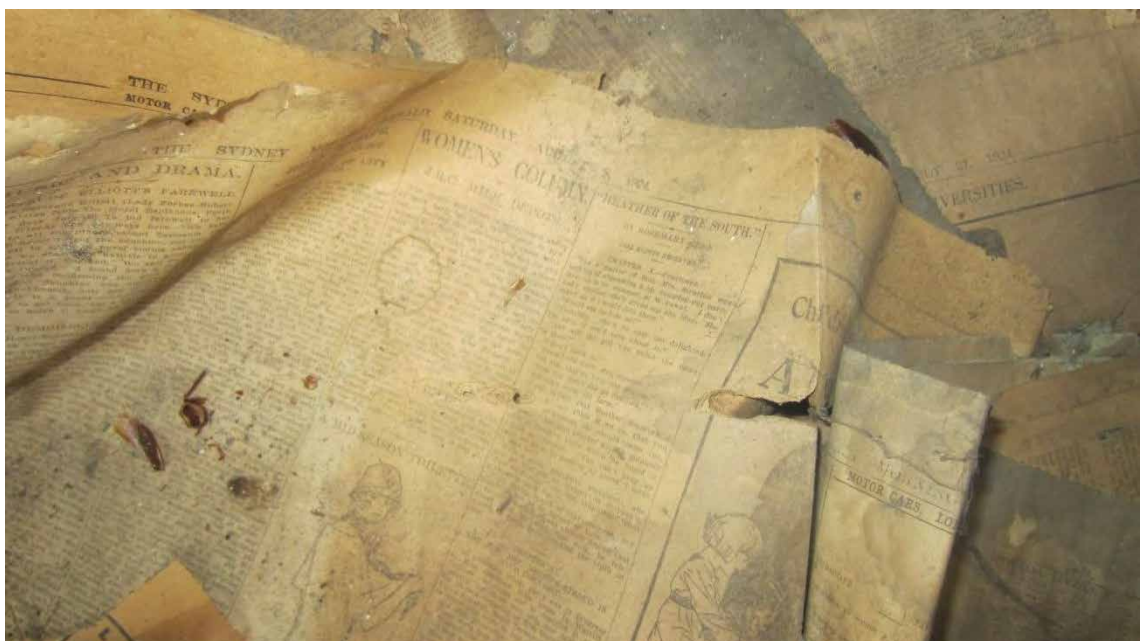
Figure 78. 1920s newspapers visible where linoleum has been lifted.

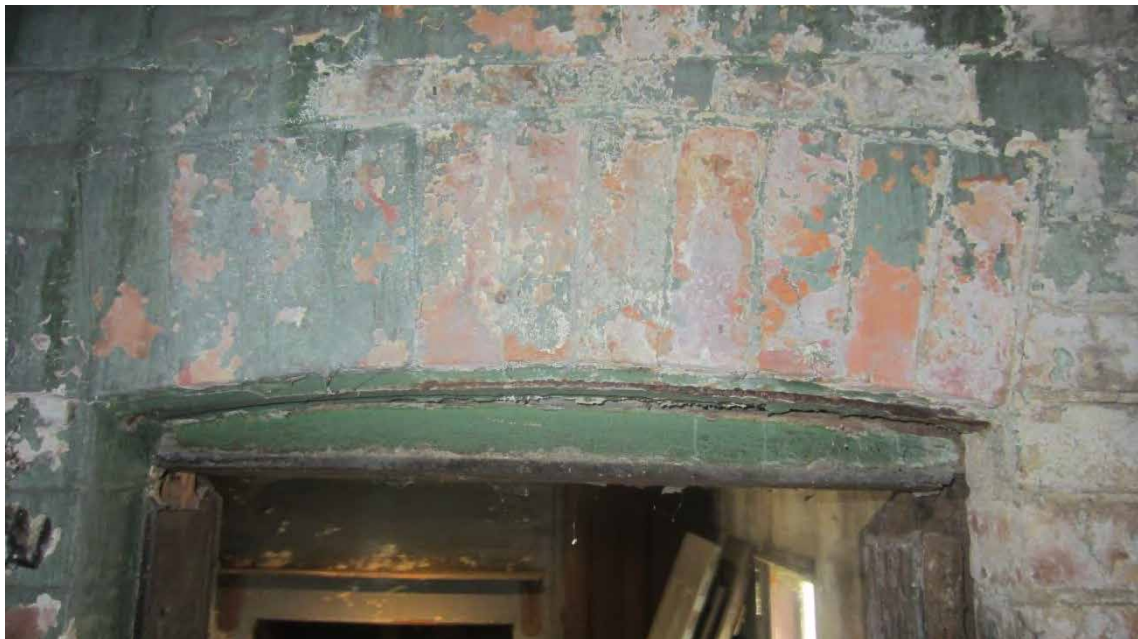
Figure 84. Kitchen door (formerly external) to kitchen from hallway.

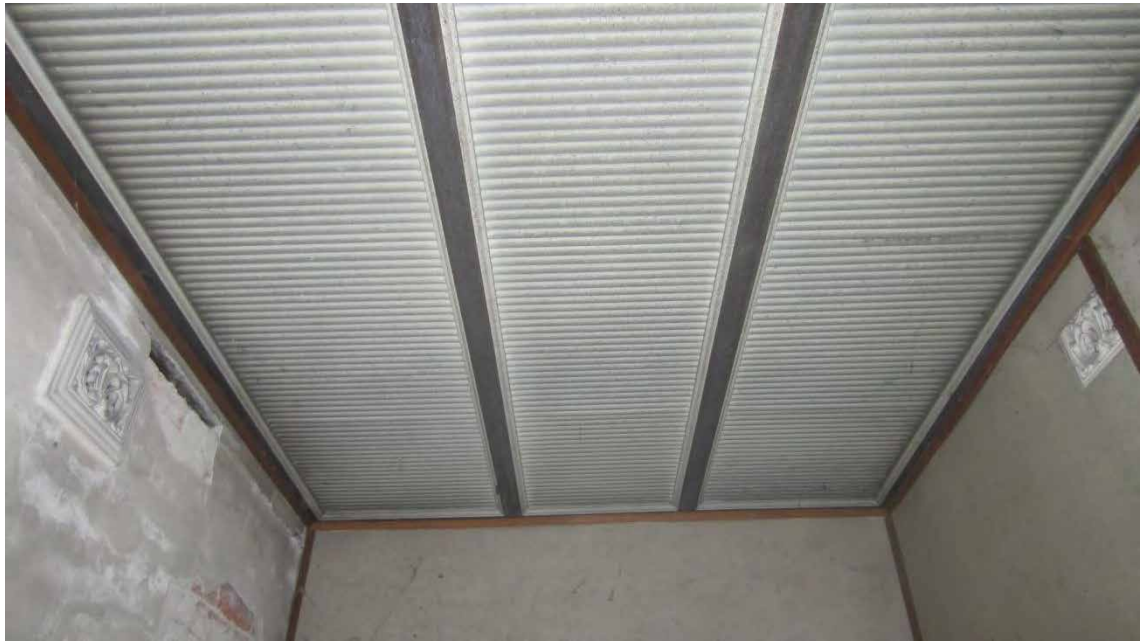
Figure 88. Pantry ceiling; note decorative wall vents.

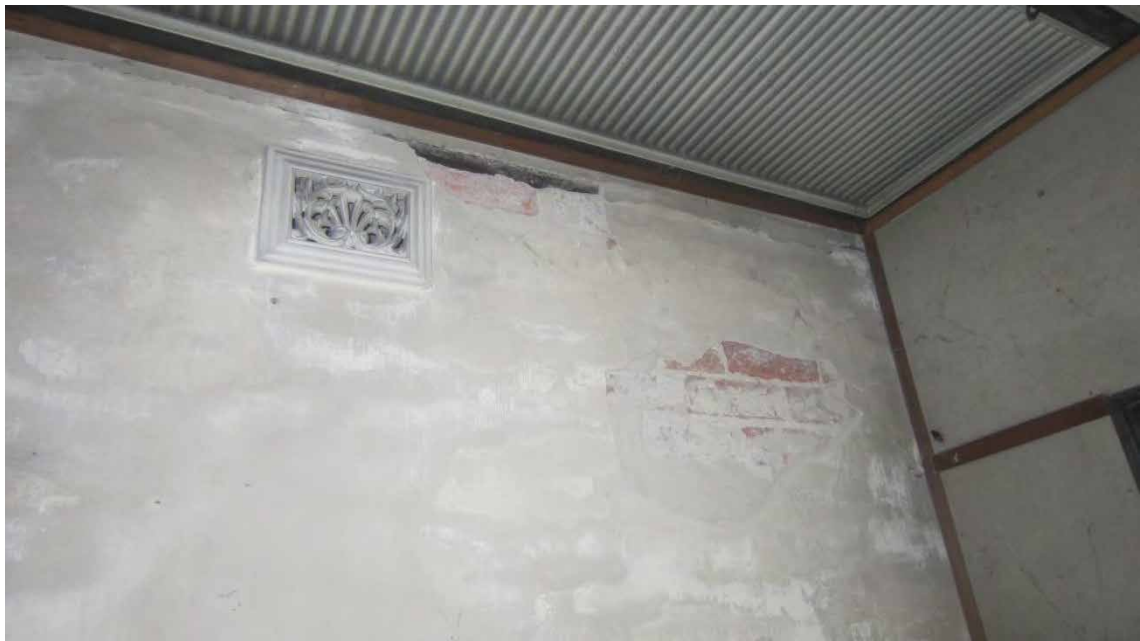
Figure 89. Southern (internal) wall of laundry, showing depleted lime plaster; note lightweight wall at right.

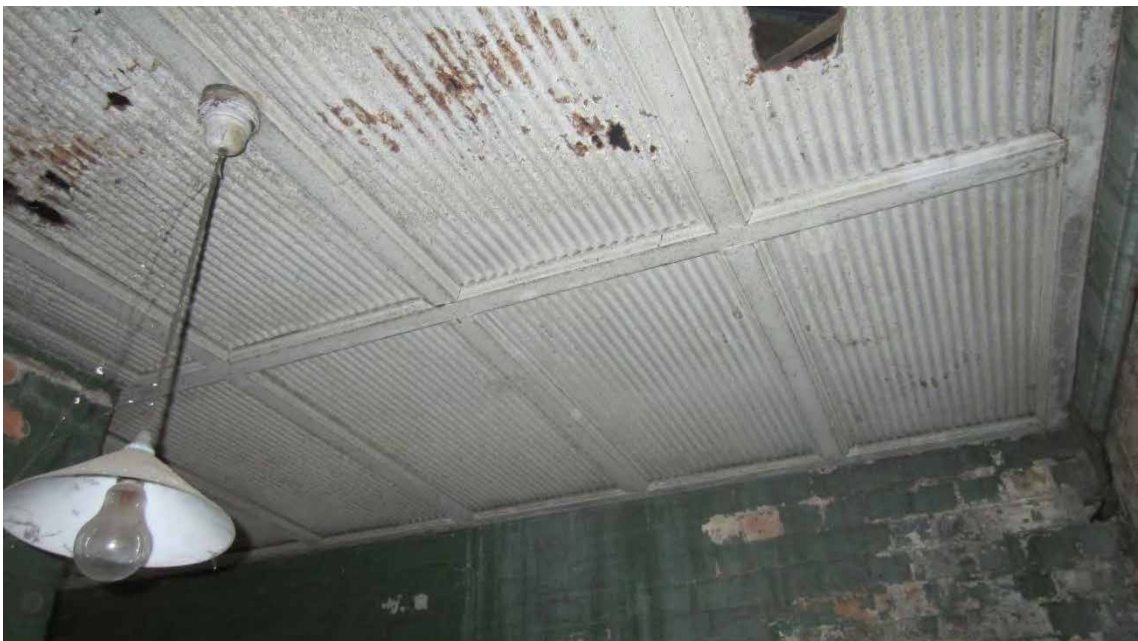
Figure 92. Hallway ceiling; note efflorescence to bricks from historic water intrusion. Light fitting is of unknown date.

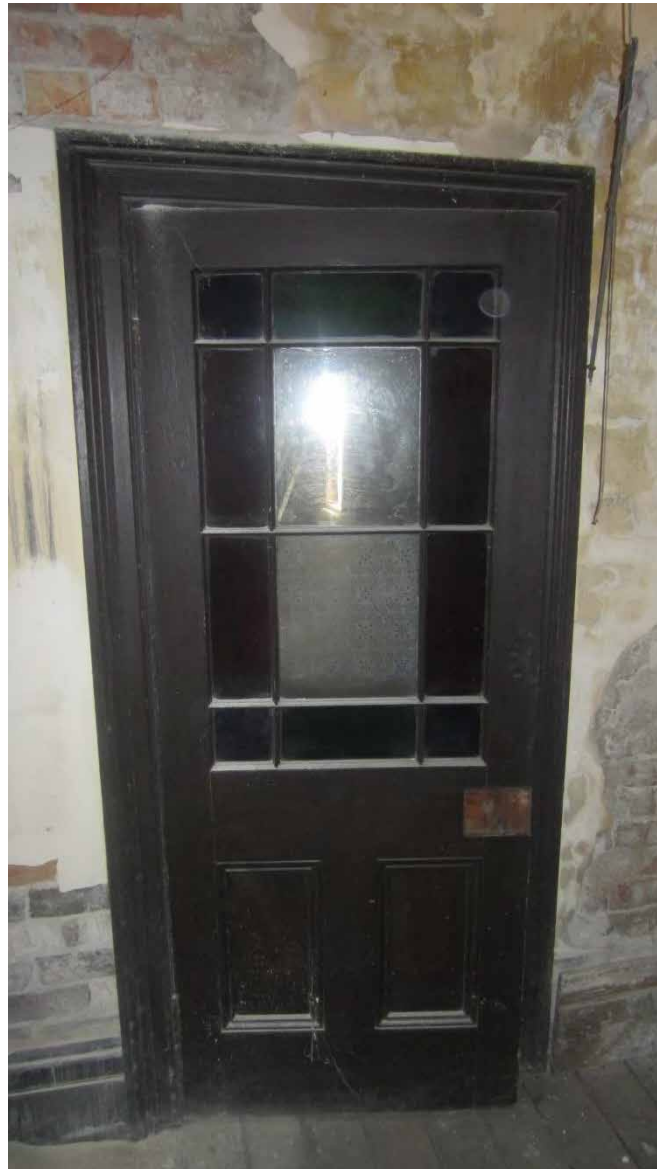
Figure 99. Door from rear hallway to dining room; note glazing colour and motifs.

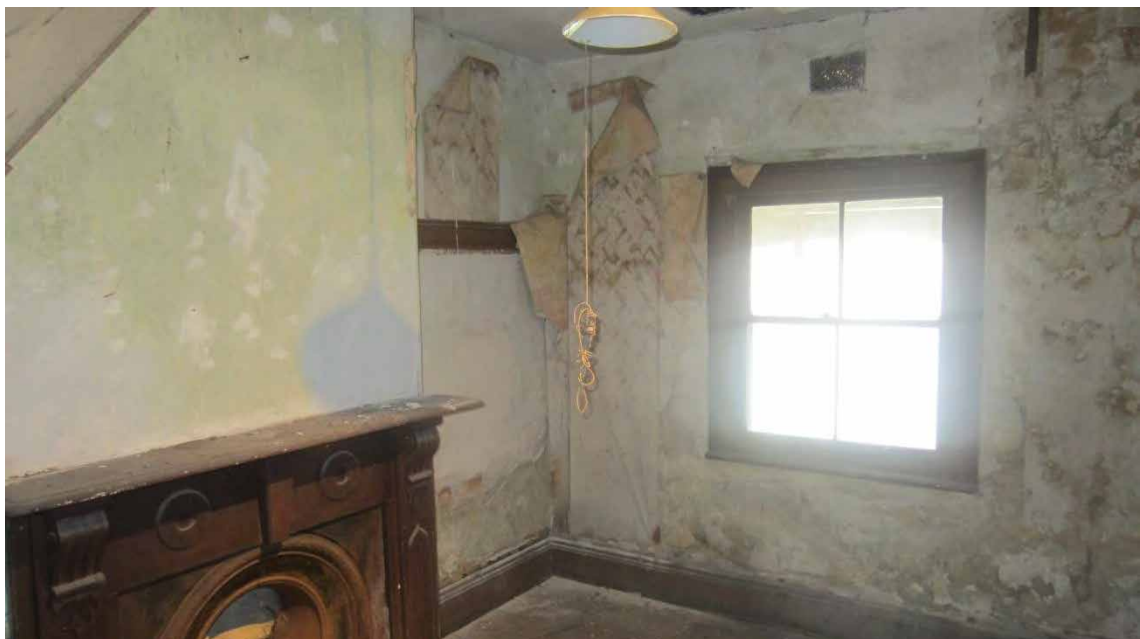
Figure 103. South-western bedroom, showing peeling wallpaper.

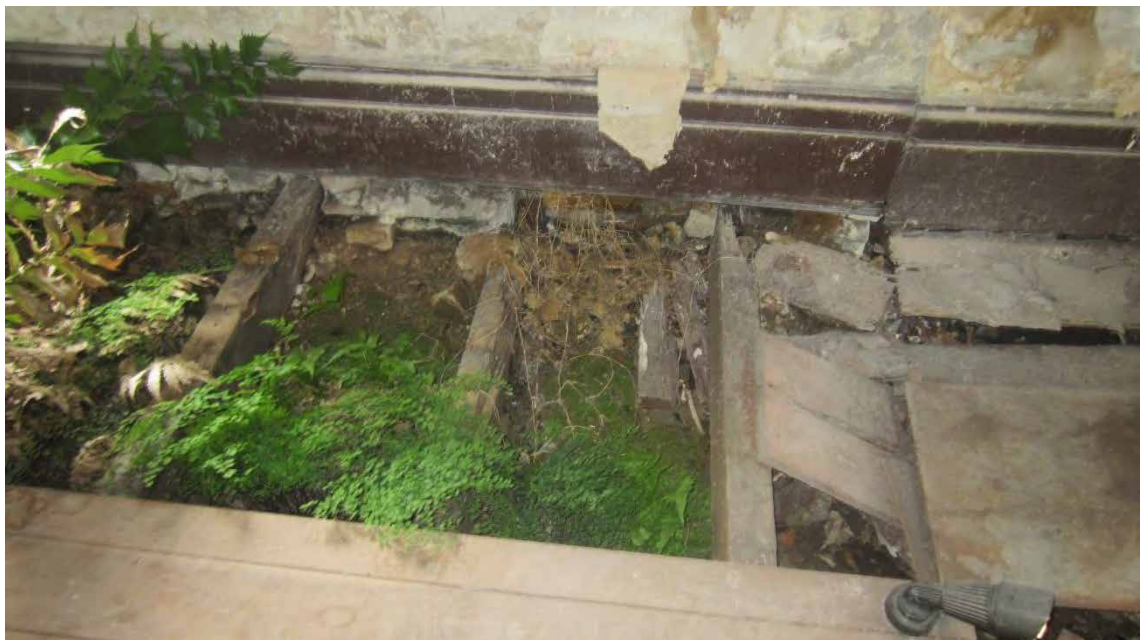
Figure 111. Plant growth in north-western corner of sitting room evinces presence of damp in sub-floor; note floor joists shaped with an adze.

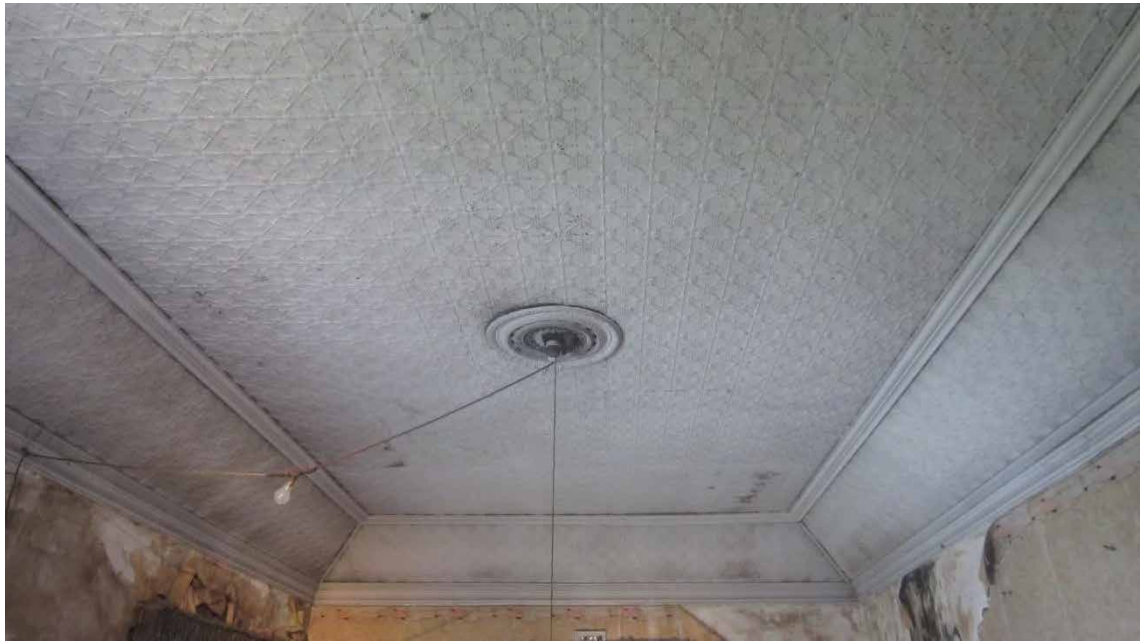
Figure 112. Pressed metal ceiling of sitting room, replacing tongue in groove ceilings and disguising amalgamation of the sitting room and north-western bedroom as originally laid out; note ceiling rose for gasolier, and later adaptation to electric light.

Ceilings: these shall be repaired where possible, and elsewhere reconstructed in accordance with remaining historic fabric.

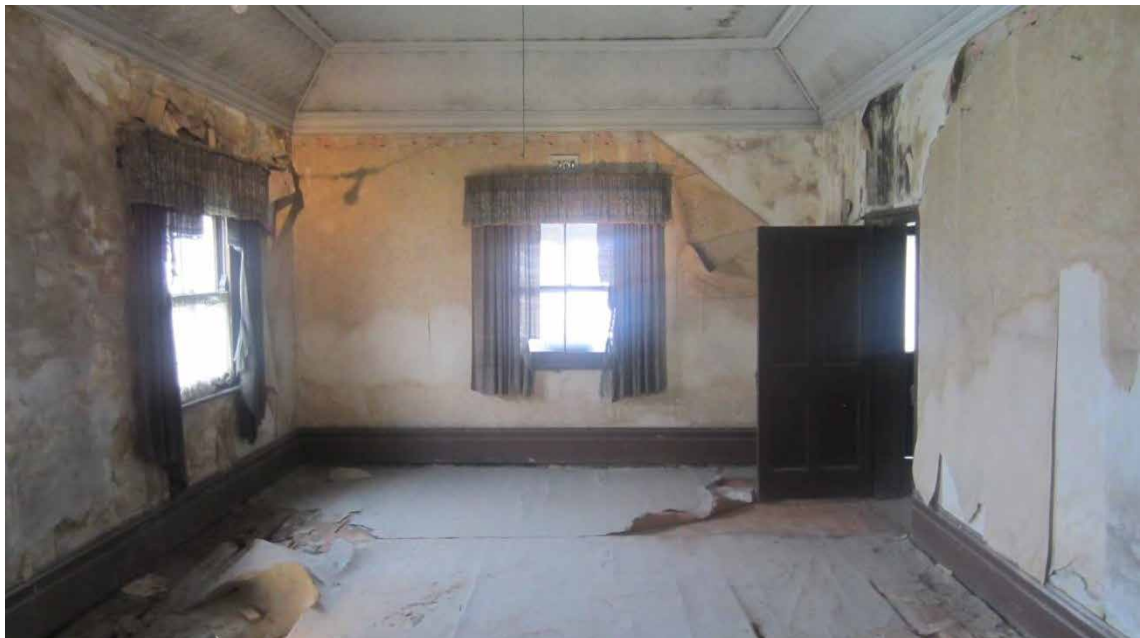
Figure 113. Sitting room, looking east; note curtains, pelmets, oilcloth and linoleum floor coverings, and peeling wallpaper. Floor coverings underlaid by newspapers dated 1903.

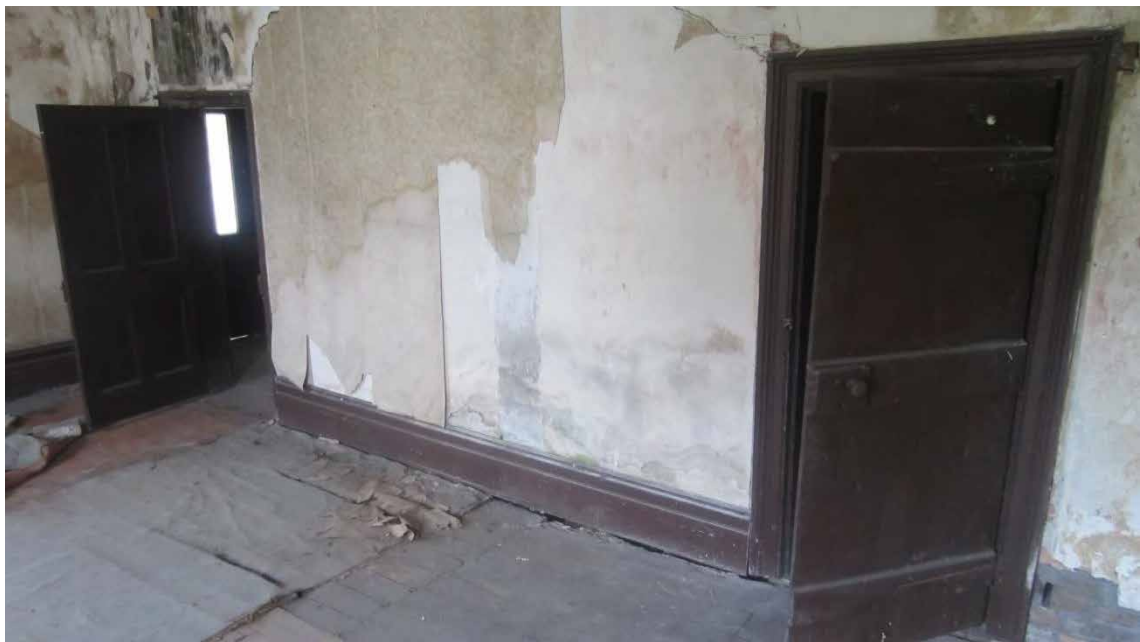
Figure 117. Contrast between door finishes; the rear of the door leaf at right, originally providing access to the former north-western bedroom later amalgamated with the sitting room to form one large room, is much more roughly finished than that of the original sitting room at left. Note short floor boards where dividing wall was formerly located.

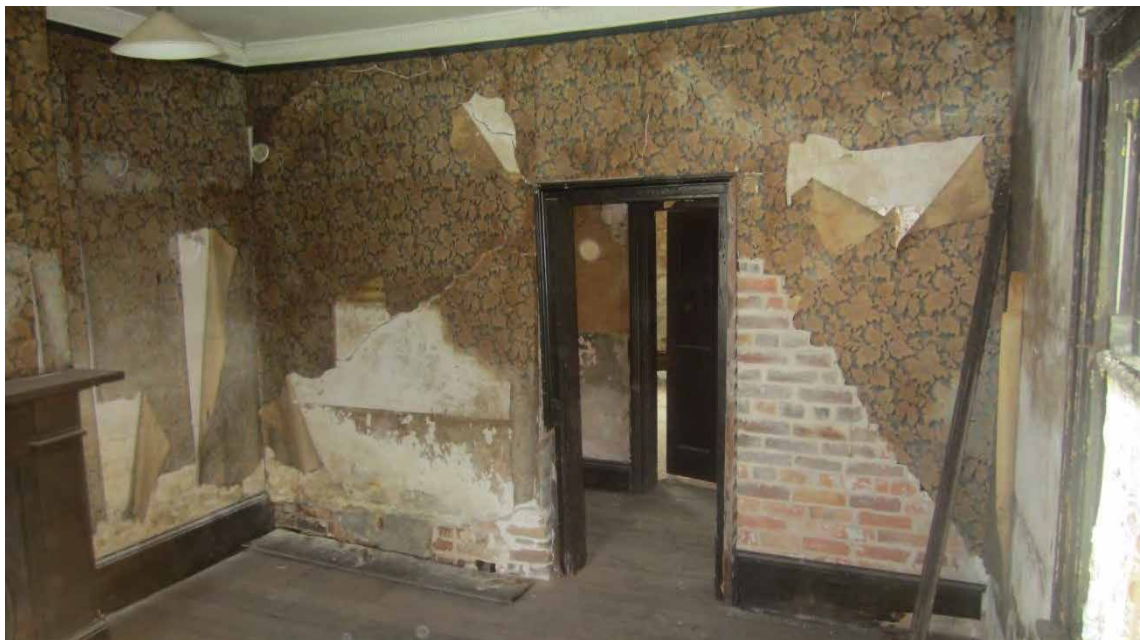
Figure 125. Note dislocated skirting board and peeling wallpaper.

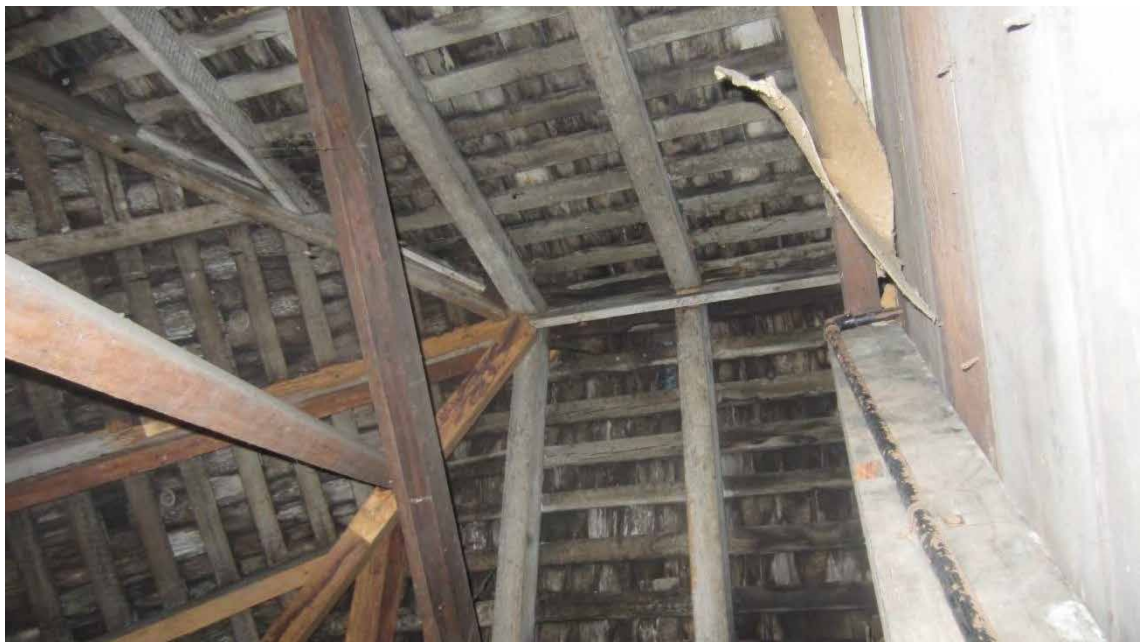
Figure 139. Roof cavity above dining room; new hardwood has been cleated to rafters following historic termite damage.

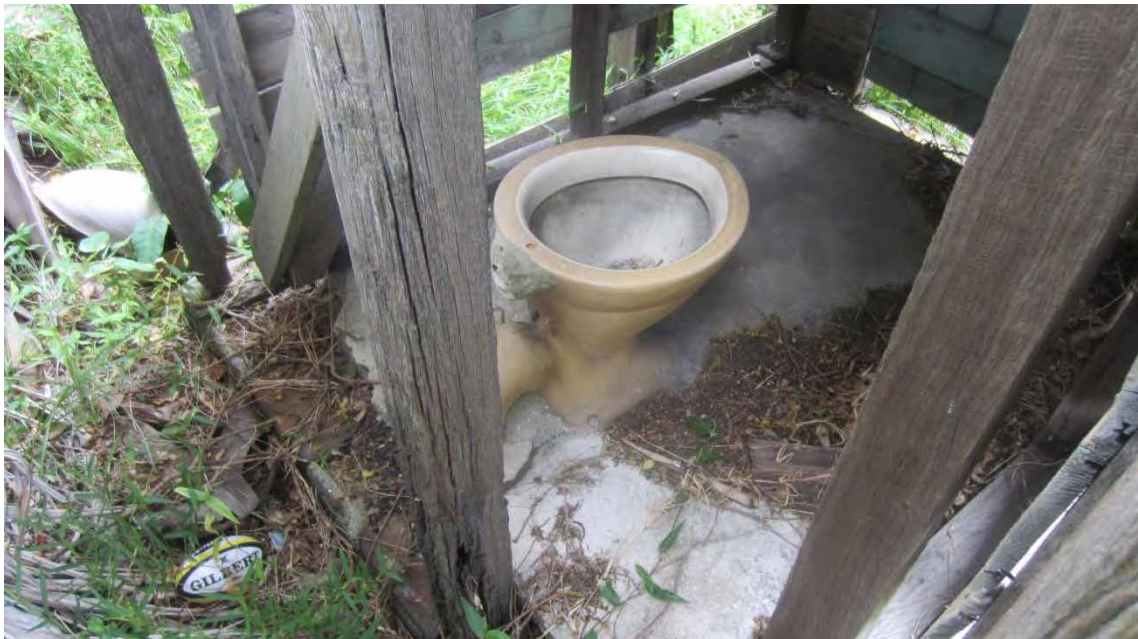
Figure 159. Outside lavatory; note proximity of garage at left.

Outside Lavatory: It being anticipated that indoor w.c. facilities will in future be provided, the outside lavatory may be converted into a storage shed or similar, and relocated on site as necessary, unless the registered proprietor wishes to retain it as a secondary toilet. The structure should be re-roofed in galvanised corrugated iron to match the dwelling, the frame should be strengthened as necessary, and the weatherboards may be repaired or replaced in similar materials as convenient. As the structure appears never to have been painted, it may be left as such, or painted according to taste.

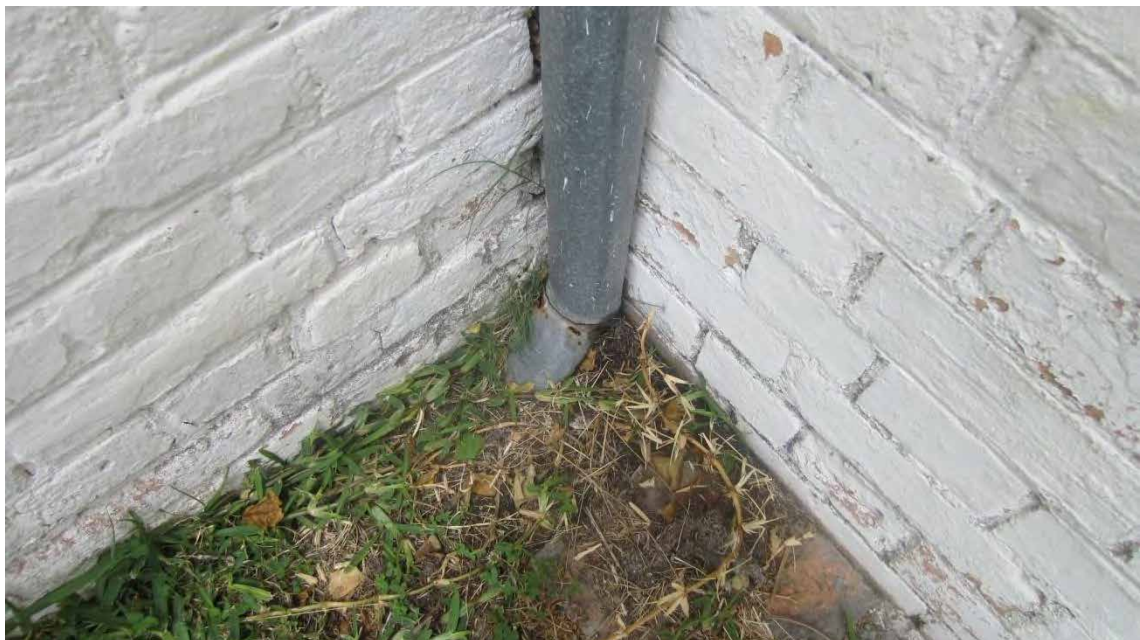
Figure 176. Limewashed walls; note redundant downpipe (left) and build-up of detritus above active downpipe (centre).

Roof, Guttering and Downpipes: These should, at the end of their service lives, be replaced in materials complementary to the original materials. Zinalume or Colorbond roofing sheets should be avoided in favour of Fielders Z600 sheeting (see <http://www.fielders.com.au/asp/home.aspx>) or similar heavily-galvanised corrugated galvanised sheeting. Rather than being continuous, sheets should be short and overlapped, rather than continuous, to complement the original.
